# Building Condition Assessment Report

## CRAIGLEITH HERITAGE DEPOT 113 LAKESHORE ROAD EAST CRAIGLEITH, ON

Township of The Blue Mountains  
32 Mill Street  
Thornbury, ON N0H 2P0  
Main: 519.599.3131  
Web: [www.thebluemountains.ca](http://www.thebluemountains.ca)

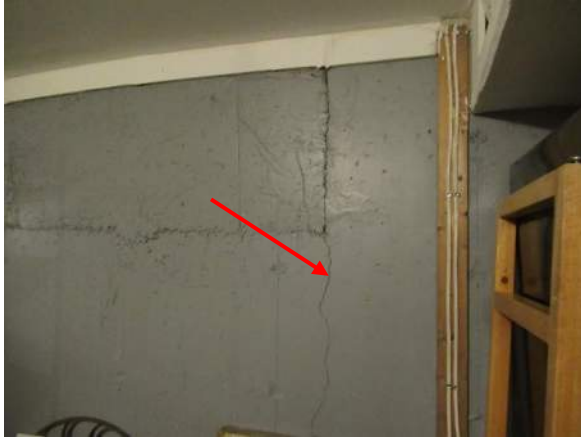
**Picture S 01**

The foundation walls are constructed of cast-in-place concrete as observed from the interior in the basement of the building. A crack in the foundation wall was observed on the west wall. In general, the foundation walls are in good condition. The roof and first level floor structures are constructed of wood. These could not be observed as they are finished. The slab-on-grade in the basement is in good condition with local areas of cracking; these are typical and are not considered to be a major structural concern.

**Components** – Concrete foundation  
**Location** – West wall

- 1) Repair the foundation wall crack observed on the west wall.
- 2) It is recommended to backfill the foundation wall area where Blueskin is exposed as part of operating. Ensure that the Blueskin is continuous and waterproof prior to backfilling.

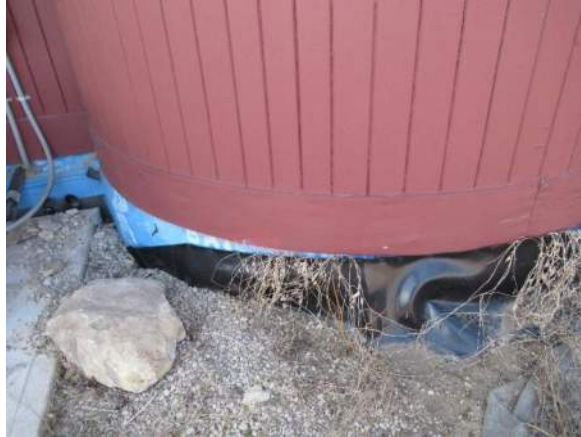
**Picture S 02**

On the northwest corner elevation of the building, Blueskin membrane was noted to be exposed.

**Components** – Foundation, exposed Blueskin  
**Location** – Tower

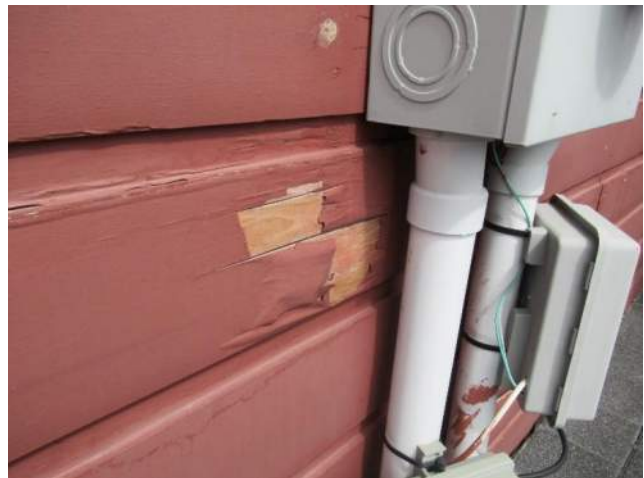
**Picture ENV 02**

- Wood components of the heritage depot are typically painted. This includes the wood siding, window frames, exterior doors, wood trims, and wood signs and posts around the building.
- In general, the paint is in poor condition. Throughout the building, peeling/weathering of paint was noted.

**Components** – Wood siding, peeling paint  
**Location** – East elevation

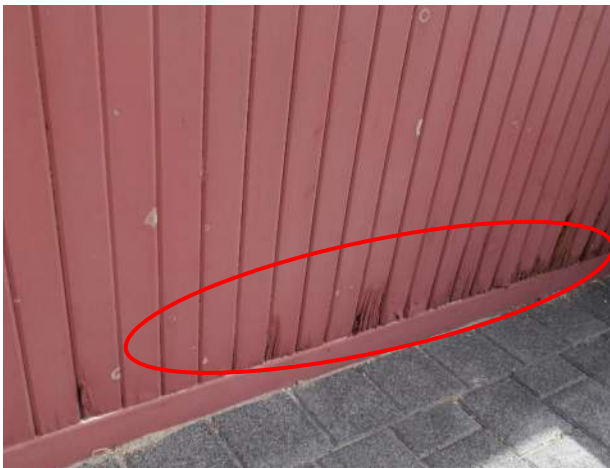
**Picture ENV 03**

- Wood siding with wainscott design in some areas are in fair condition.
- The site personnel noted that local areas at the base of the wood siding have been replaced in the past due to water damage. Water is reported to be seeping up onto the exterior wall from grade. The siding has rotted on the east and south elevations.
- In isolated areas, the wood siding has cracked/split.

**Components** – Wood siding, water damage  
**Location** – South elevation

- 1) Replace wood siding on the south and east elevations in the next 2 years.
- 2) Repair local areas of wood damage in the next 2 years.
- 3) It is recommended to further investigate into the water damage to the wood siding within the year. An allowance for the investigation has been provided.

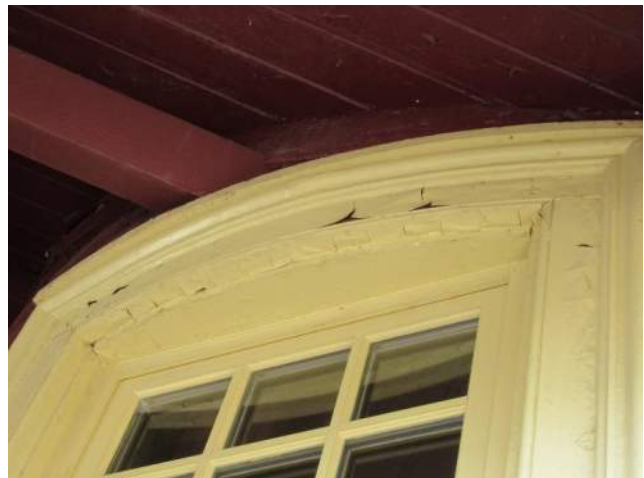
**Picture ENV 04**

**Components** – Window frame, peeling paint  
**Location** – East elevation

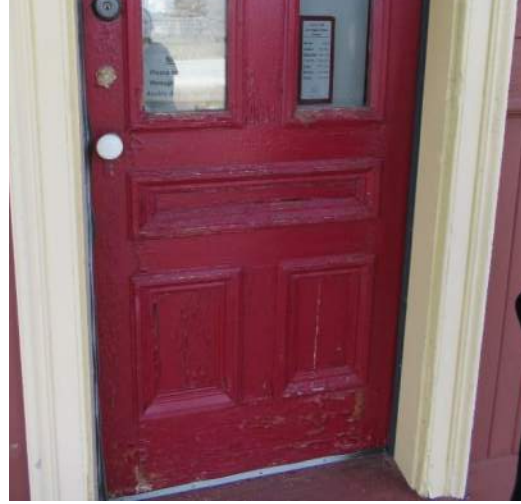
Picture ENV 06

- There are 8 exterior wood doors with half lite glazing present at the building.
- Most doors of the 1900 building are original and are in poor condition. The wood doors have rotted and cracked. At one location on the south elevation, the site personnel noted that the door has been replaced, however, it is observed to be in poor condition as noted by impact damage. The site personal also noted of moisture issues at the base of the replaced door.
- The doors of the 2008 addition are in good condition, however, it is reported that water infiltrates at the base of the doors on the north and south elevations.

**Components** – Original exterior door, rotted wood, peeling paint  
**Location** – Throughout

- 1) Replace all 1900 original doors within the year.
- 2) Replace all 2008 doors in the next 20 years.

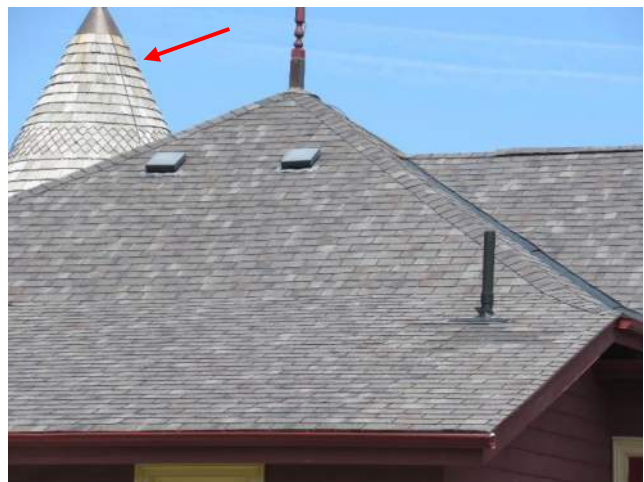
Picture ENV 08

- The main roofs are clad with asphalt shingles. The asphalt shingles were installed in 2008. The shingles are generally in fair condition with the exception of isolated areas where the shingles are beginning to deteriorate or is missing.
- The site personnel noted that the roofing will be replaced this year.
- The tower is clad with cedar shingles and is in good condition.

**Components** – Asphalt shingles and cedar shingles  
**Location** – Throughout

- 1) Asphalt shingles will be replaced this year.

- 2) It has been assumed that the cedar shingles have been installed in 2008. Replace cedar shingles in the next 2 years. Regular and good maintenance will increase service life.

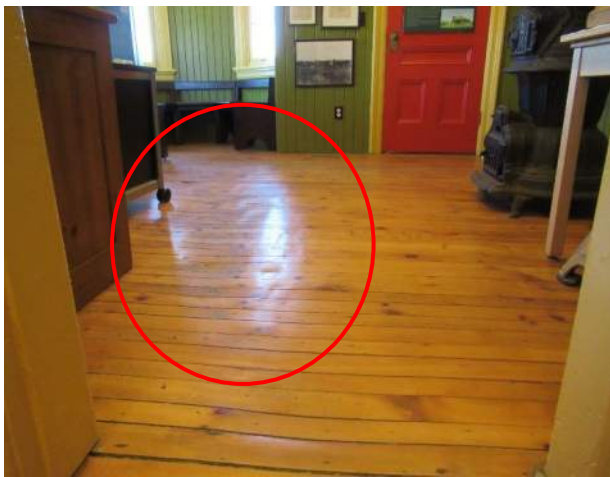
**Picture INT 03**

- Hardwood flooring in the main gallery area is in poor condition. The floor surface has weathered over time and the joints of the flooring are becoming visually prominent. In local areas, particularly at the Tower, the flooring has warped. The flooring near doors shows water staining/discolouration.

**Components** – Hardwood flooring, note warp  
**Location** – Throughout

- 1) Allow to repaint the walls and ceilings in the next 5 years and every 15 years thereafter.
- 2) Replace hardwood flooring in the next year.

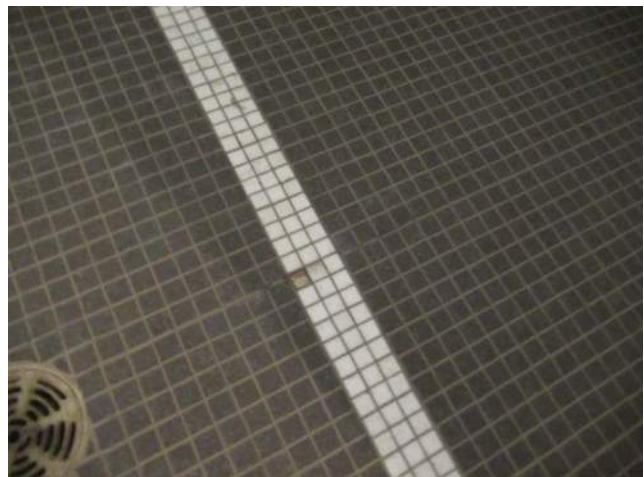
**Picture INT 04**

- 1" ceramic tile flooring is present in the washrooms and the office space in the main gallery. The tiles are in poor condition as the tiles are beginning to pop in isolated areas. A gap was noted between the wall tiles and floor tiles.

**Components** – Ceramic tile flooring  
**Location** – Washrooms

- 3) Repair ceramic floor tiles in the next year.
- 4) Repair ceramic wall tiles in the next 15 years.
- 5) Consider to grind the stone tile flooring to make level surface for patrons within the year.
- 6) Replace interior doors on an as needed basis. An allowance is allocated in the next 10 years.

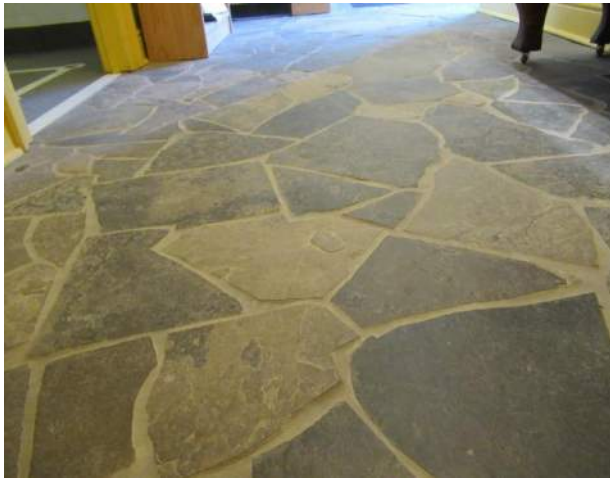
- Stone tile flooring is present in the 2008 addition and is in good condition. The flooring is noted to be uneven and could pose as a potential tripping hazard.

**Picture INT 05**  
**Components** – Stone tile flooring  
**Location** – 2008 Addition

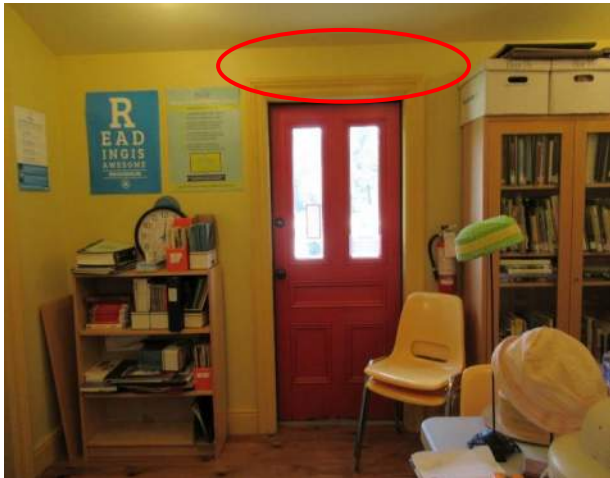
Picture ME 03

**Components** – Missing exit sign.

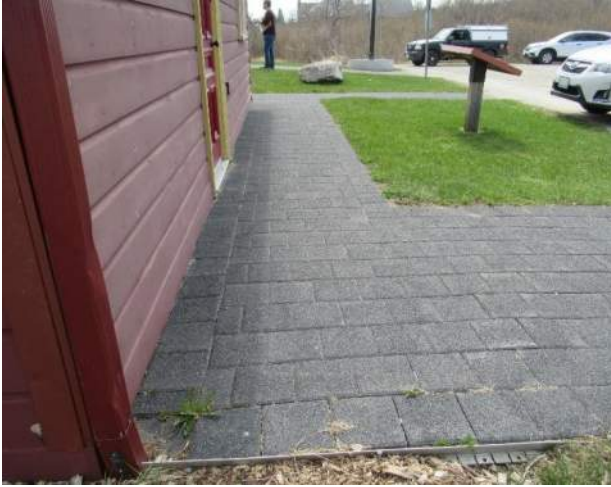
Picture SITE 01

- Water ingress was reported at the front doors. Based on site conditions, it appears that the pavers are graded with a negative slope (towards the building) and may be high in some areas.

Components – Pavers  
Location – Front elevation

- 1) The front lot of the building is not paved. Consider to pave the parking lot for enhanced use/accessibility for people with wheelchairs.
- 2) Regrade the pavers with positive slope to help mitigate moisture build up close to the building wall. It is recommended to regrade within the year.

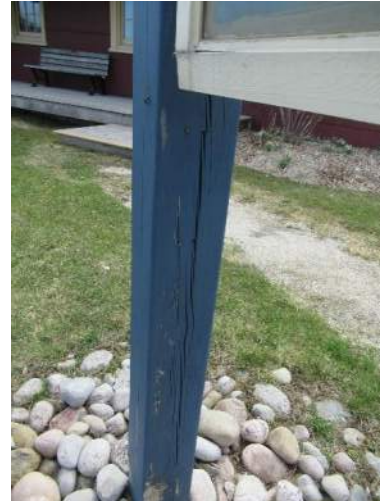
Picture SITE 02

- A hanging building sign is present on the west elevation of the building and as a stand alone building sign is present on the west lot of the building. The building signs are generally in good condition. Wood posts of the stand alone building sign is noted to have split. The paint on both signs has lightly deteriorated.

Components – Building sign post  
Location – West lot

- 3) An allowance has been allocated for potential replacement of the remaining two (2) lightning rods in the next 5 years.
- 4) Repair and repaint the building signs and display signs in the next year. Repair/repaint every 10 years.

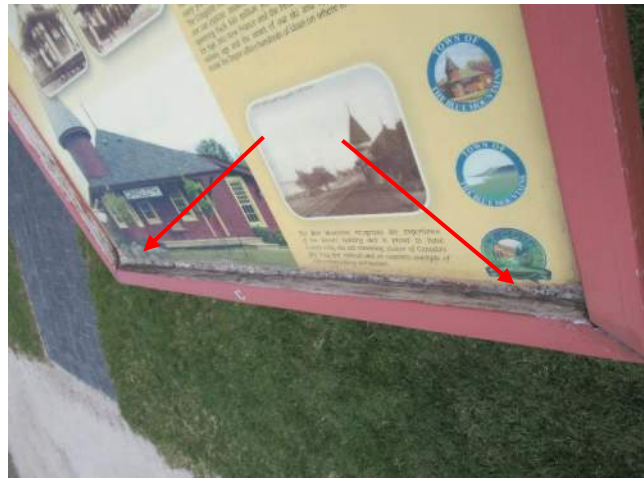
Picture SITE 04

- Site display signs are present in front of the building and along a trail adjacent to the site. The signs are constructed of wood and is painted. The paint has deteriorated and some parts of the wood is noted to be rotting.

Components – Wood display sign, rotting wood  
Location – Front elevation

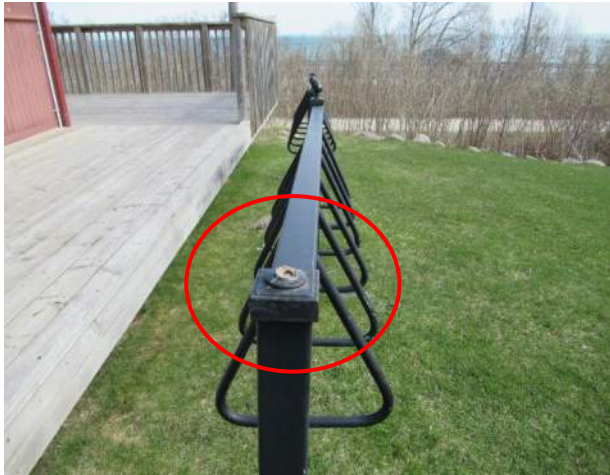
**Picture SITE 05**

- A bollard is present next to electrical pole. The bollard has lightly corroded at the base and top with wearing of paint finish.
- Two (2) bike racks are present on the east elevation of the building next to the wood deck. At one of the bike racks, the head at the post has been sheared. The racks are in good operating condition however the missing head may pose as a safety hazard.

**Components** – Bike rack  
**Location** – East lot

- 8) Repair the head of the bike rack post for user safety as part of operating.
- 9) Replace wood bench in the next 25+ years.
- 10) Consider to install a light stand with an electrical source for night lighting. An allowance has been allocated in the next year. Replace solar lighting in the next 20+ years.
