Building Condition Assessment Report

BLUE MOUNTAINS PUBLIC LIBRARY
173 BRUCE STREET SOUTH
THORNBURY, ON

Town of The Blue Mountains
32 Mill Street
Thornbury, ON N0H 2P0
Main: 519.599.3131
Web: www.thebluemountains.ca

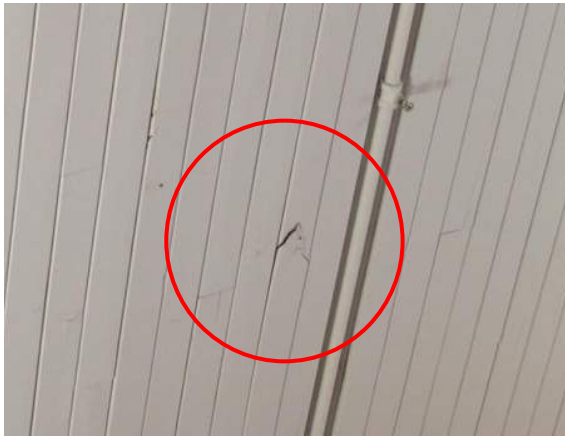
Picture S 01

Components – Wood ceiling
Location – Library

- 1) An allowance has been allocated to repair local areas of the wood ceiling in the next 2 years. Allow to repair wood ceiling every 25 years.
- 2) It is recommended to replace the wood structures at the entrances in the next 2 years.

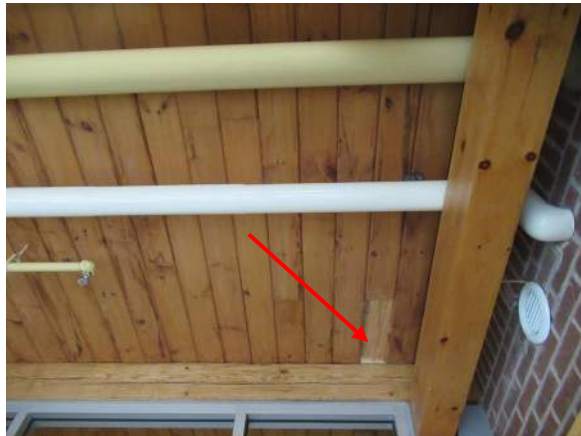
Picture S 02

Components – Wood ceiling
Location – Entrance vestibule

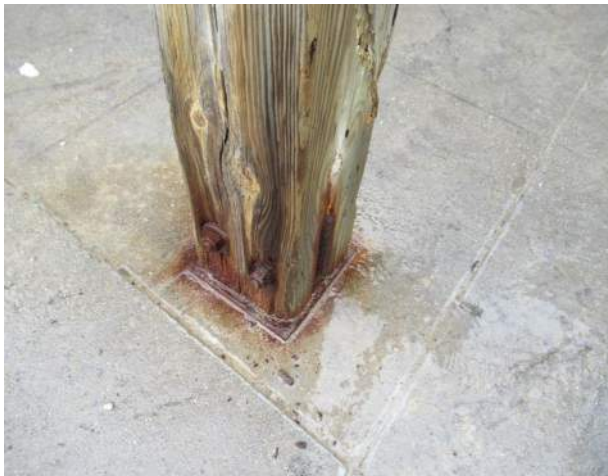
Picture S 03

The front and rear entrances to the building are supported by wood beams and posts. The base of the wood posts show corrosion staining from the fasteners. The wood beams have split in some areas and appear to be original to the building construction.

Components – Wood structure
Location – Entrance

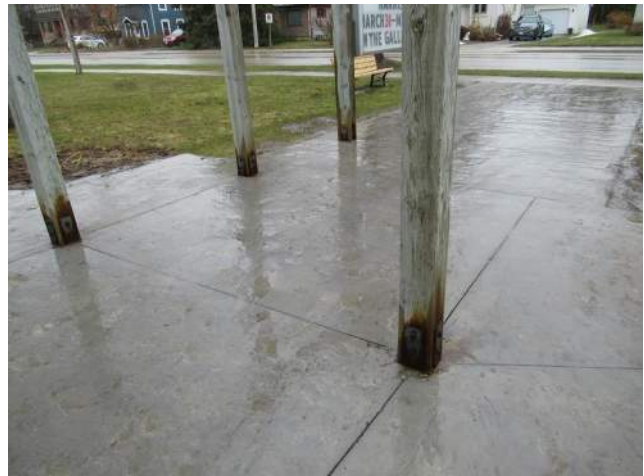
Picture S 04

Components – Wood posts
Location – Entrance

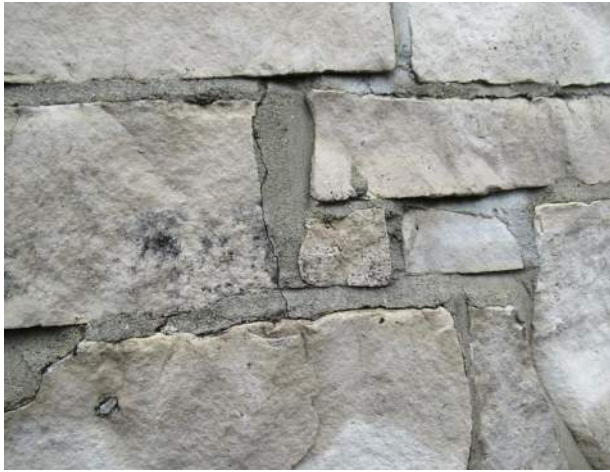
Picture ENV 01

- Prefinished metal siding panels are present above the first level and are noted to be in good condition.
- Masonry bricks are present below the first level and is in good condition. Some of the mortar joints appear to have cracked or are missing.
- Stone walls are present at the courtyard located by the front entrance and at the Tower. The stone walls are in fair condition with cracked mortar joints particularly at the Tower. Water staining and the presence of organic was observed on the coping stones of the stone wall at the courtyard.

Components – Stone wall
Location – Tower

- 1) Replace metal siding in the next 15 to 18 years.
- 2) Repair the masonry and stone walls in the next 3 years. Allow to repair every 15 years.
- 3) Consider to clean the coping stones from organic growth/staining.

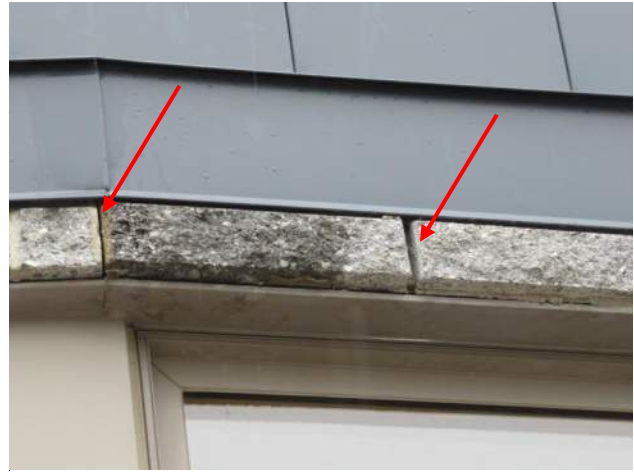
Picture ENV 02

Components – Masonry wall
Location – Throughout

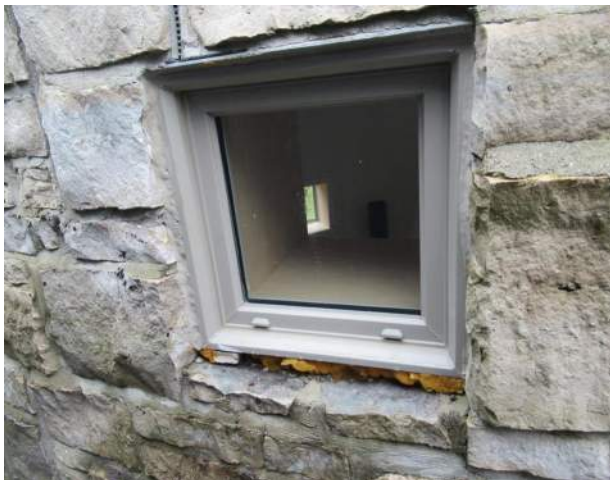
Picture ENV 03

- Original windows are typically wood framed with insulated glazing units dated 1995. The windows have been clad with metal on the exterior.
- The site personnel noted that windows at the Tower and select windows in the building were replaced with vinyl framed windows in 2015.
- The windows installed at the Tower (2015) are incomplete as noted by missing sealant and window sills. In some locations, the sealant appears to have been improperly installed as noted by air bubbles in the sealant.

Components – Windows, missing sill
Location – Tower

- 1) It is recommended to complete the rehabilitation of the windows at the Tower, which includes installing window sills and new sealant, and replacing improperly installed sealant with new. It is recommended that this work be completed within the year.
- 2) Given the age of the windows and the water staining observed at the windows located on the north and northwest elevations, it is recommended to replace these windows in the next 5 years.
- 3) It is expected that the remaining original windows would have to be replaced in the next 10 years with good maintenance.
- 4) It is recommended that the skylight be replaced in the next 20+ years.

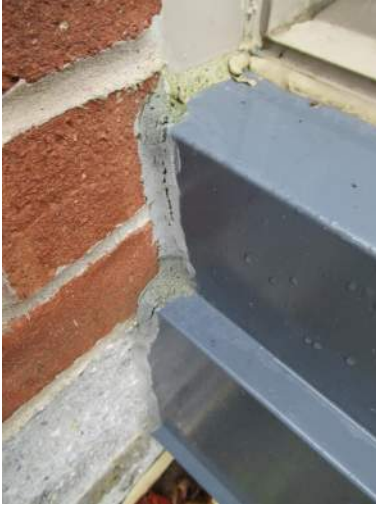
Picture ENV 05

- Sealants around windows and control joints are in poor condition. Window perimeter sealants and control joints were found to have failed/deteriorated as noted by crazing, splitting, and cracking.

Components – Sealant
Location – Throughout

- 1) Replace all sealants in the next 1 to 3 years.

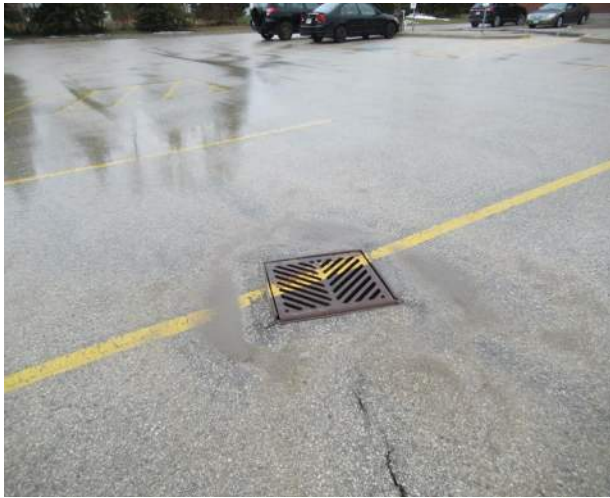
Picture SITE 01

- Asphalt parking lot in front of the building was found in good condition. Longitudinal cracking and local settlement at the catch basin was noted.
- Concrete curbs were generally in good condition. In local areas, the curb has cracked.

Components – Pavement
Location – Parking Lot

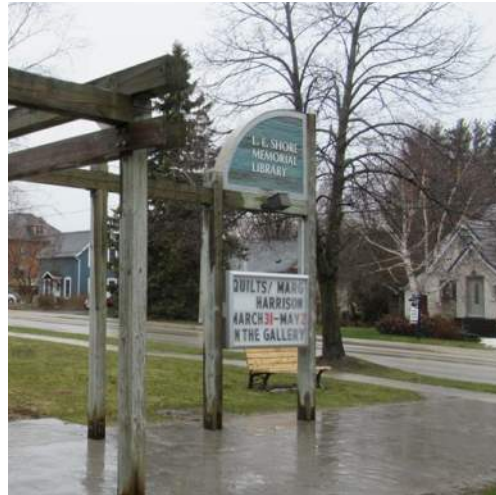
Picture SITE 02

- Stone tile walkway is present at the entrance near the parking lot of the building and is in good condition. No major damages were noted.
- The building sign is located west entrance to the building and appears to be original to the building. The sign is in fair condition.

Components – Building Sign
Location – Near Building Entrance

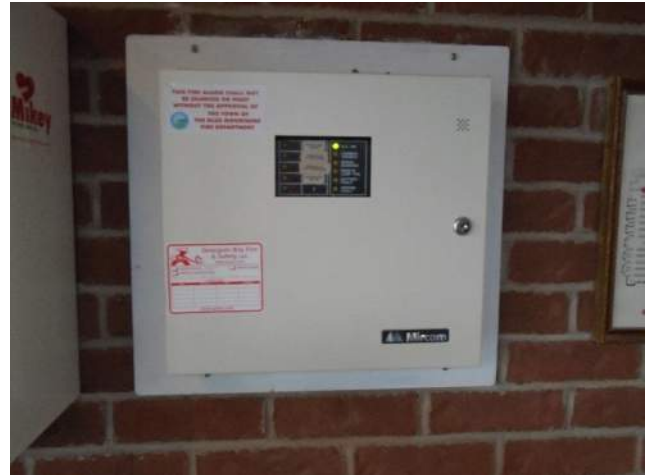
Picture ME 02

- The defibrillator in the main vestibule is in good condition.
- The building is equipped with a fire alarm system. The fire alarm panel is manufactured by "Mircom" that appears to be equipment installed in the early circa 2000s and is located in the main vestibule. The fire alarm panel is wired to the initiating and signaling devices throughout the building. This includes smoke detectors in the gallery and the reading areas and heat detectors in the service rooms, flow switches on sprinkler mains and manual pull stations near exit doors. The fire alarm panel is in fair condition.

Components – Fire alarm panel
Location – Vestibule

- 2) Allow to replace the "Mircom" fire alarm panel in the long-term (within 6-10 years). Individual fire detection devices can be replaced as part of regular operation and maintenance. (O&M).
- 3) Allow to replace the check valve, the supervised valve and other accessories in the long-term (within 6-10 years).
- 4) Allow to replace exit lights with battery-operated emergency lighting units in the long-term (within 6-10 years).
- 5) Allow to fire seal all piping penetration in the electrical room in the immediate term.

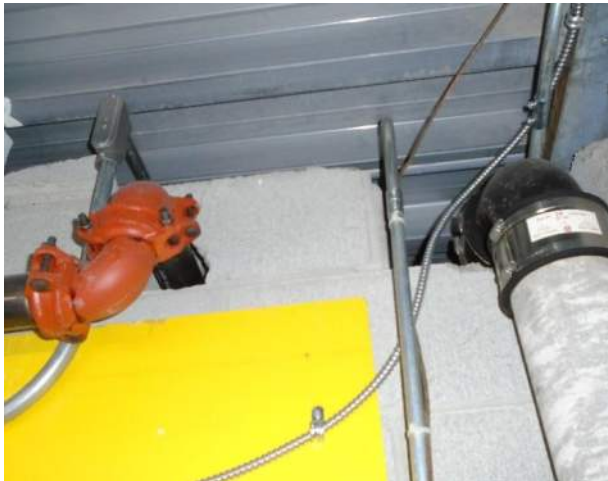
Picture ME 07

- Some sprinkler piping, electrical conduits and drain piping penetrations on the wall were observed in the electrical room.

Components – Sprinkler/ electrical conduit/drain piping penetrations

Location – Electrical room.

Deficiency – Wall penetration.

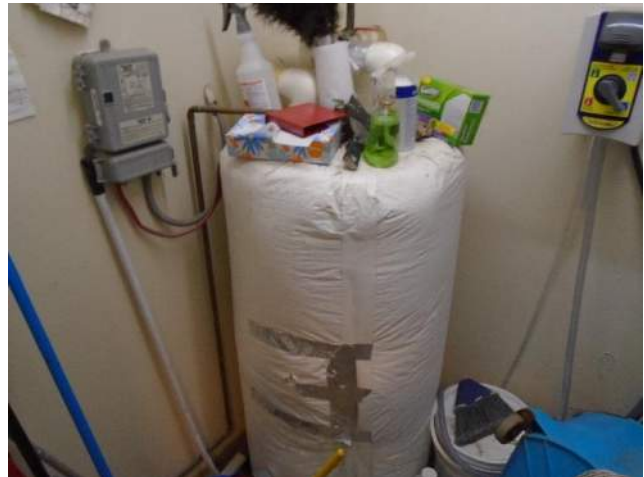
Picture ME 08

- An electric insulated domestic hot water tank heater located in the Janitor room (B4). The tank heater has a 3000W heating element and a storage capacity of 145 litres. The hot water tank heater appears to be in fair condition.

Components – Insulated domestic hot water tank heater

Location – Janitor's room

- 1) Allow to replace the hot water tank heater in the short-term (within 1-5 years). The probable cost to replace this item is below the threshold report level.
- 2) Allow to upgrade the plumbing fixtures in the short-term (within 1-5 years).
- 3) Allow to replace the domestic cold/ hot water piping in the long-term (within 15-20 years).

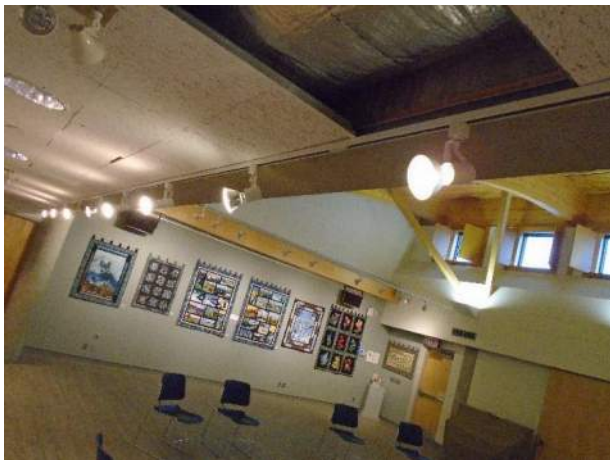
Picture ME 23

- Combination of T5 and T8 fluorescent light fixtures, pot lights throughout the building are in good condition.
- HID lighting fixtures provide lighting to the community hall/ gallery. (See Picture ME 23).

Components – HID lighting fixtures
Location – Gallery
