Unity Design Studio was commissioned by the Town of The Blue Mountains and the Blue Mountains Public Library to review the accessibility of the L.E Shore Memorial Library at 173 Bruce St South in Thornbury.

Unity Design Studios’ scope of work included a visit to the building to assess current conditions as they relate to accessibility, and to subsequently propose various possible improvements that could be undertaken to improve the meaningful accessibility of the site.

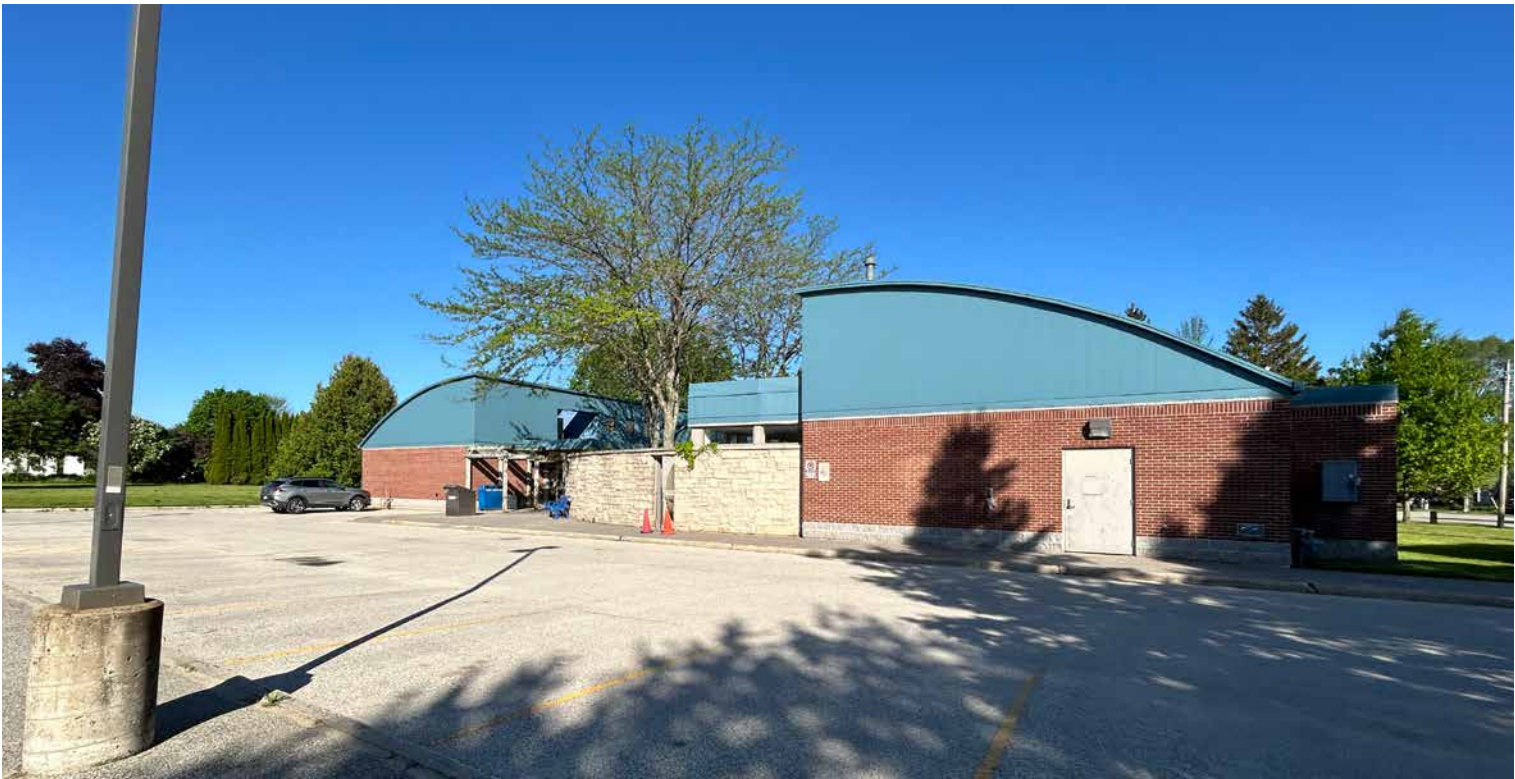
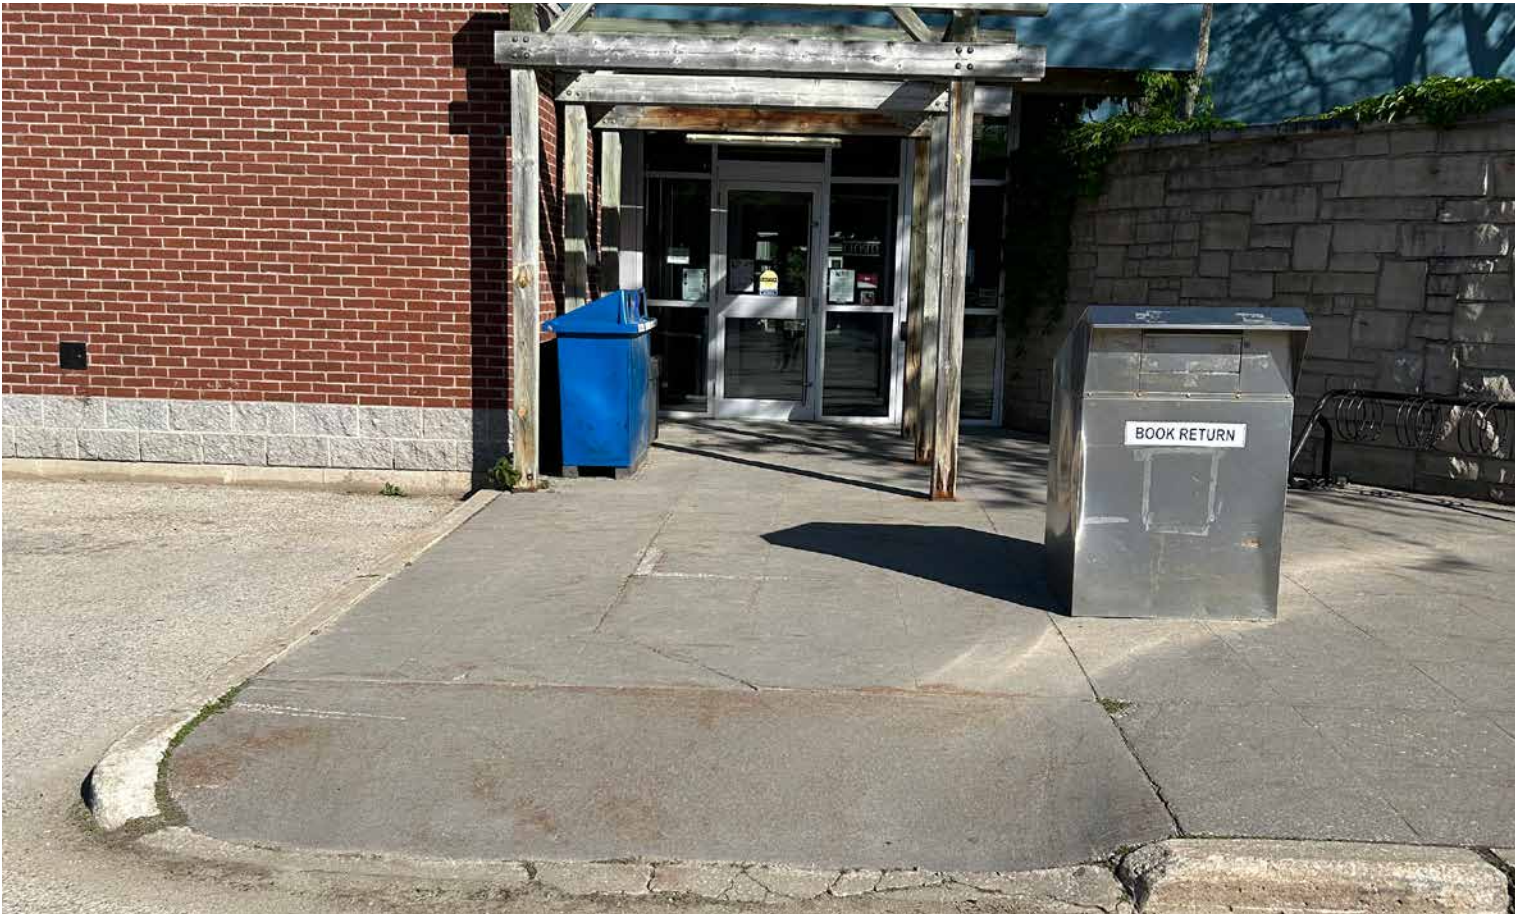
Paths of travel to the entrances are wide enough to accommodate two-way pedestrian traffic and include rest areas, however the benches at the Bruce Street entrance are not accessible.

The door to the courtyard swings out into the path of travel, which is a safety hazard. It's currently marked by pylons, but the remaining space on the sidewalk is too narrow.

The door should swing inwards, be removed entirely, or the walkway could be widened and the door swing protected by a wall or cane-detectable guard.

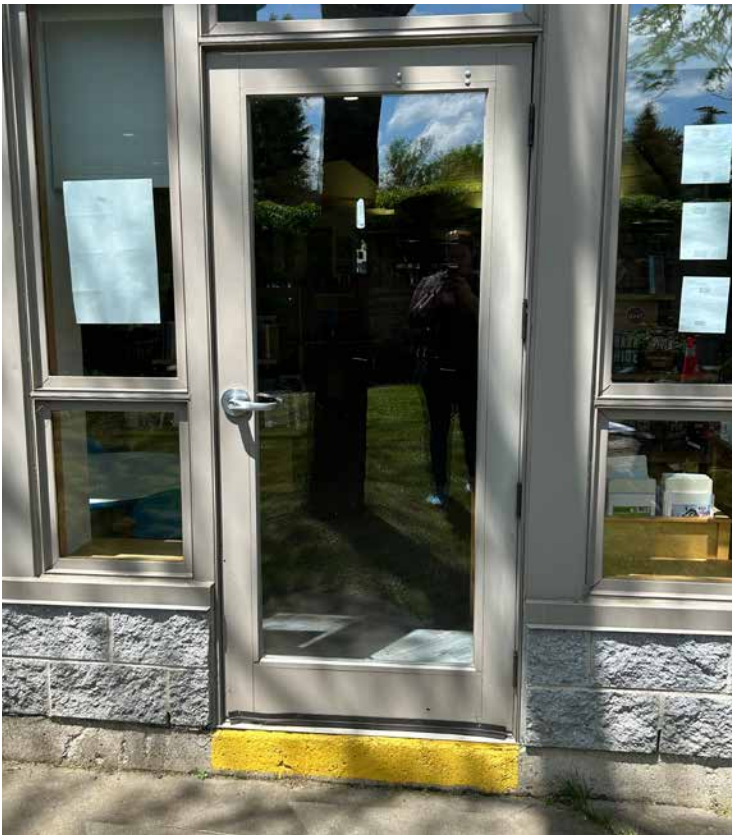
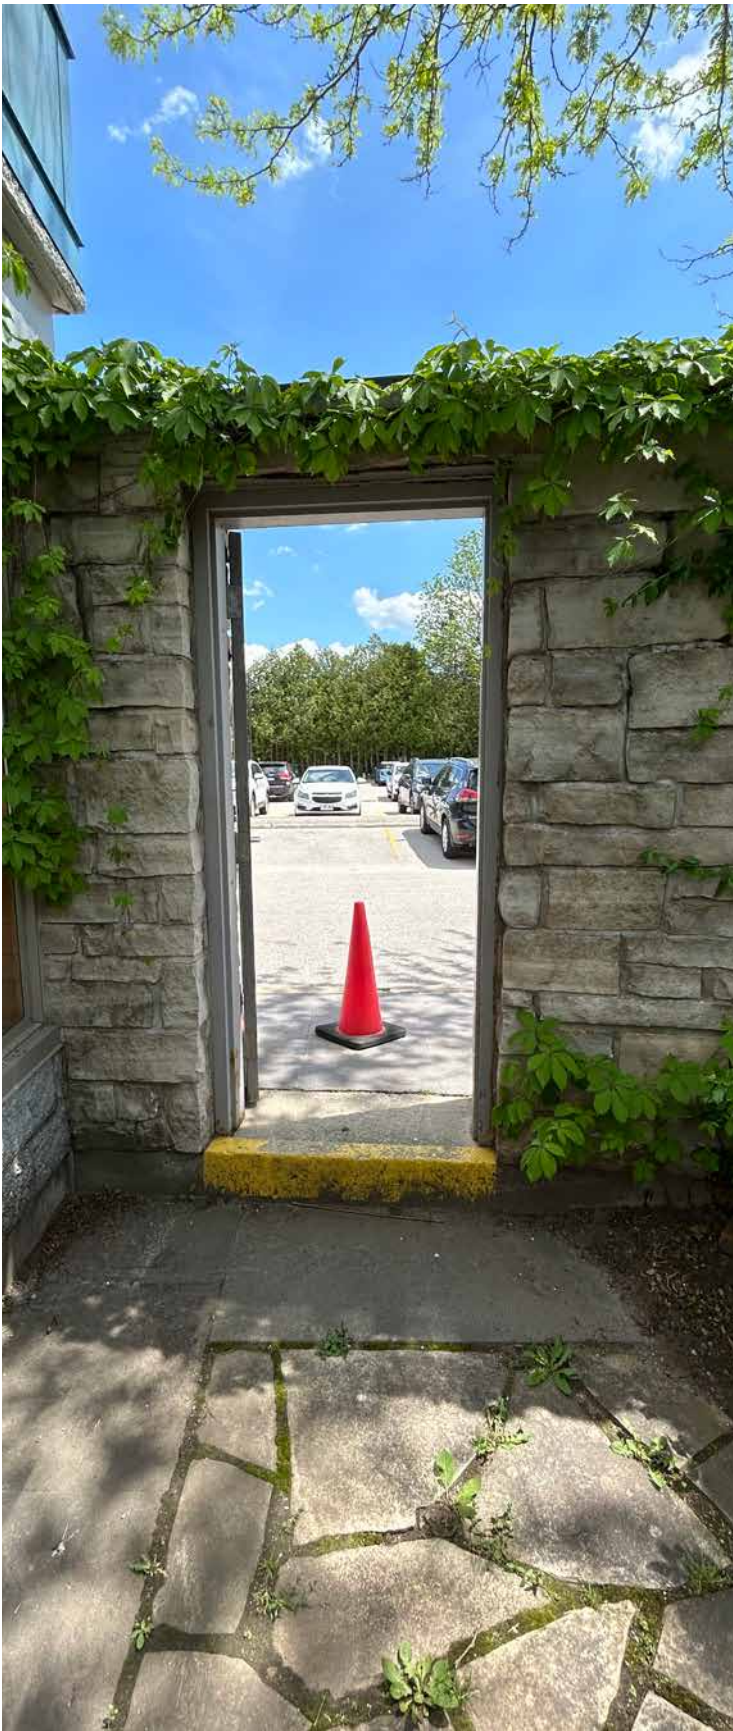
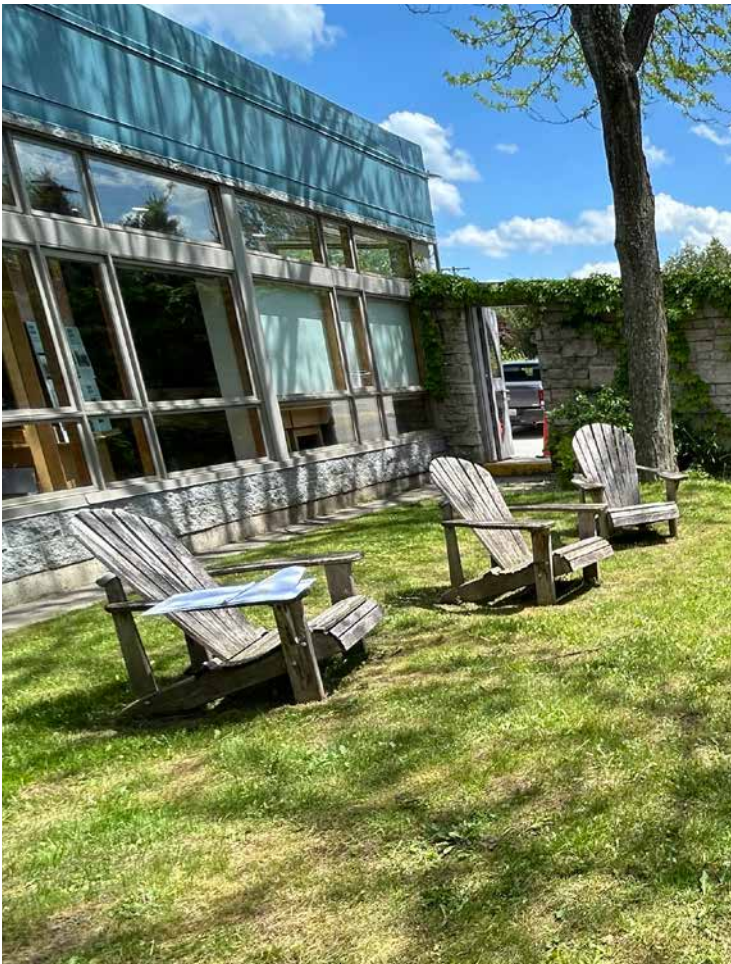
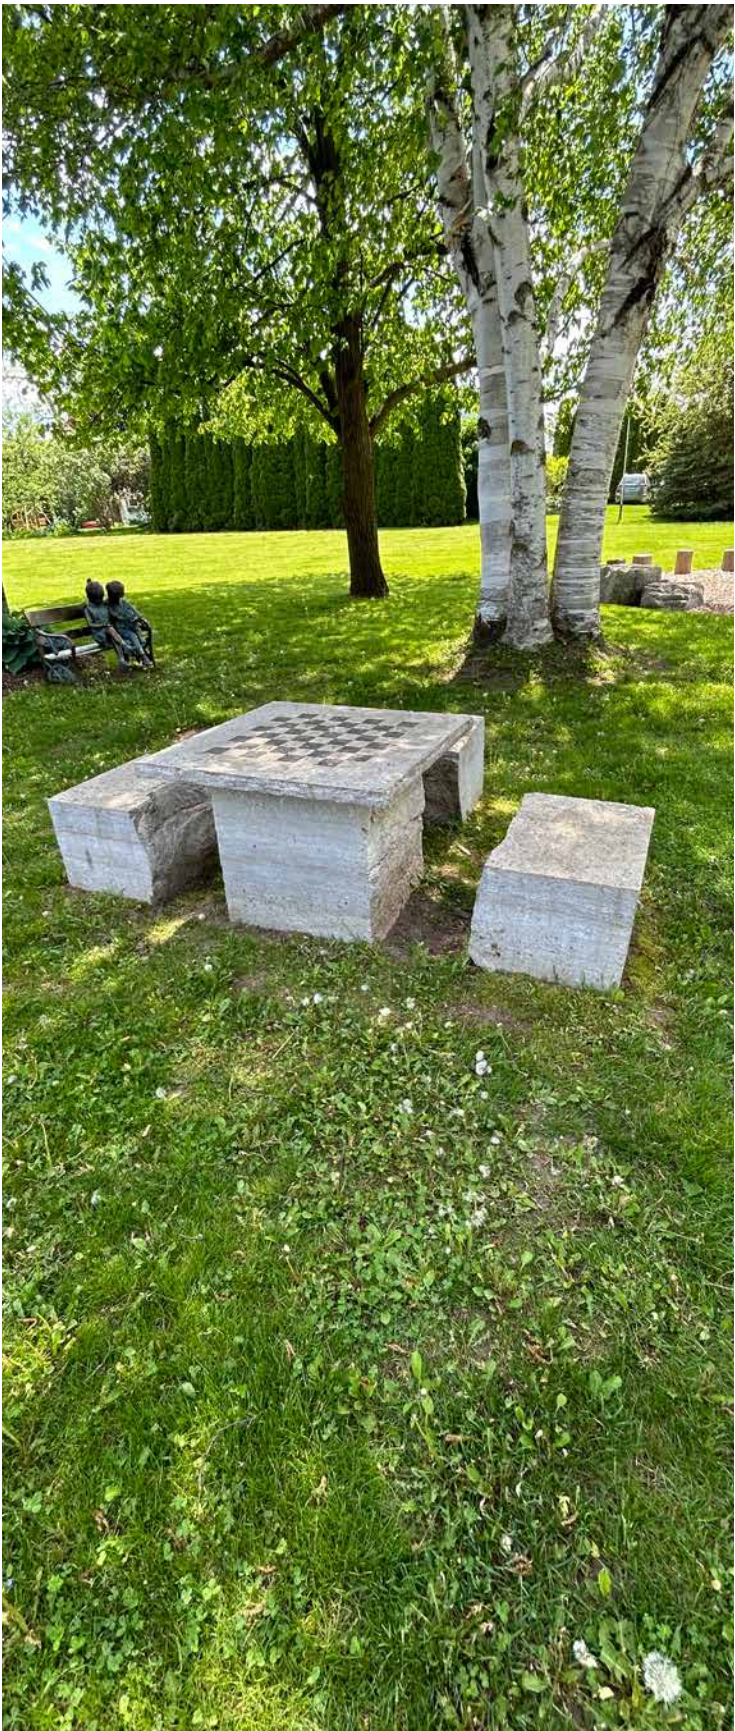
Doors into the courtyard have a 200mm step down into the courtyard area with no access ramps or sloping walkways, which make this space inaccessible to people in wheeled mobility devices.

Having a step right on the threshold of a door is also a safety hazard.

The outdoor seating areas require pathways that are firm and stable to be accessible for people in wheeled mobility devices or with blindness and low vision.

Muskoka chairs, which are currently provided in the courtyard, can be challenging to get up from due to their low, rear-sloping seats.

Outdoor seating options should include styles that have backs, heel space, arms and no arms, as well as an appropriate seat height.

Seating should also contrast with surroundings to make it easier to locate for people with reduced vision.

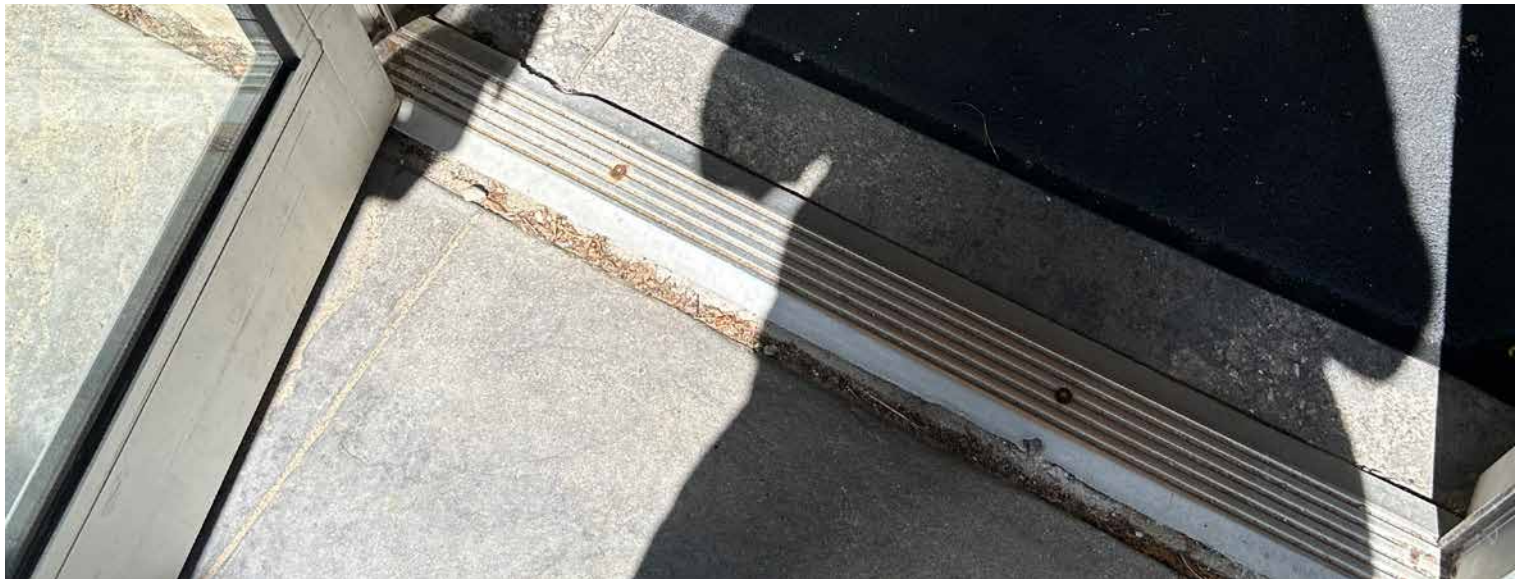
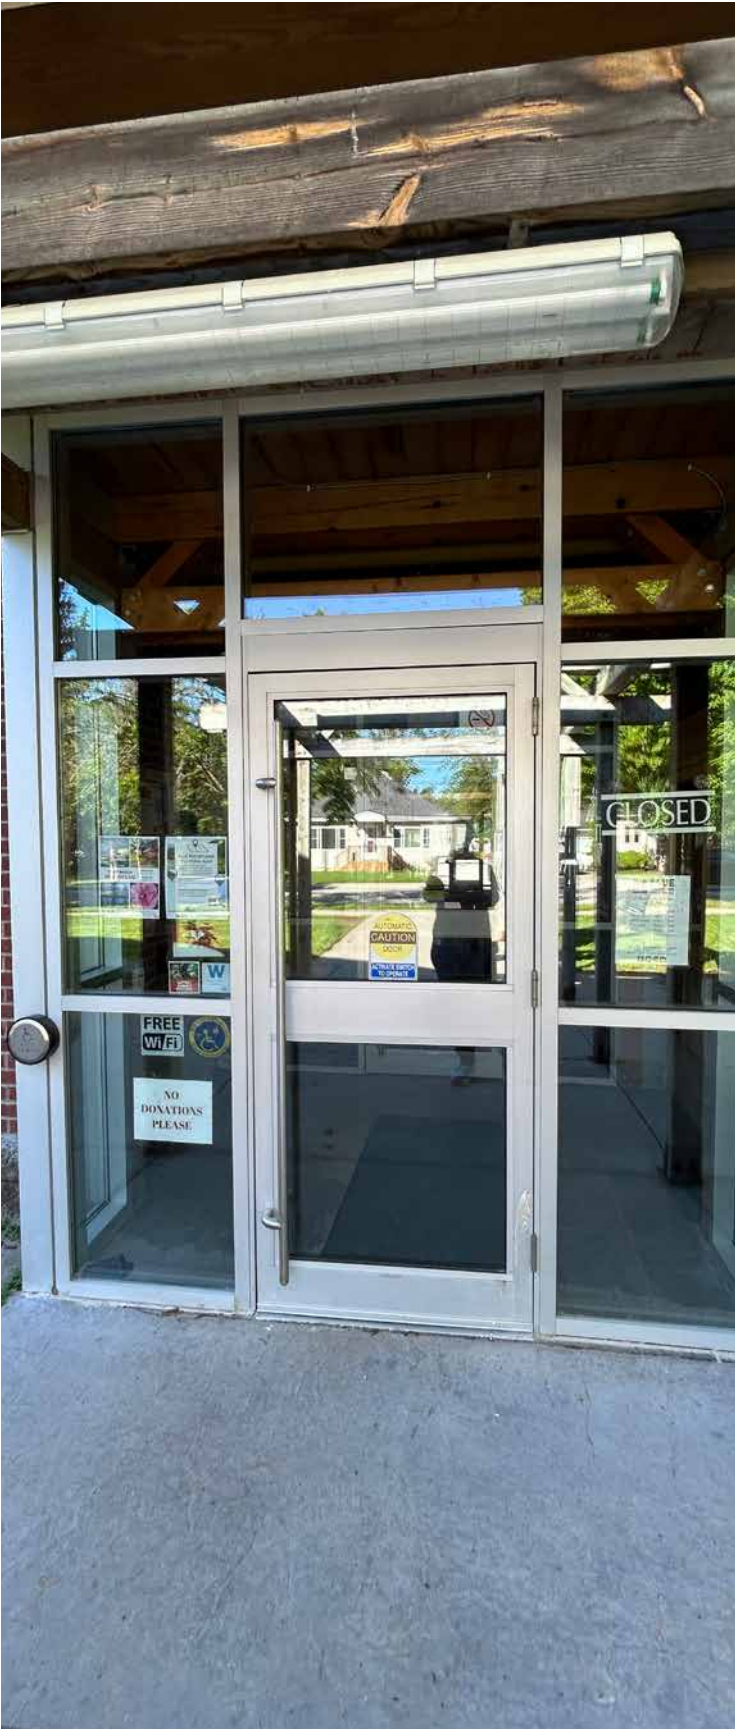
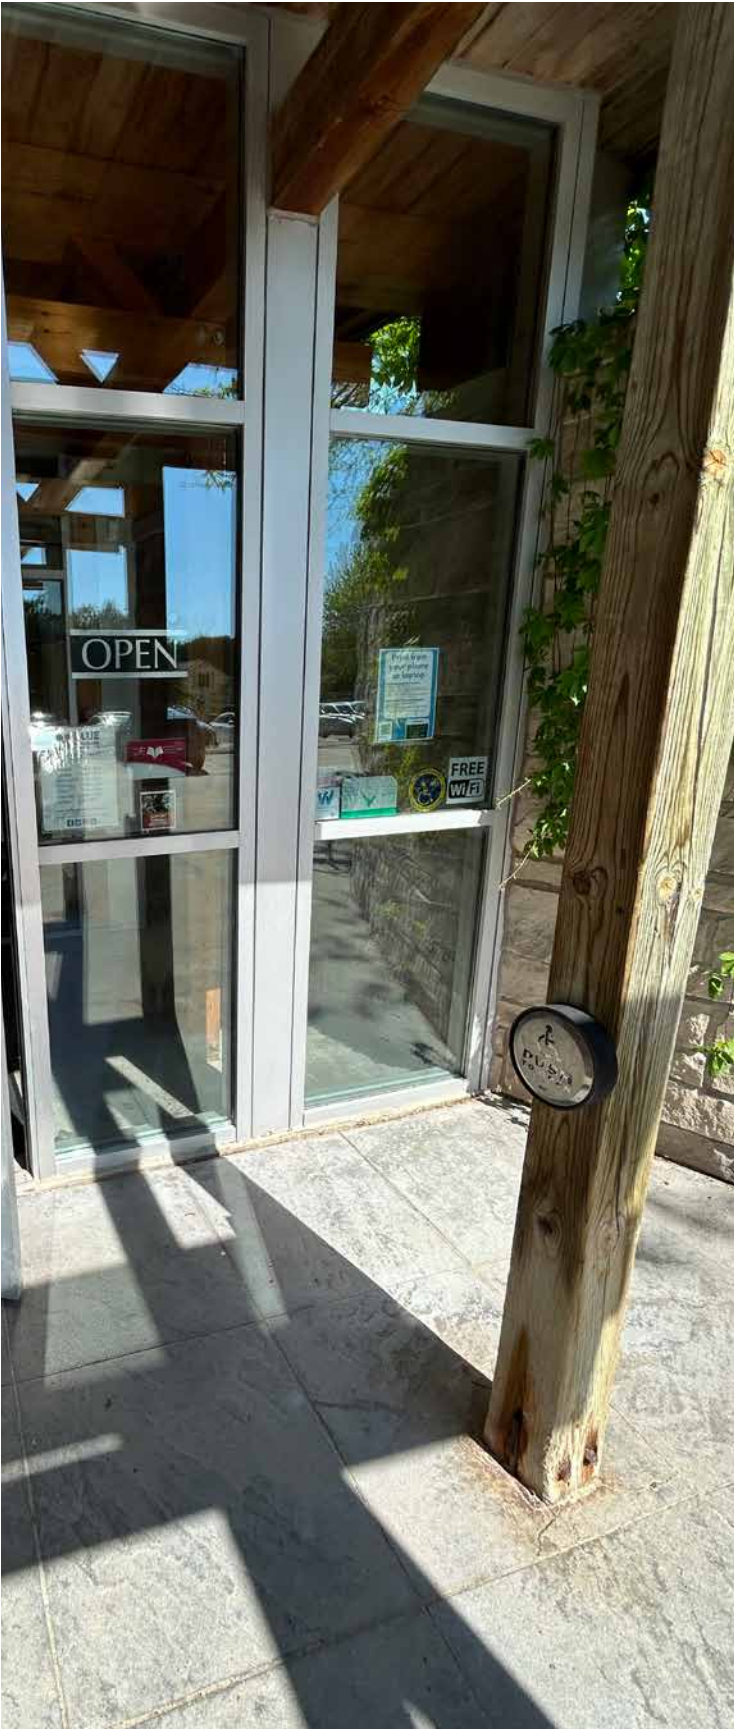
Current Ontario Building Code and CSA B651 standard require a minimum accessible door width of 860mm.

The entrance glazing has horizontal mullions, but best practice would be to add another contrast strip at a higher level.

Glazing should have vision strips at two heights to ensure glazing is not mistaken for openings.

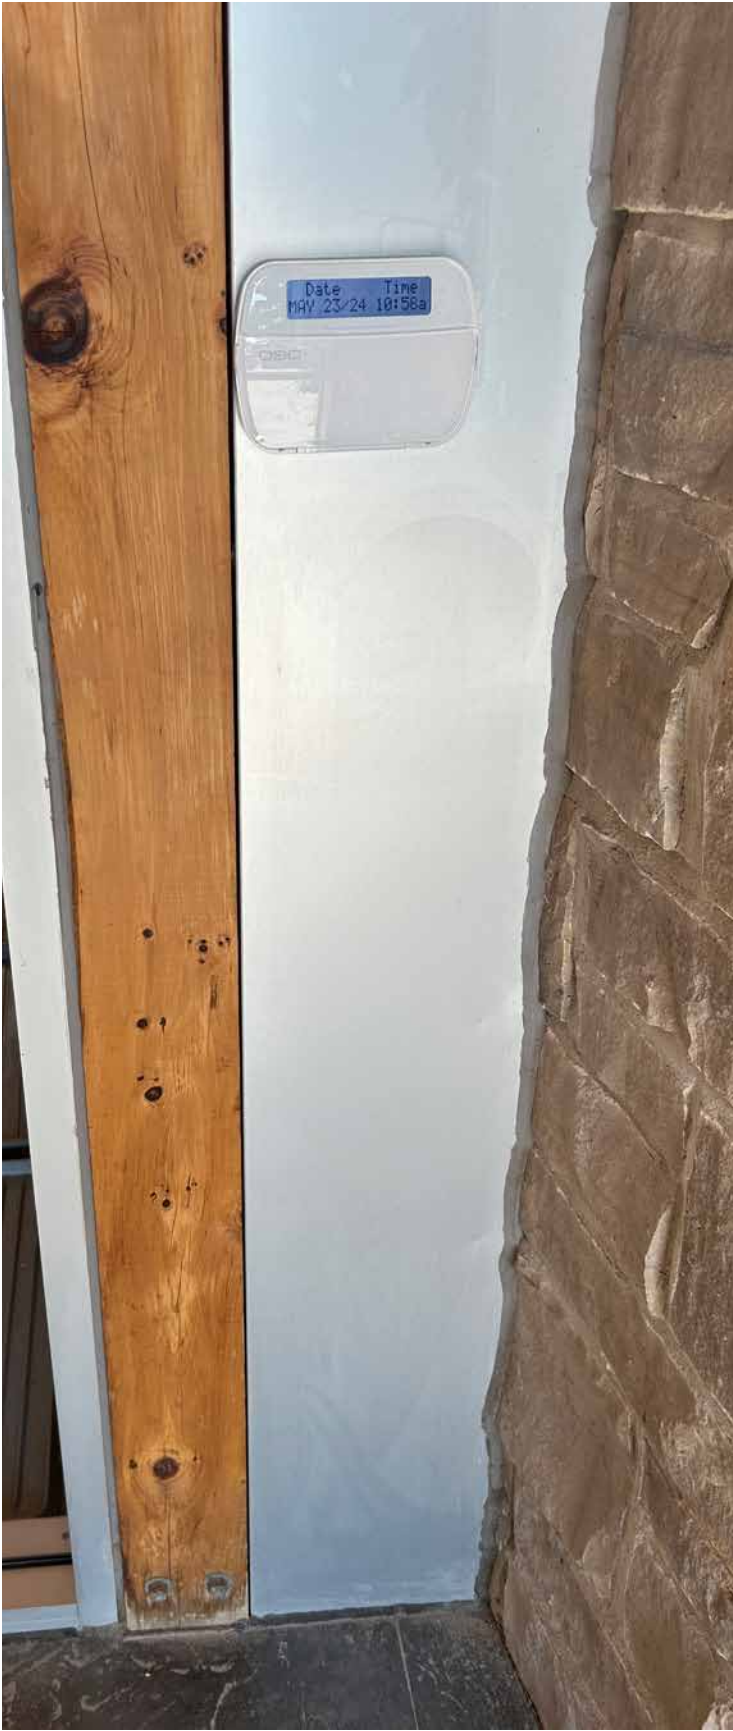
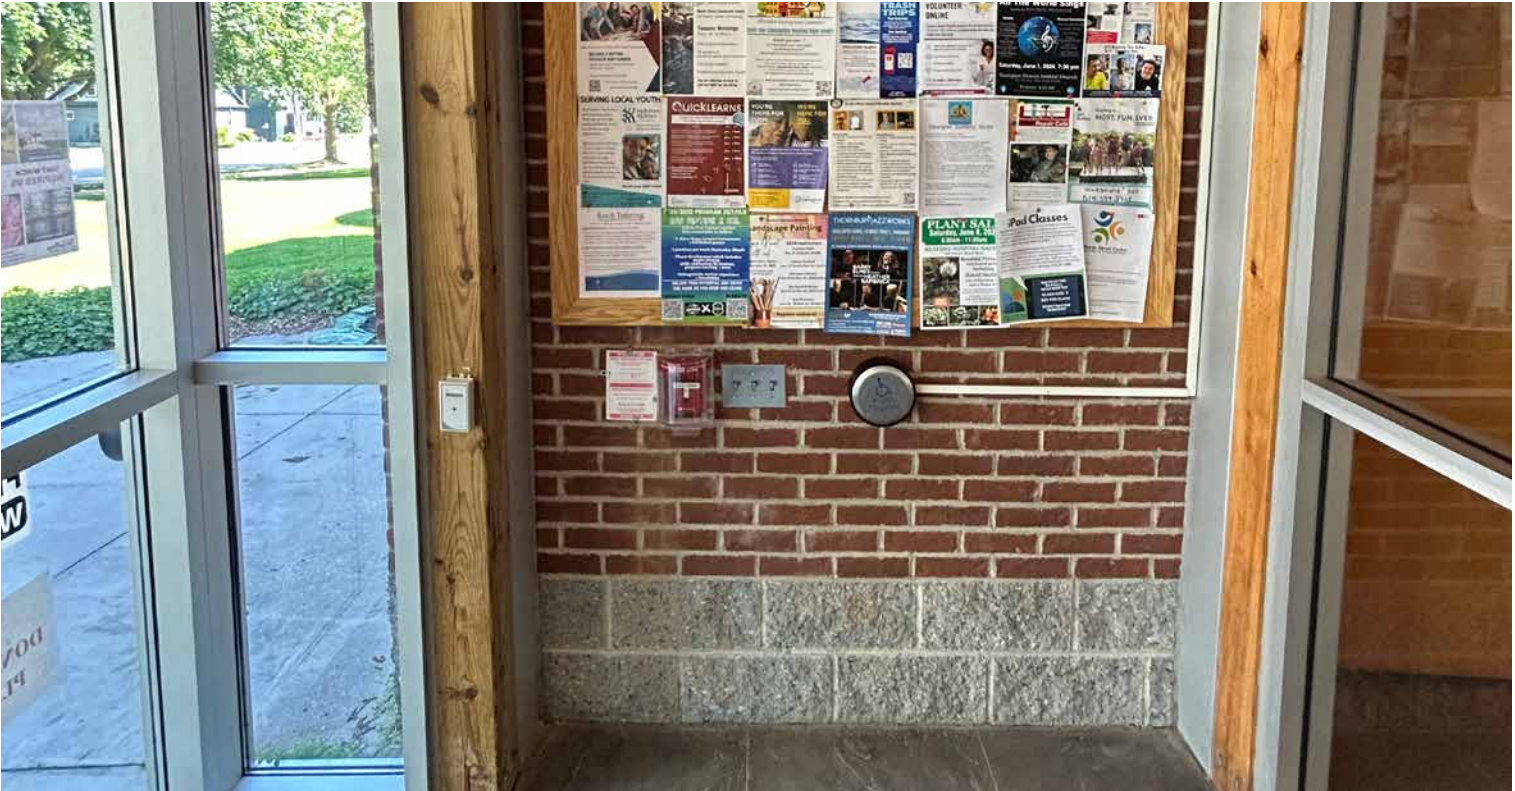
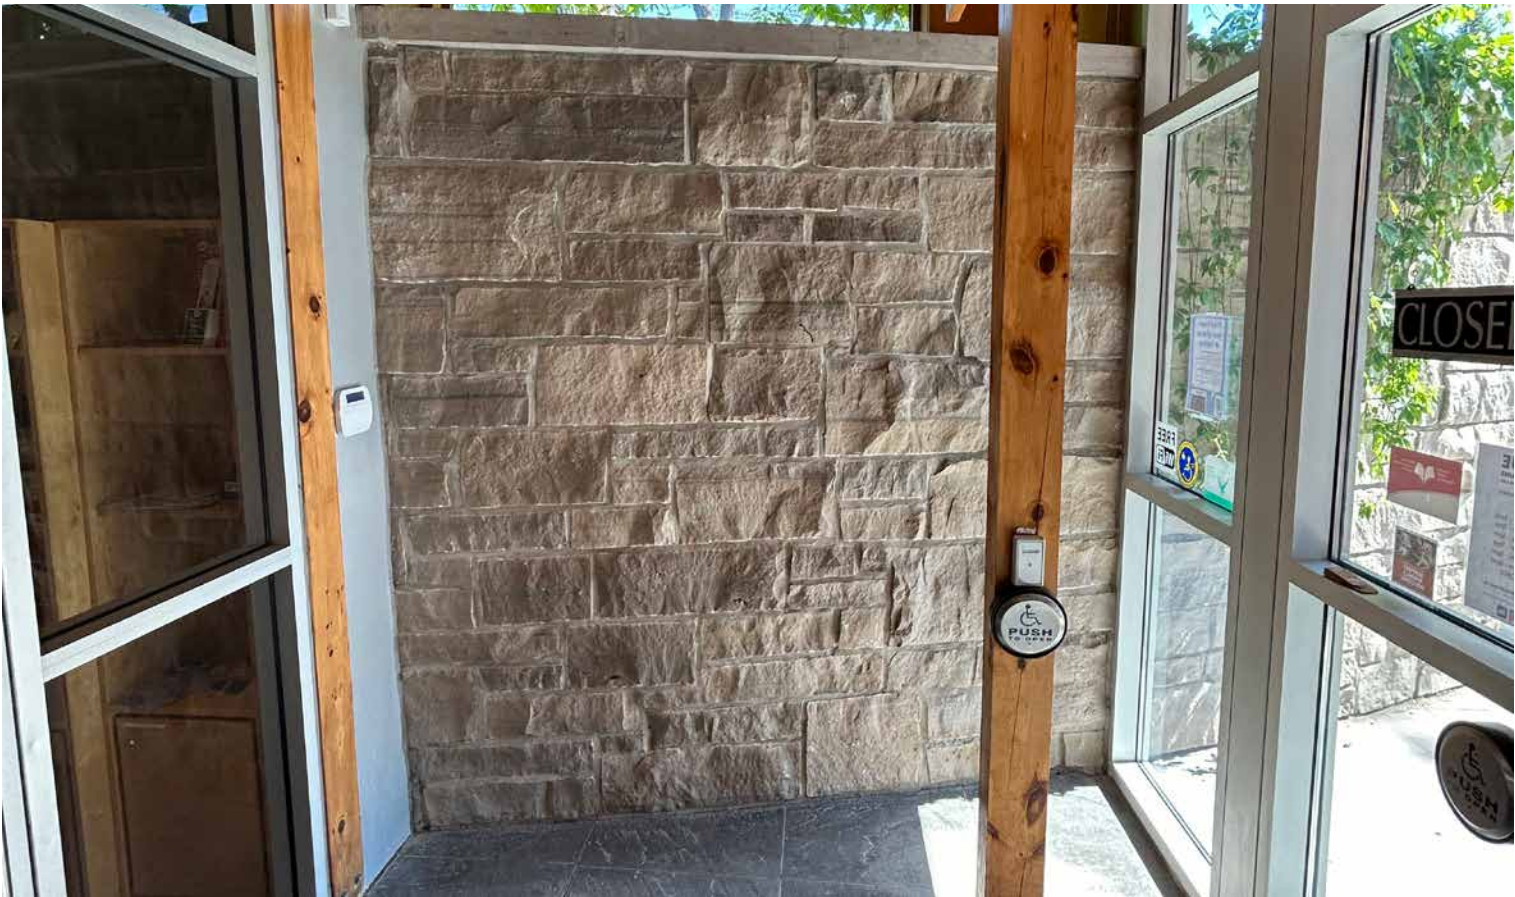
The size of the vestibules is somewhat smaller than current OBC requirements, but meets or is close to CSA B651 requirements.

The security access panel is mounted too high and too close to the wall – someone using a wheeled mobility device would not be able to access it.

The style of panel, which has a keypad with raised buttons, is accessible.

It is also better for the device to contrast with its mounting surface so it can be more easily located by someone with low vision.

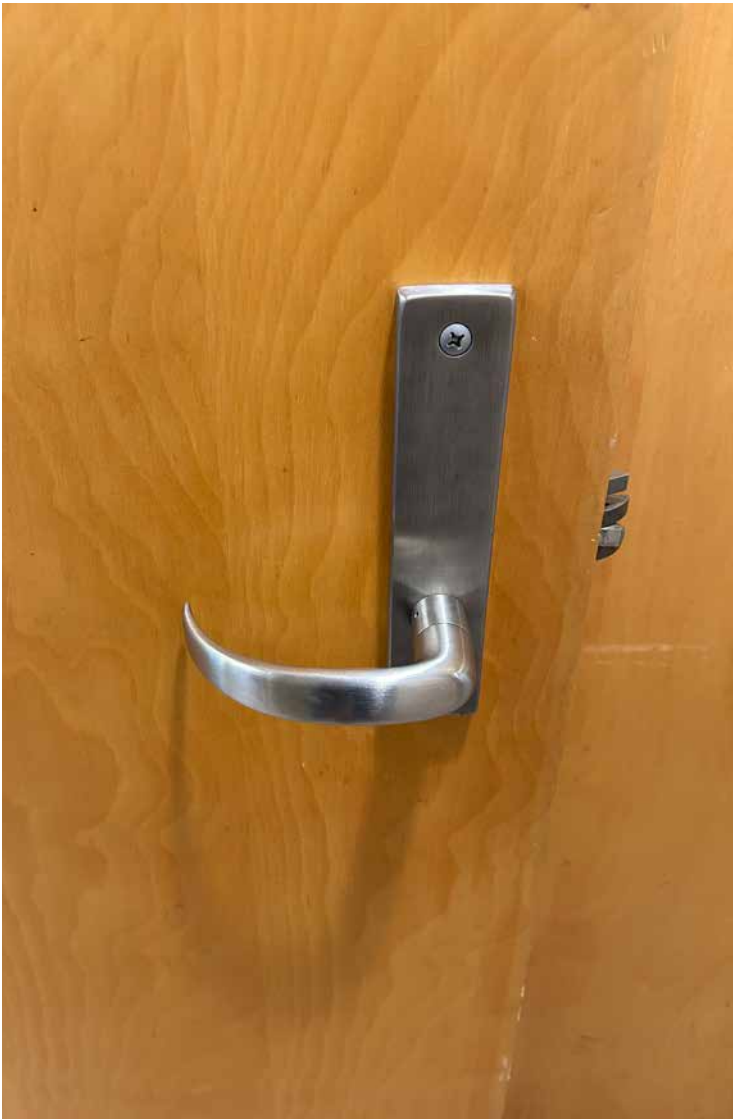
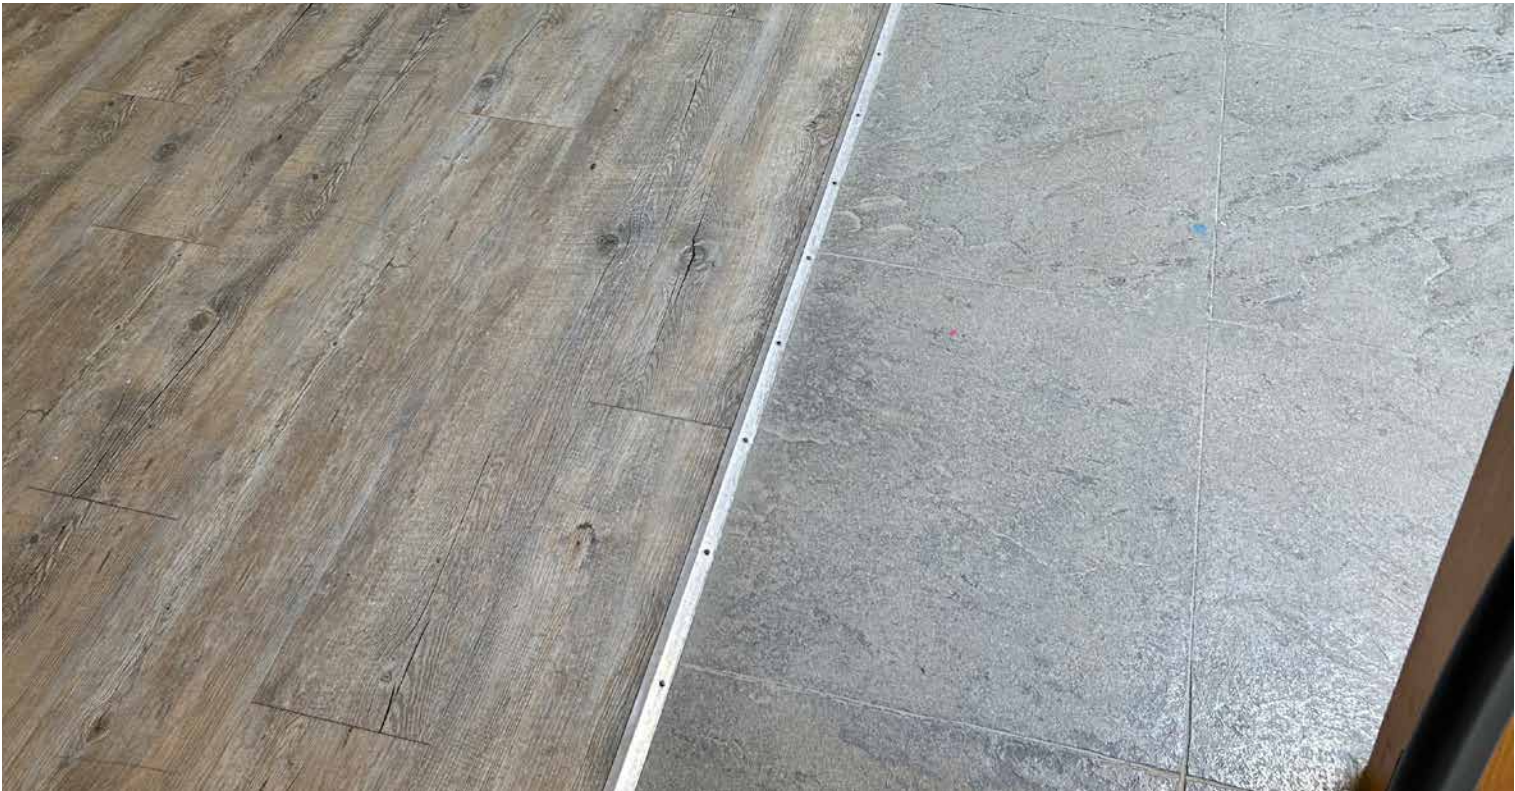
Many of the doors in the building do not have adequate clear space on the pull side and the push side of a door. OBC and CSA require 300mm on the push side of a door and 600mm on the pull side, if the doors are not on power door operators.

This style of lock is difficult to operate for people with limited dexterity.

Change to a style of lock that can be operated with a knuckle or closed fist, or proximity cardreaders.

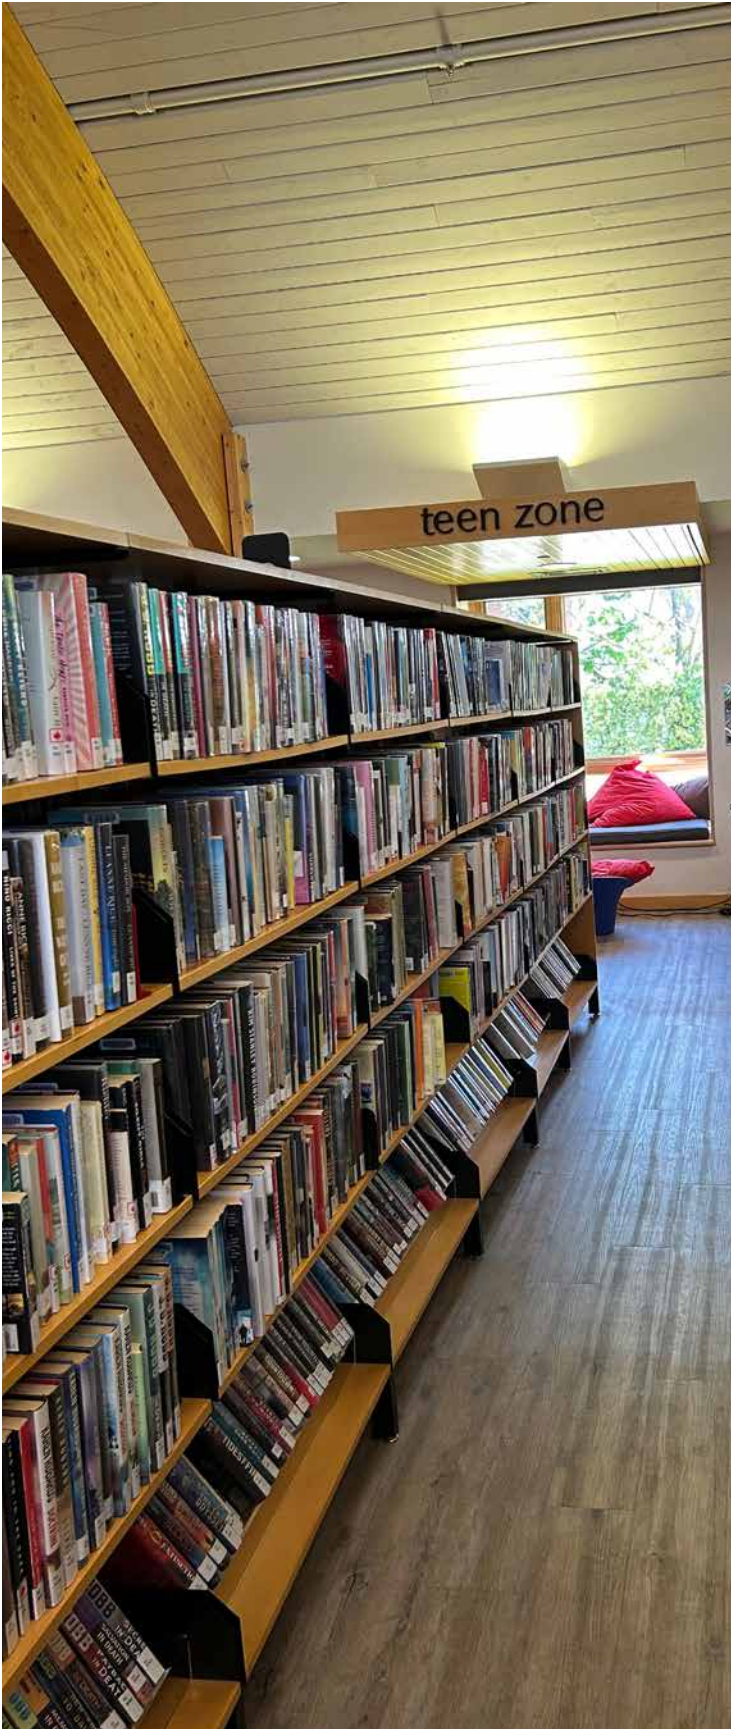
The flooring running throughout has a strong linear pattern that can act as a source of directional confusion for people with diverse neurological experiences.

At the sitting height section of the desk the staff side does not have adequate knee space available due to the drawer under the counter.

There is no knee space available on the public-facing side of either desk.

A library is intended to be a quiet setting and it is recommended to use a soft flooring material that will dampen sounds from sources such as footsteps that would otherwise echo through the space.

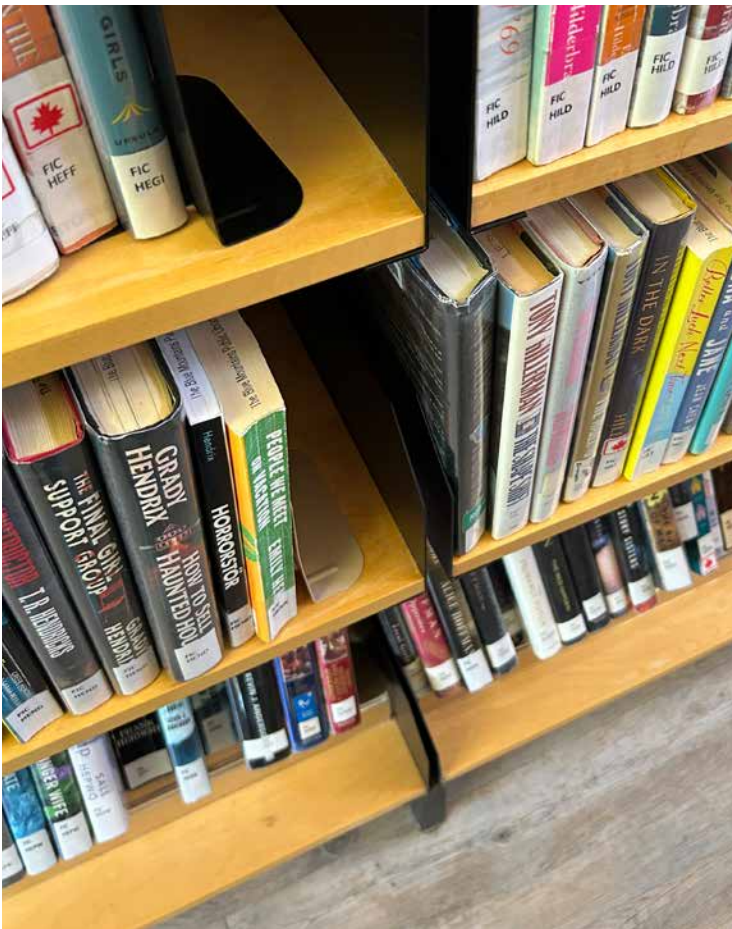
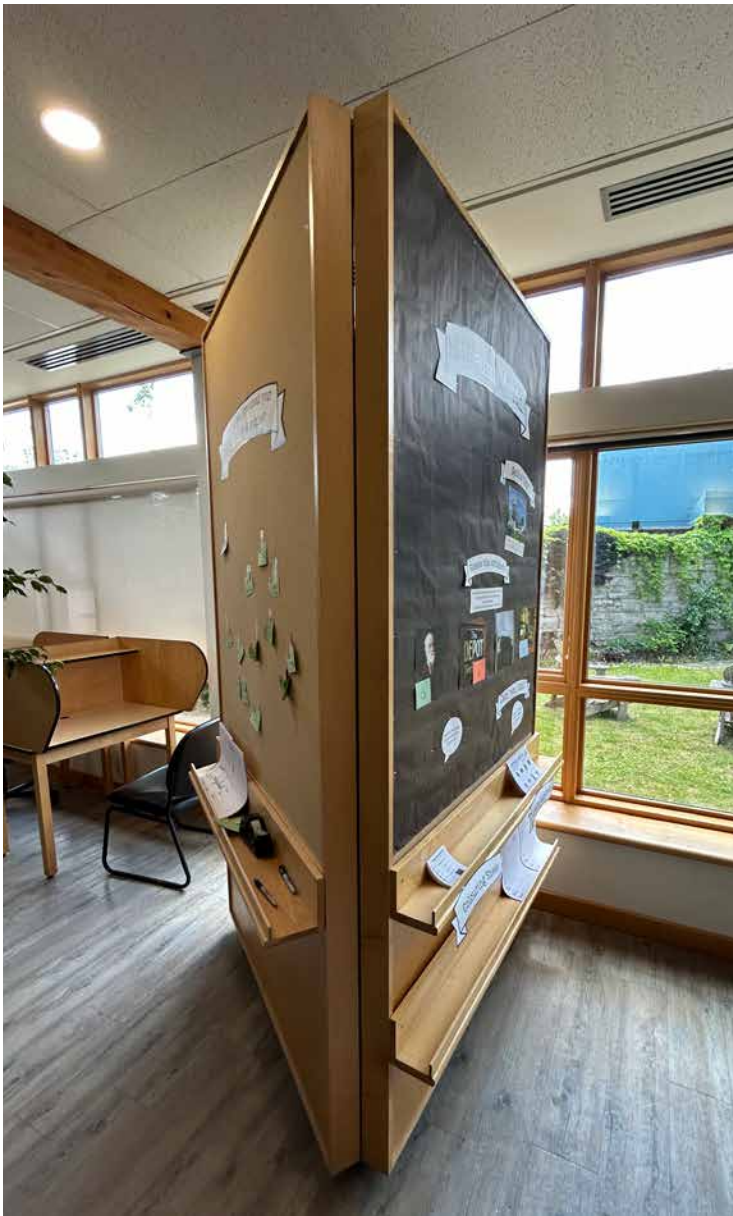
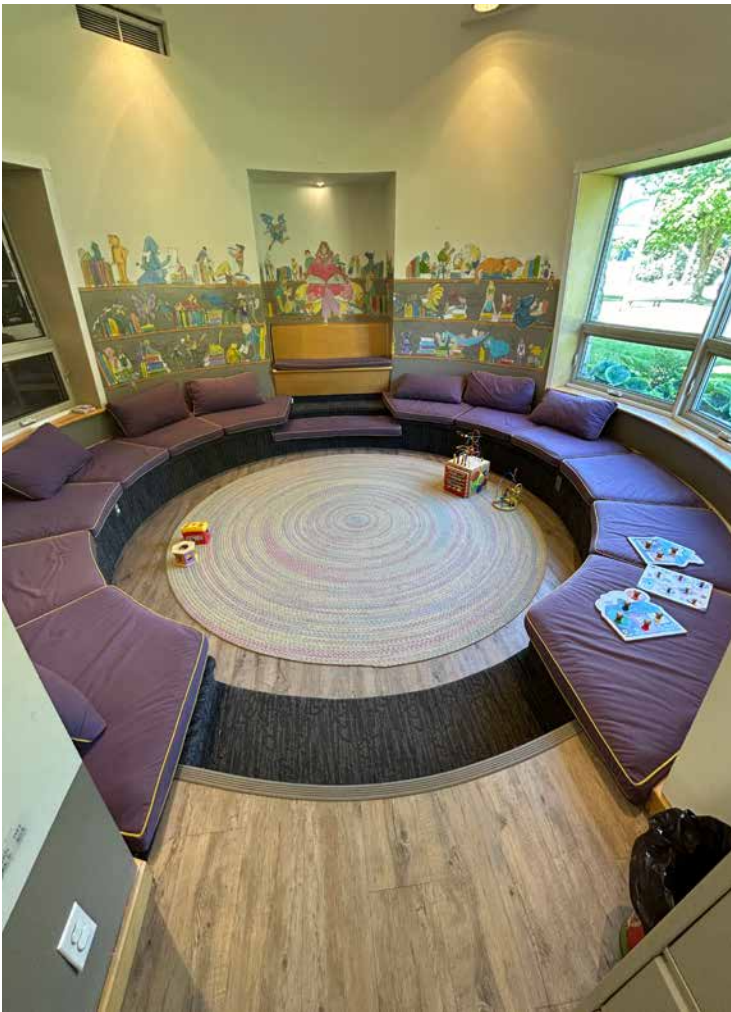
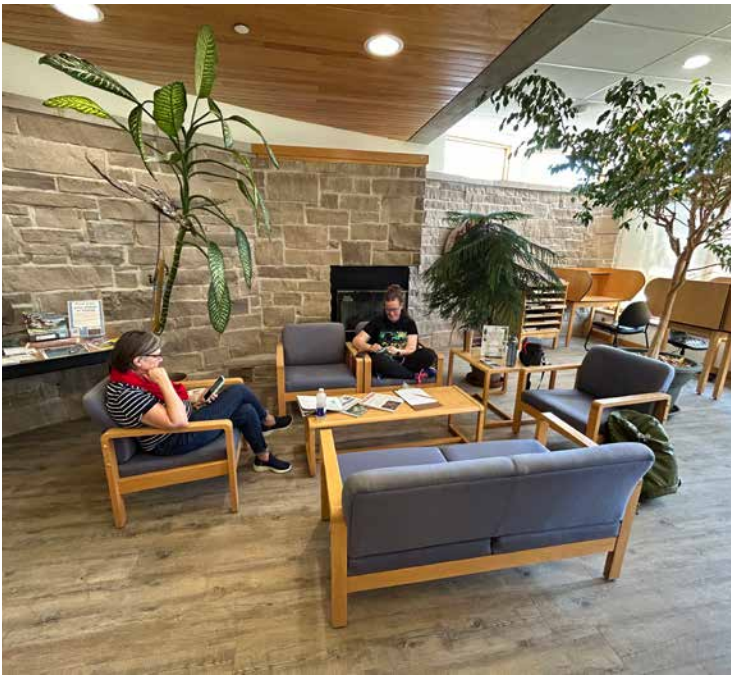
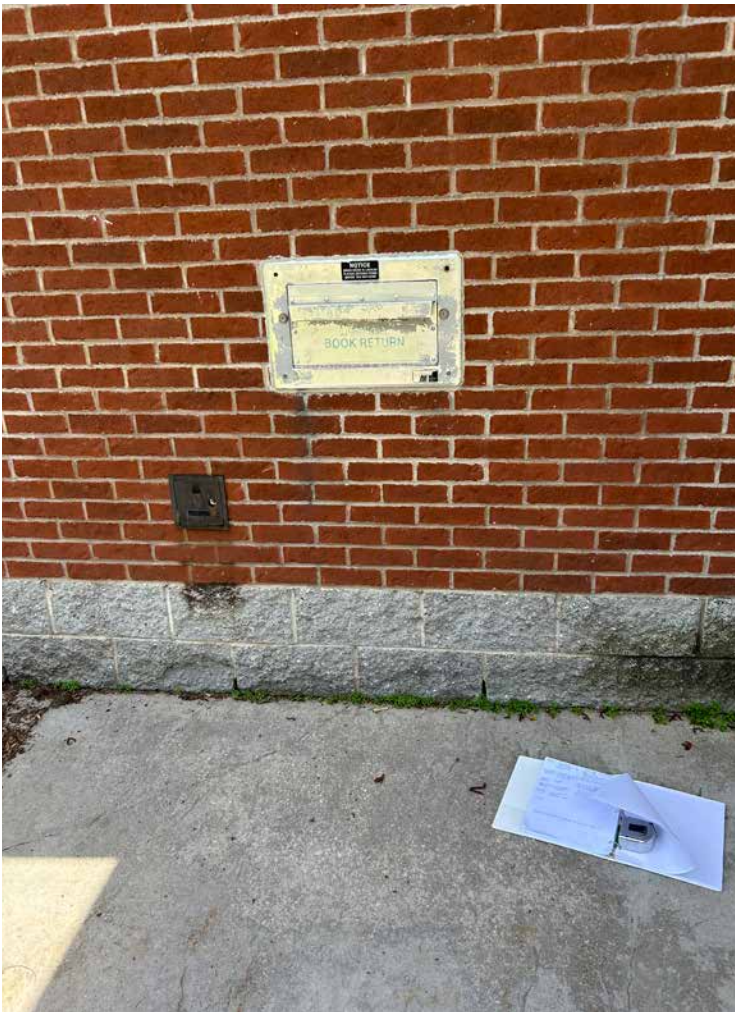
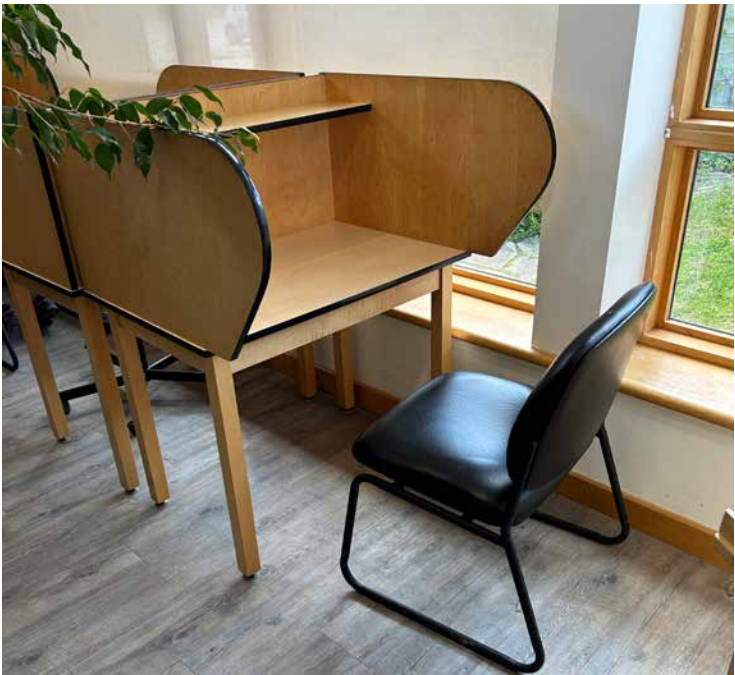
Within the book stacks, the top two shelves and bottom of the lowest shelf are not within accessible reach.

Many of the aisles comply with the minimum OBC width for accessible path of travel and they're close to the CSA B651 minimum, but there are some aisles that do not meet the OBC minimum.

Loose furniture has been arranged in such a way that there is no space in the seating arrangement for people with wheeled mobility devices.

The outdoor book returns are slightly above accessible reach, and the weight of the drawer makes it very difficult to open with a closed fist.
