Unity Design Studio was commissioned by the Town of The Blue Mountains and the Blue Mountains Public Library to review the accessibility of the L.E Shore Memorial Library at 173 Bruce St South in Thornbury.

Unity Design Studios’ scope of work included a visit to the building to assess current conditions as they relate to accessibility, and to subsequently propose various possible improvements that could be undertaken to improve the meaningful accessibility of the site.

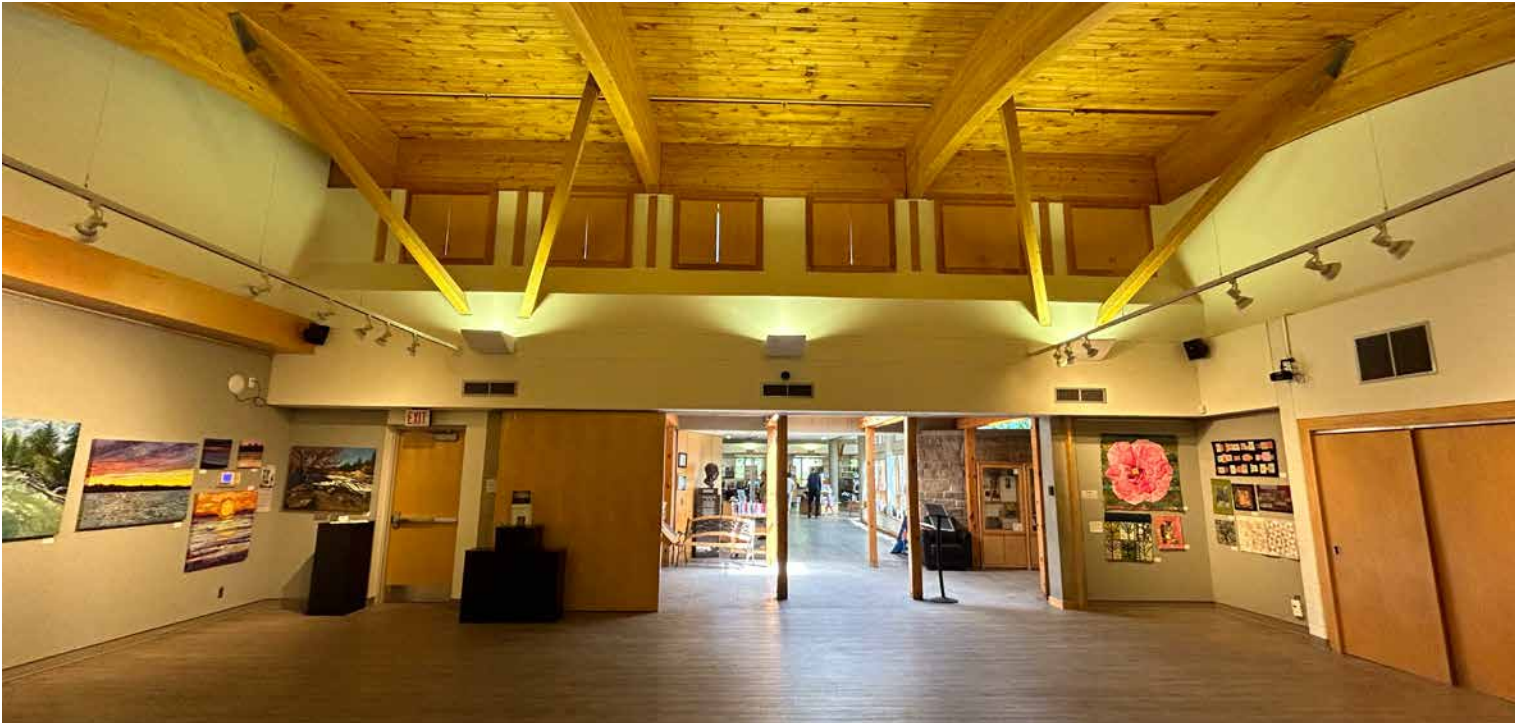
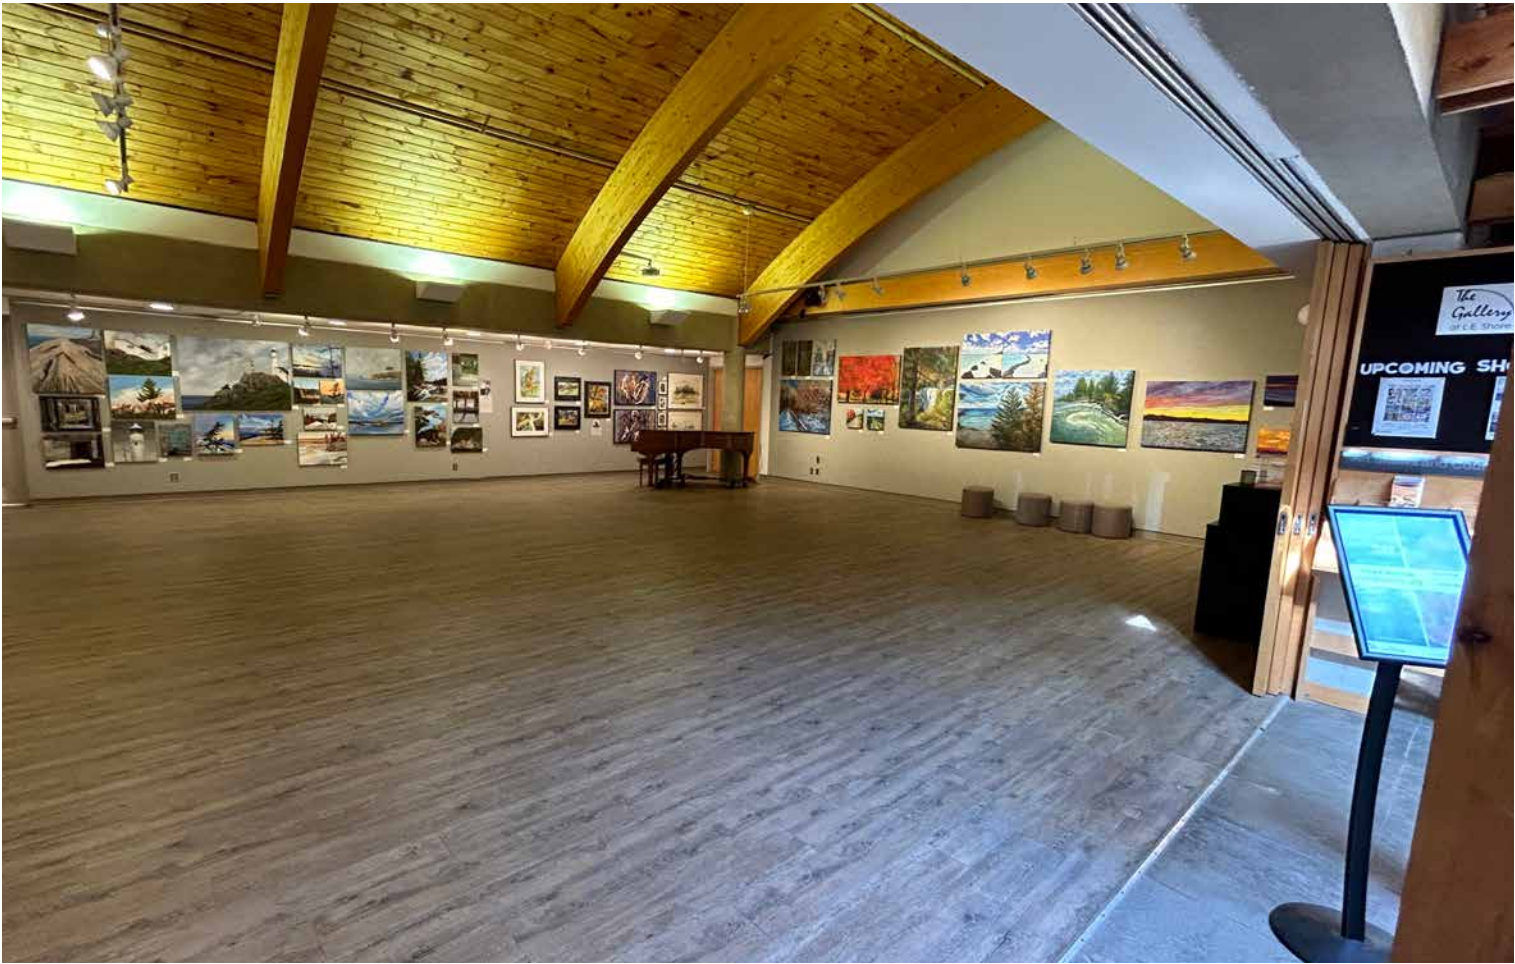
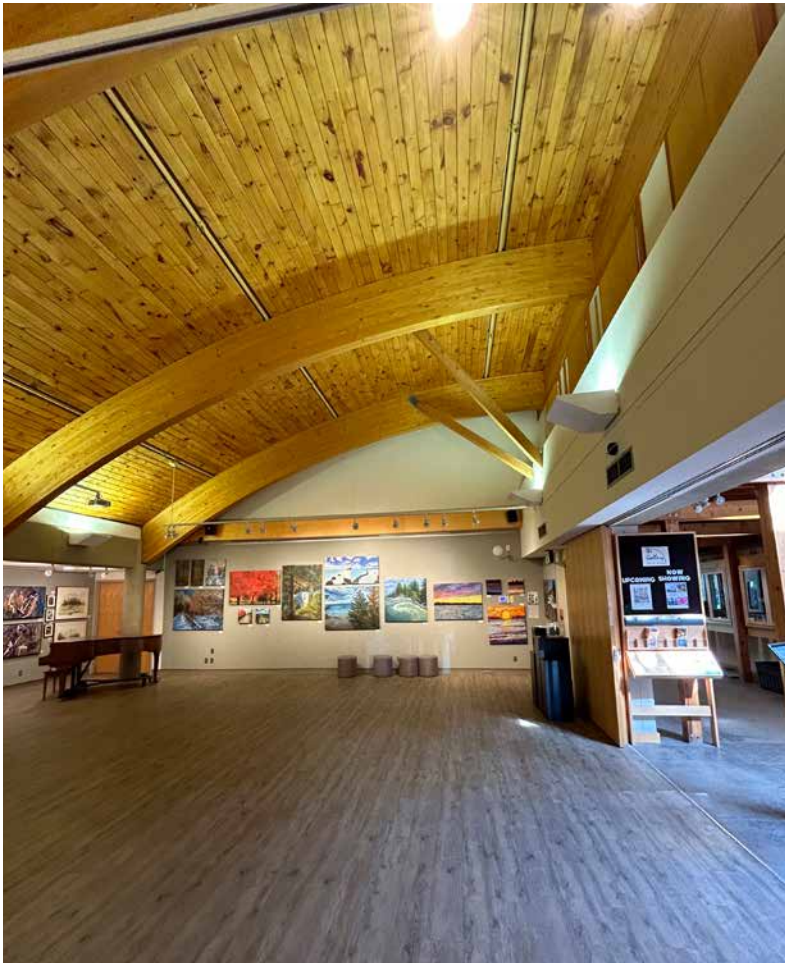
The gallery is a large volume mainly consisting of hard surfaces and therefore has some issues with echo. Similar to the library, the flooring running throughout has a strong linear pattern that can act as a source of directional confusion for people with diverse neurological experiences.

Lighting levels in the gallery are also rather low, especially with the window shutters closed.

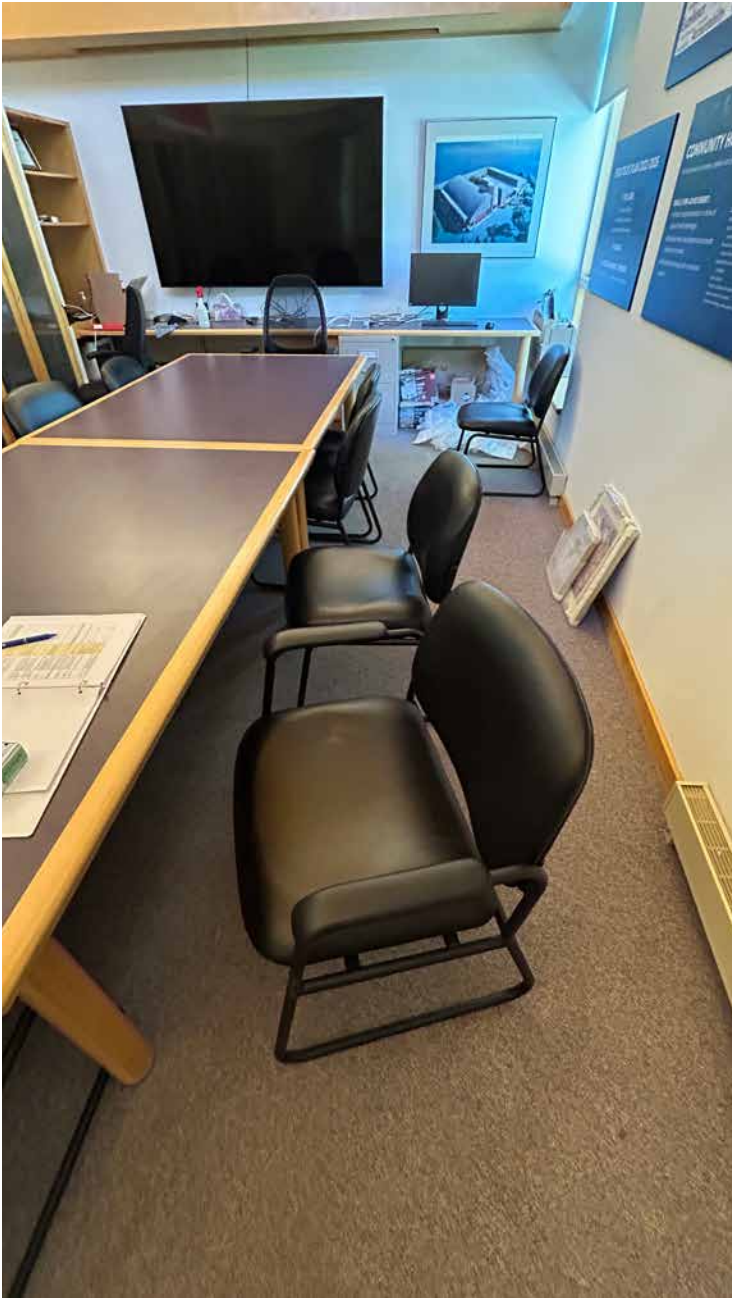
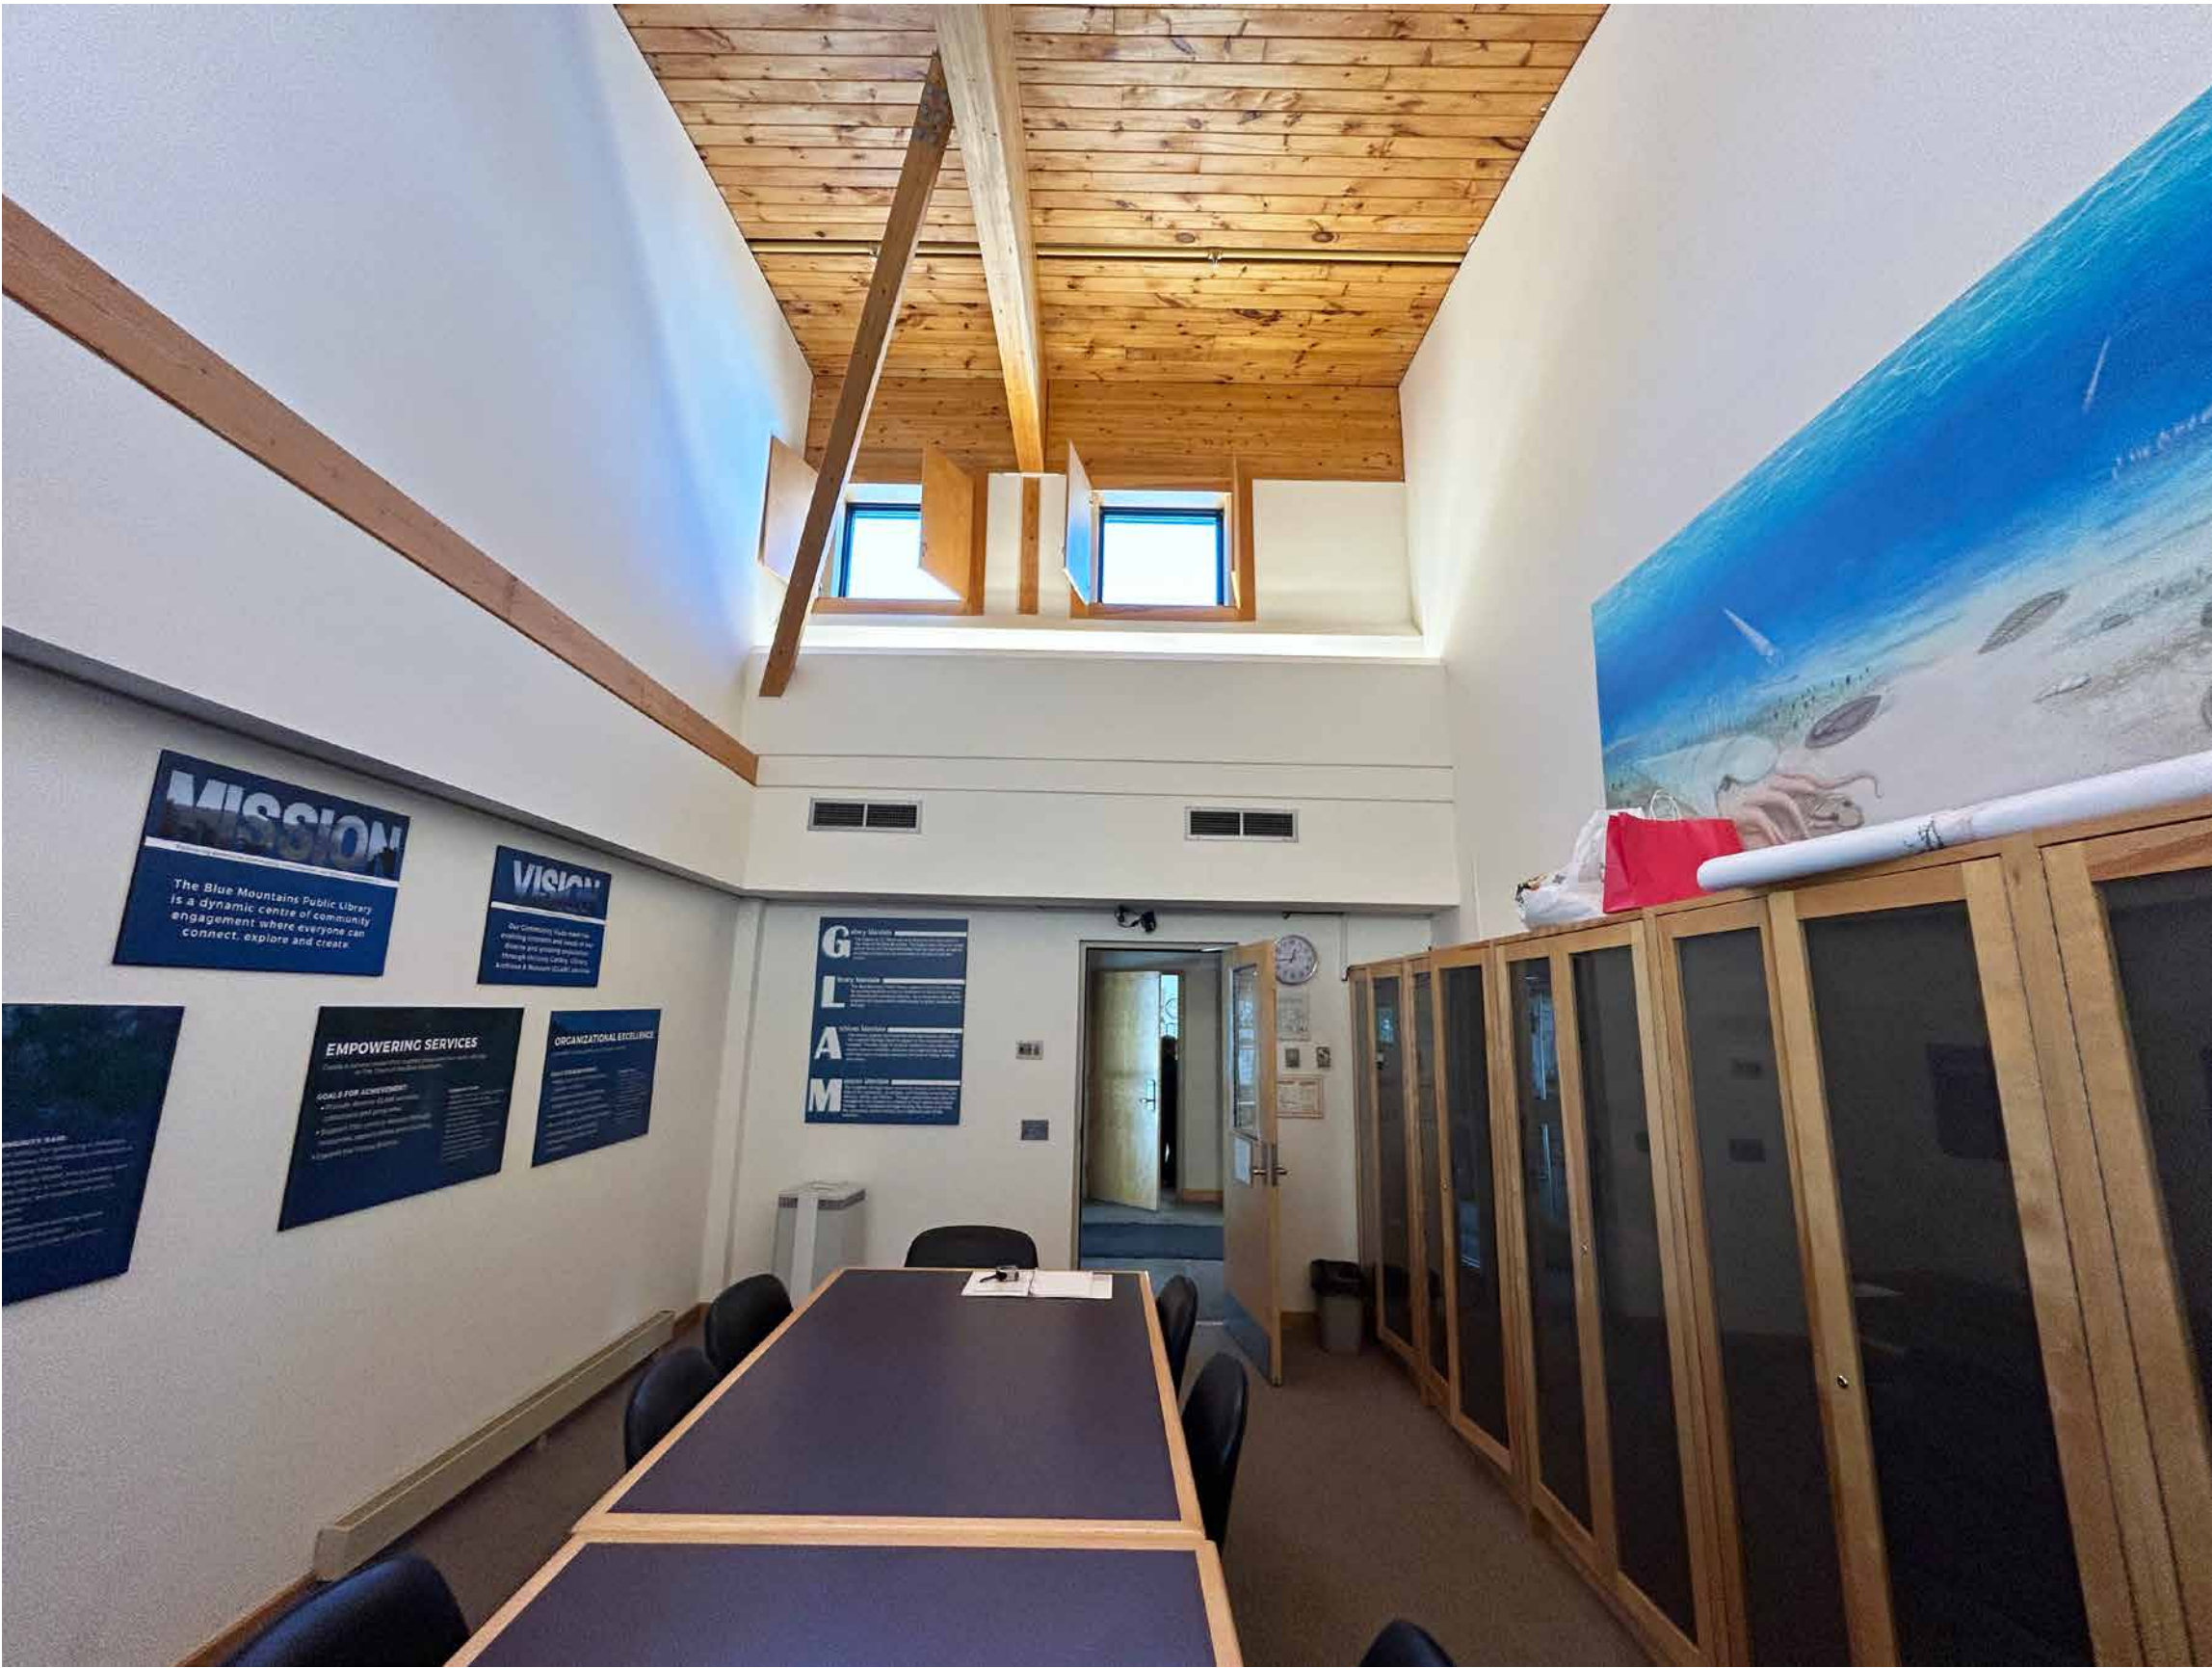
The boardroom is fairly accessible. Improvements can be made by increasing colour contrast between the furnishings and surroundings, and reducing clutter.

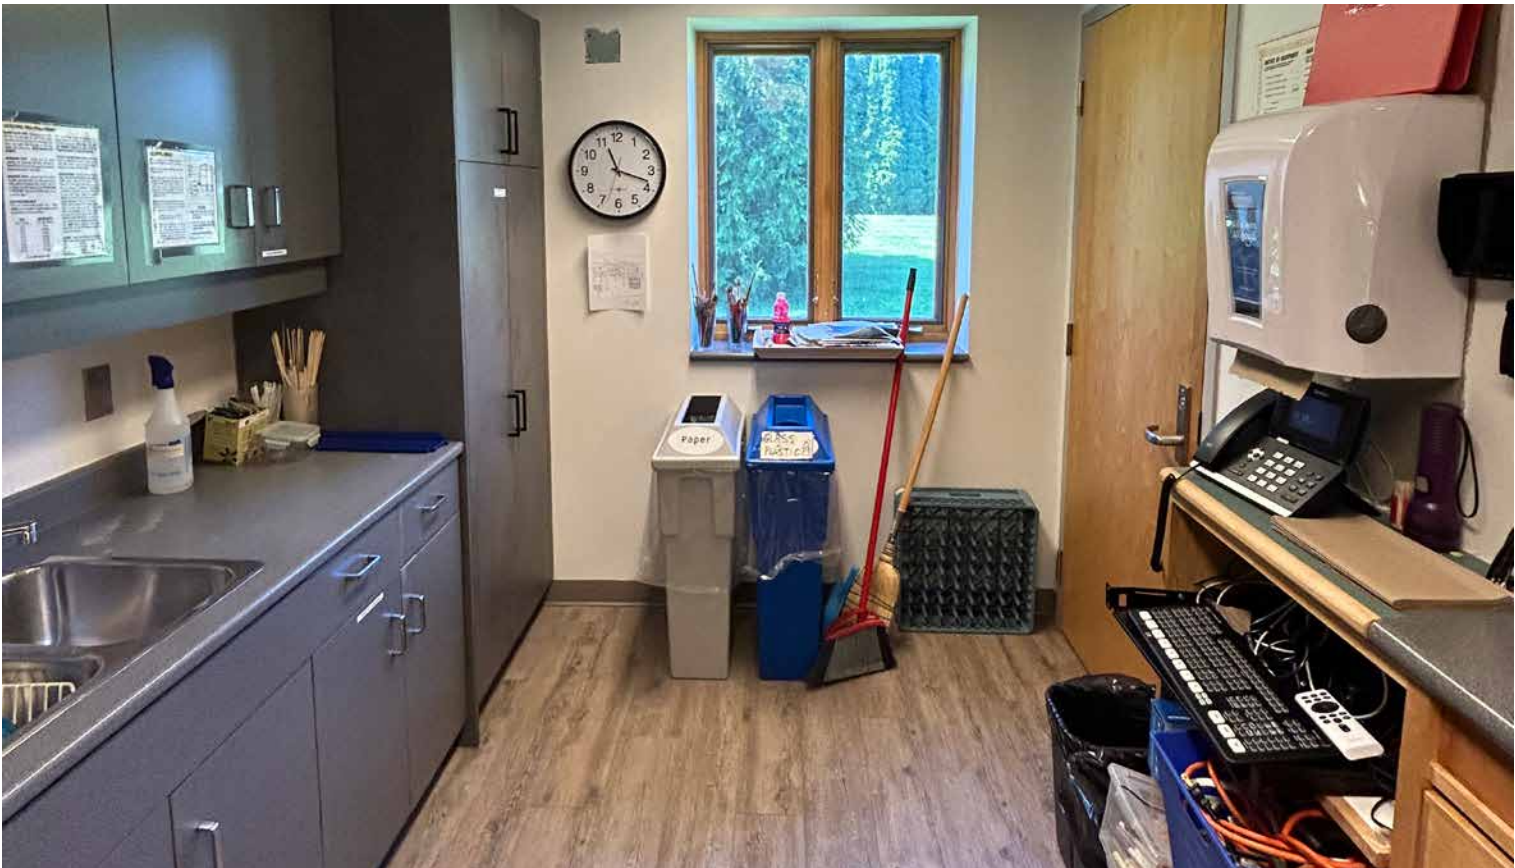
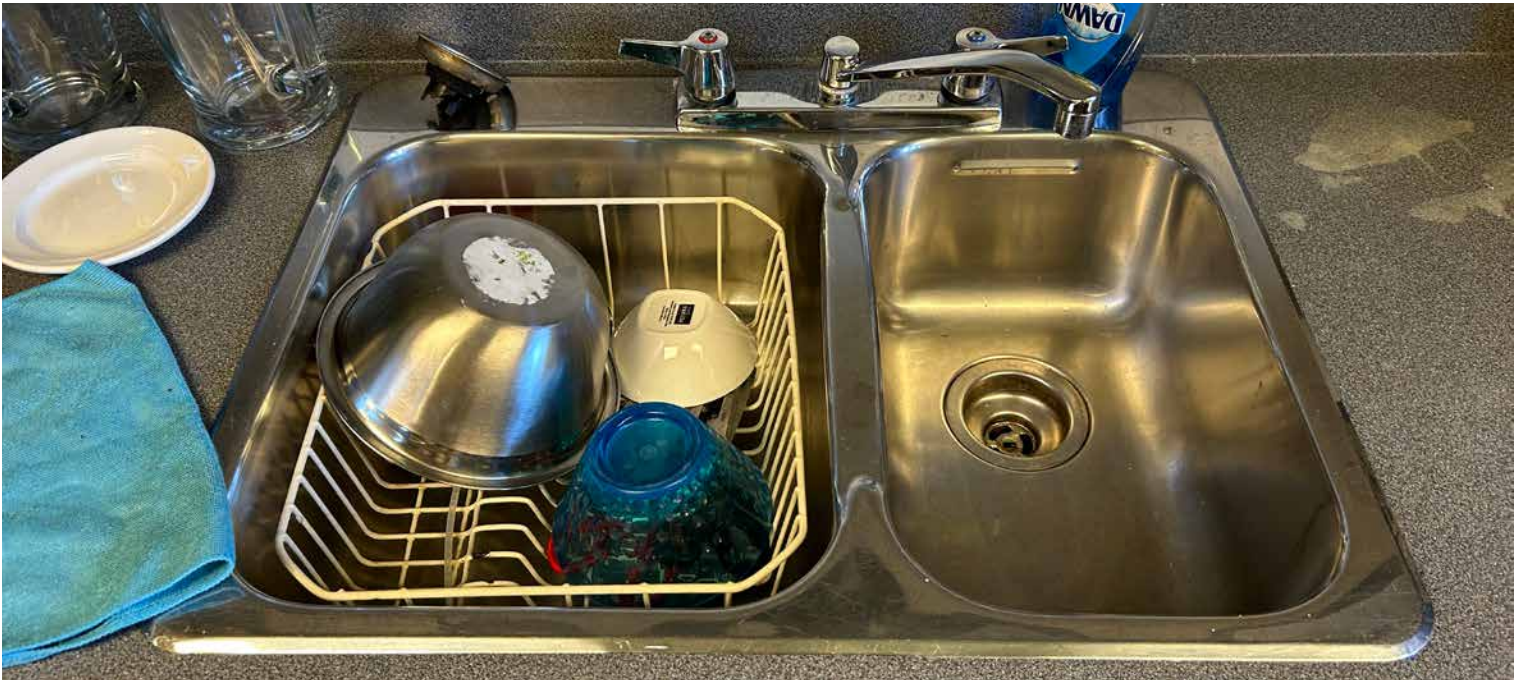
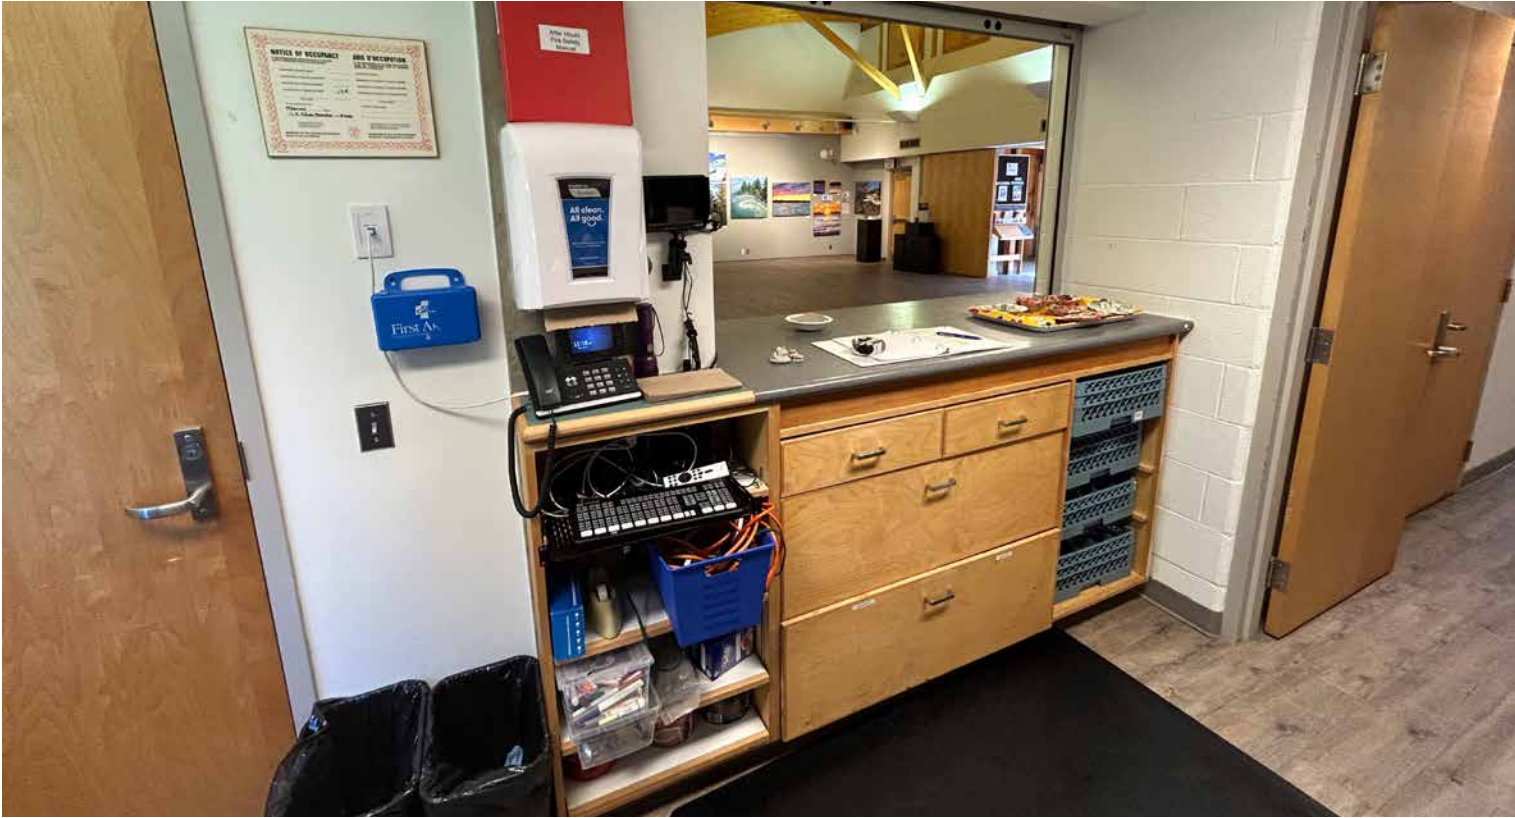
Kitchen provides a turning radius that is compliant with the OBC, though not the CSA B651 standard.

The pantry is inaccessible as it is too close to the wall and has obstacles placed on the floor in front of it.

The bar height is too high for accessible use and people of short stature, it also has no knee space on the service side or the public side.

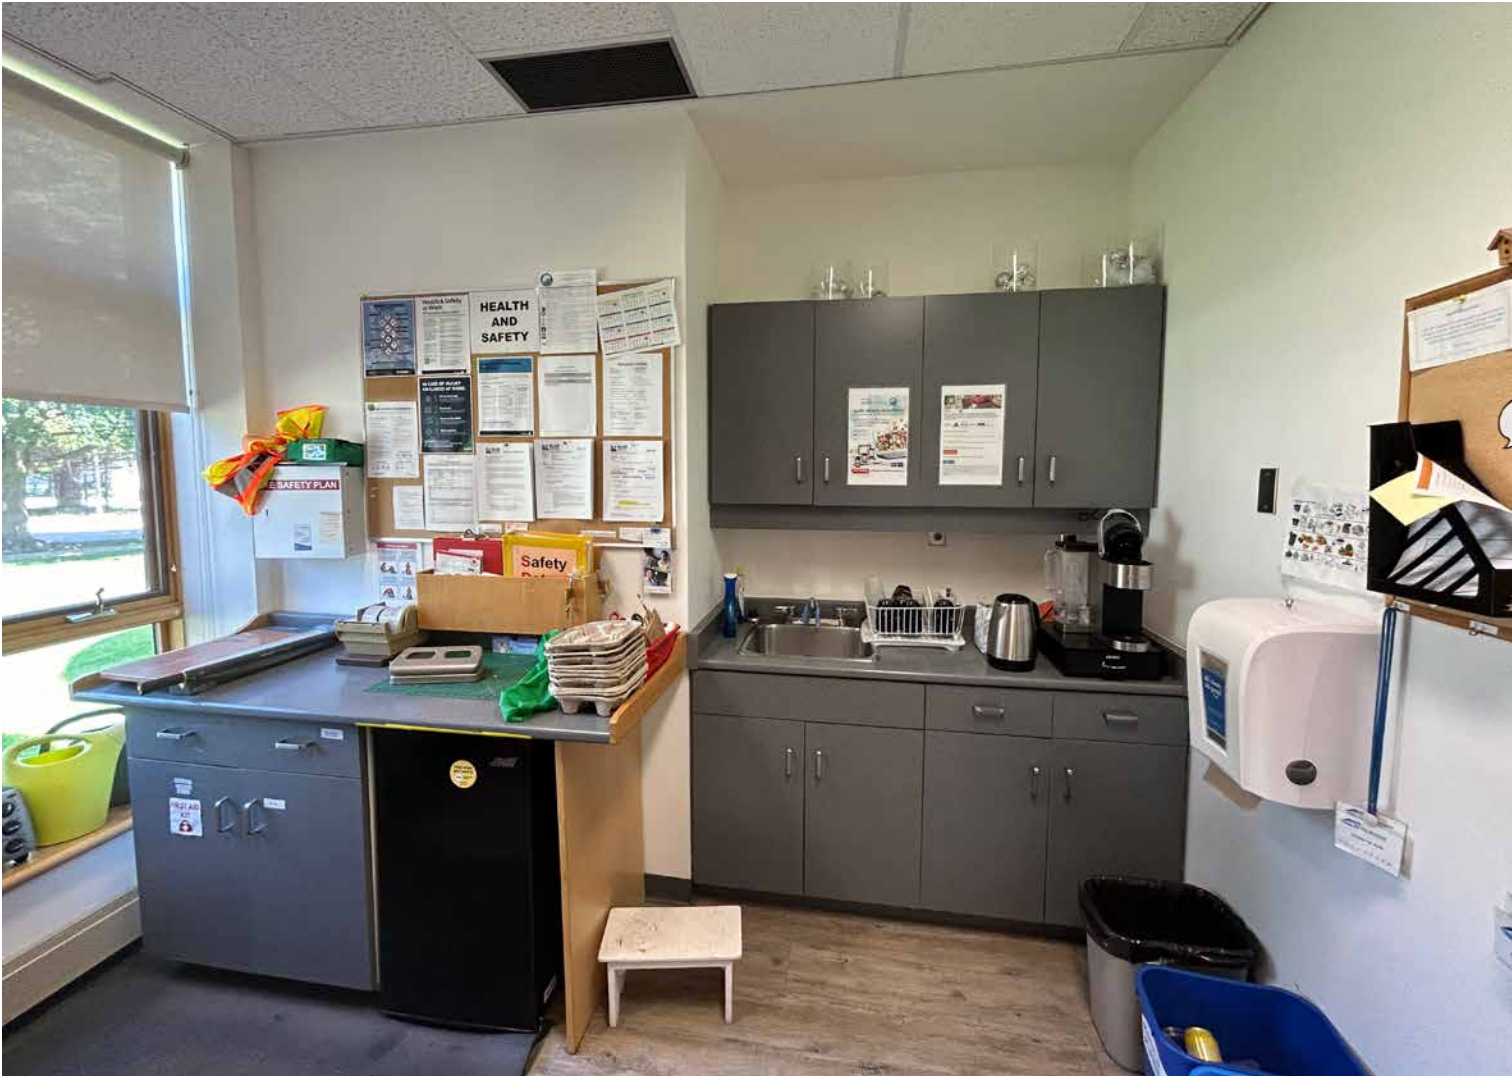
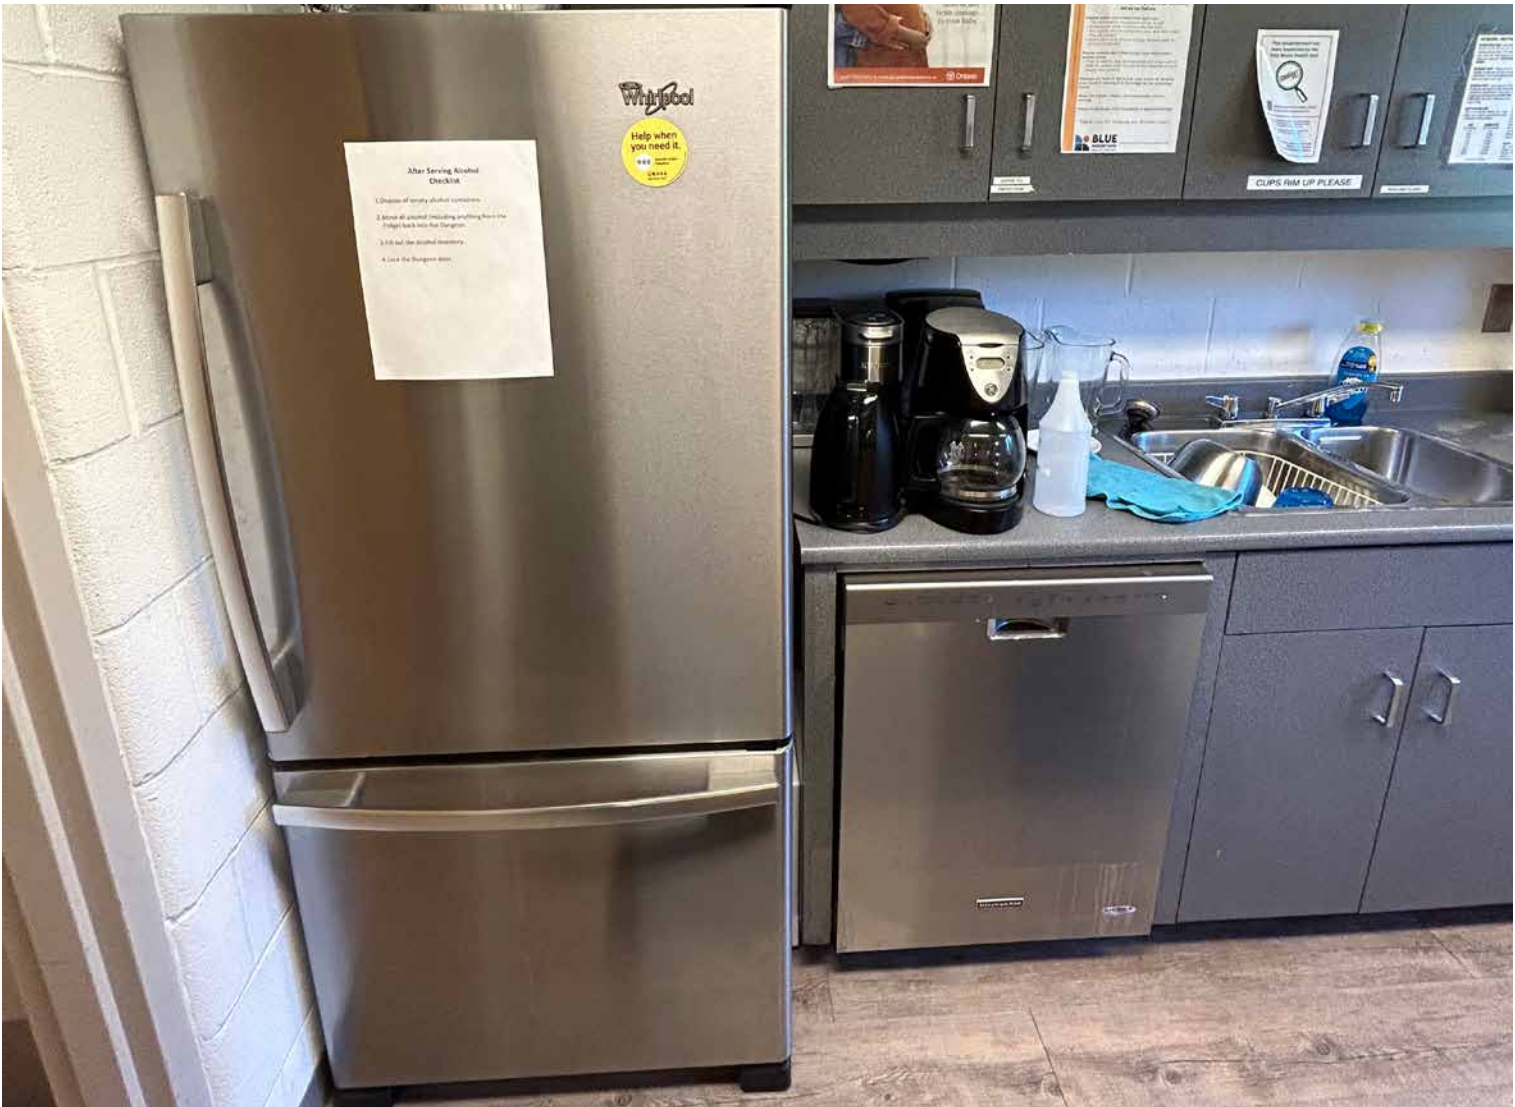
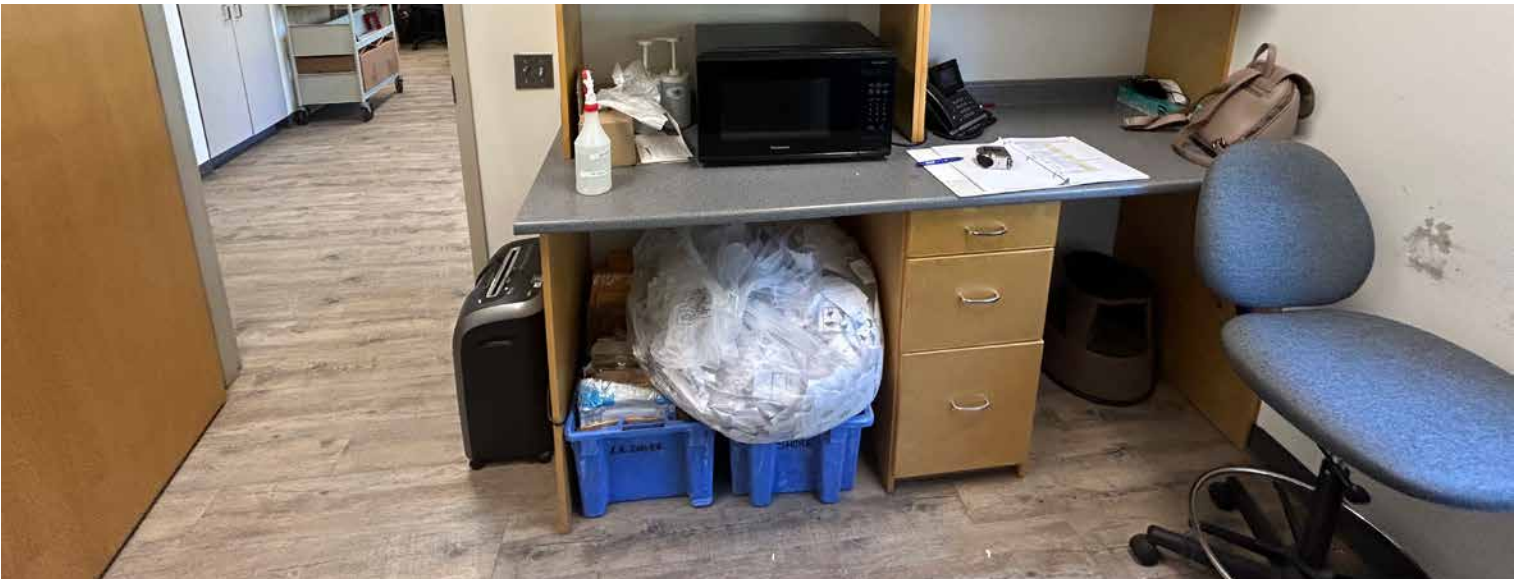
The style of the bottom drawer freezer fridge is good however the door swing on the fridge needs to open in the opposite direction to be accessible.

The undercounter fridge in the staff room cannot be opened with a closed fist.

General amount of clutter in kitchen spaces needs to be resolved to make the spaces more maneuverable.

The staff lounge in particular appears to have serious functionality issues as it is trying to serve too many different purposes.

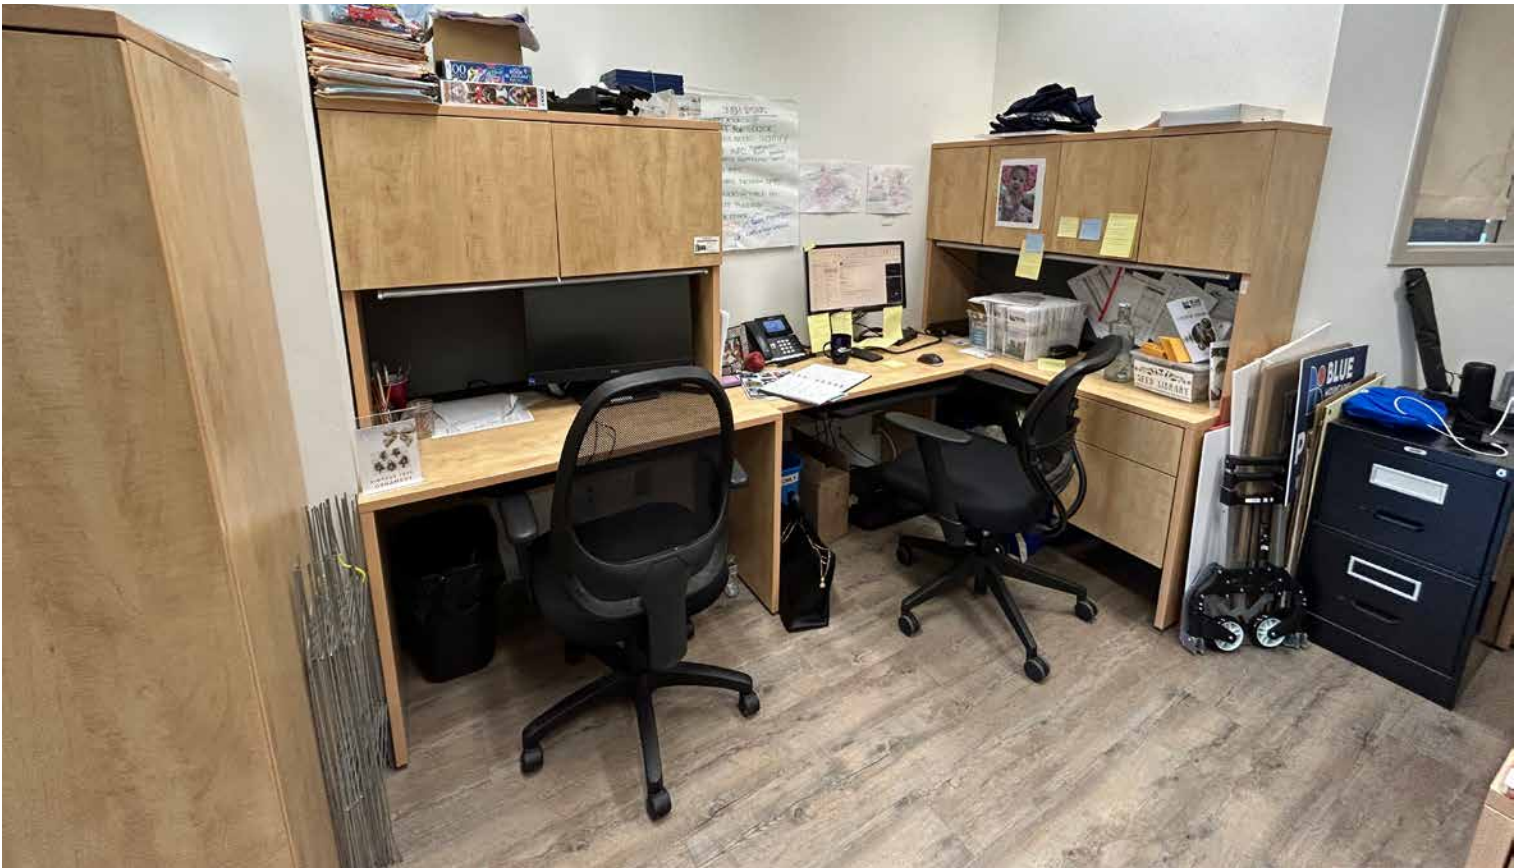
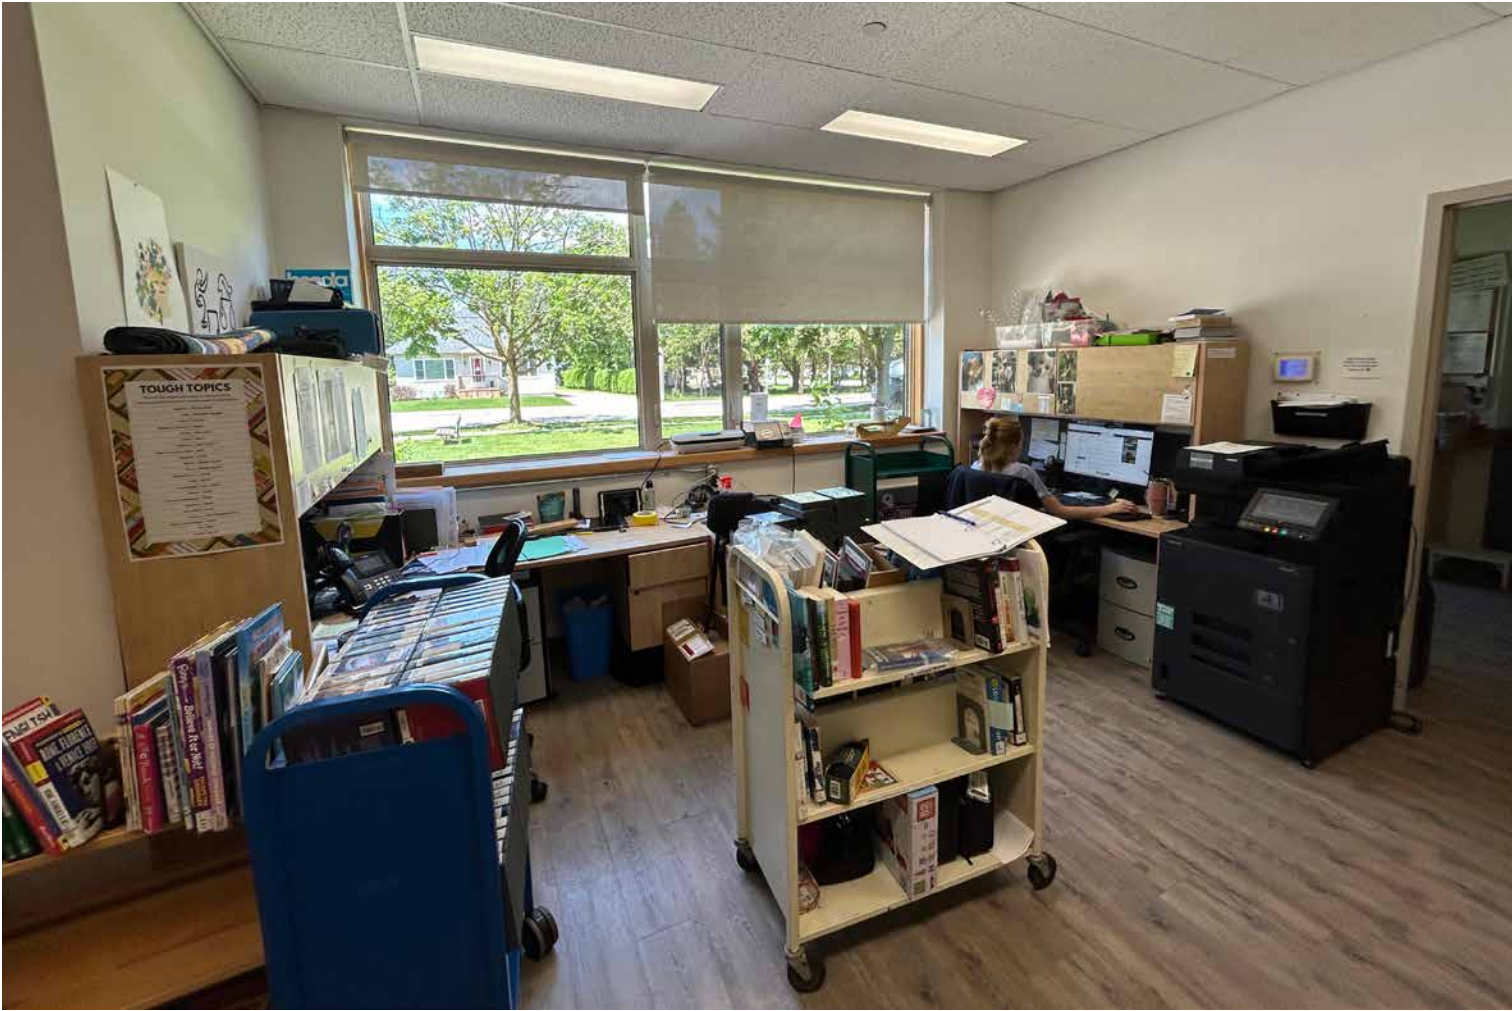
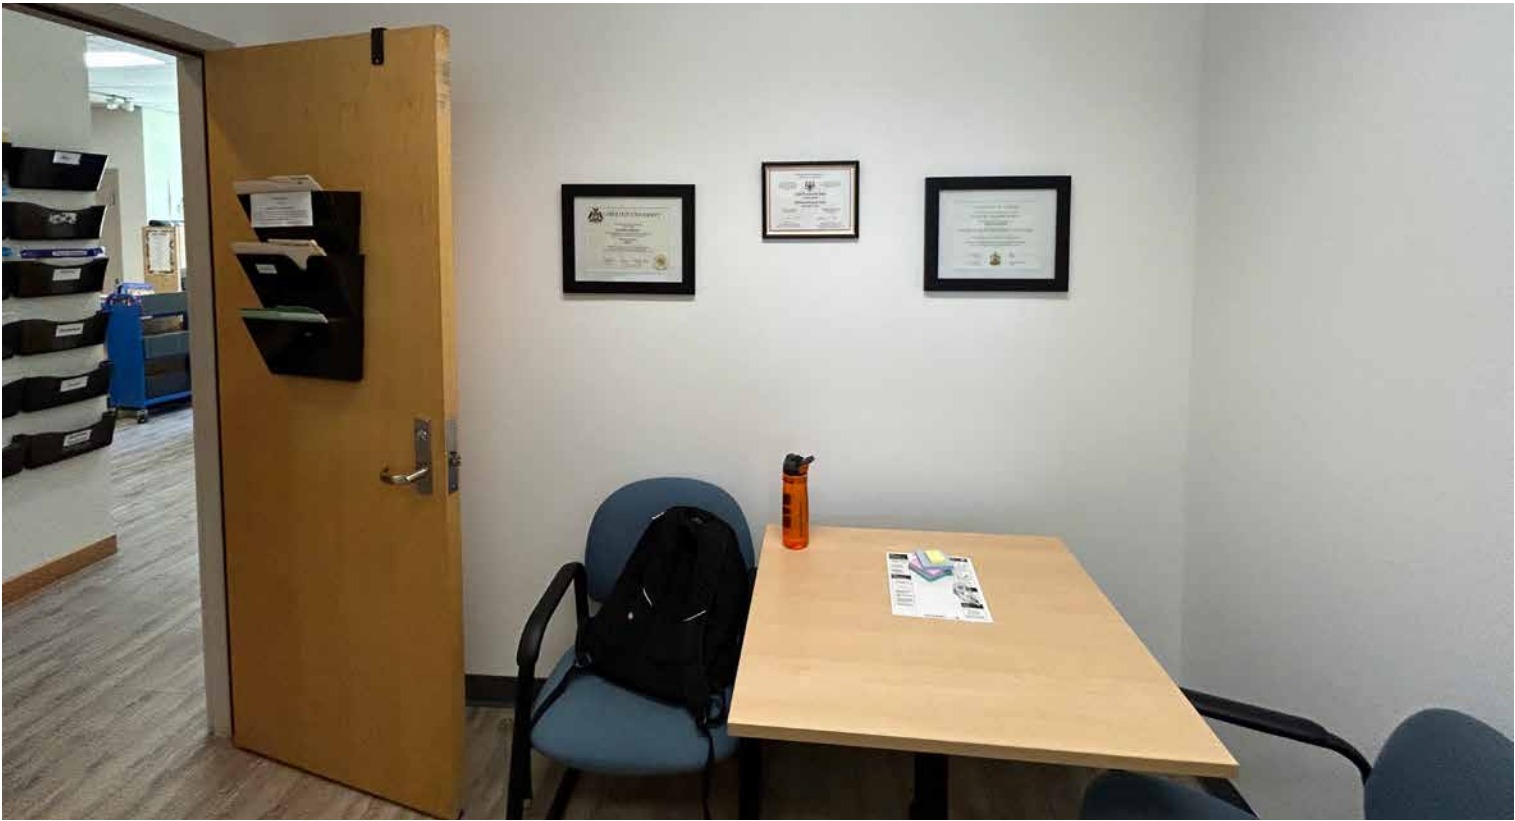
Volume of items in the space impedes circulation in many areas of the office.

The furniture has sharp corners, and there is not much contrast between the furniture and its surroundings.

Provide variable height desks that can accommodate a wide variety of users at a comfortable height.
