Unity Design Studio was commissioned by the Town of The Blue Mountains and the Blue Mountains Public Library to review the accessibility of the L.E Shore Memorial Library at 173 Bruce St South in Thornbury.

Unity Design Studios’ scope of work included a visit to the building to assess current conditions as they relate to accessibility, and to subsequently propose various possible improvements that could be undertaken to improve the meaningful accessibility of the site.

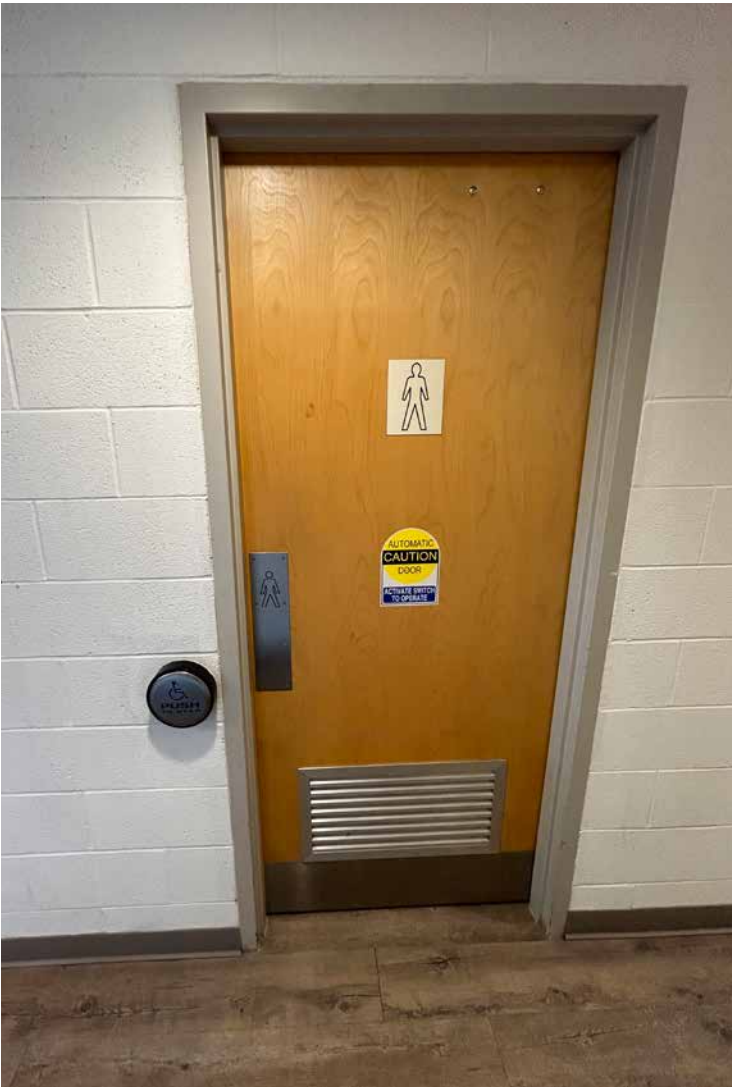
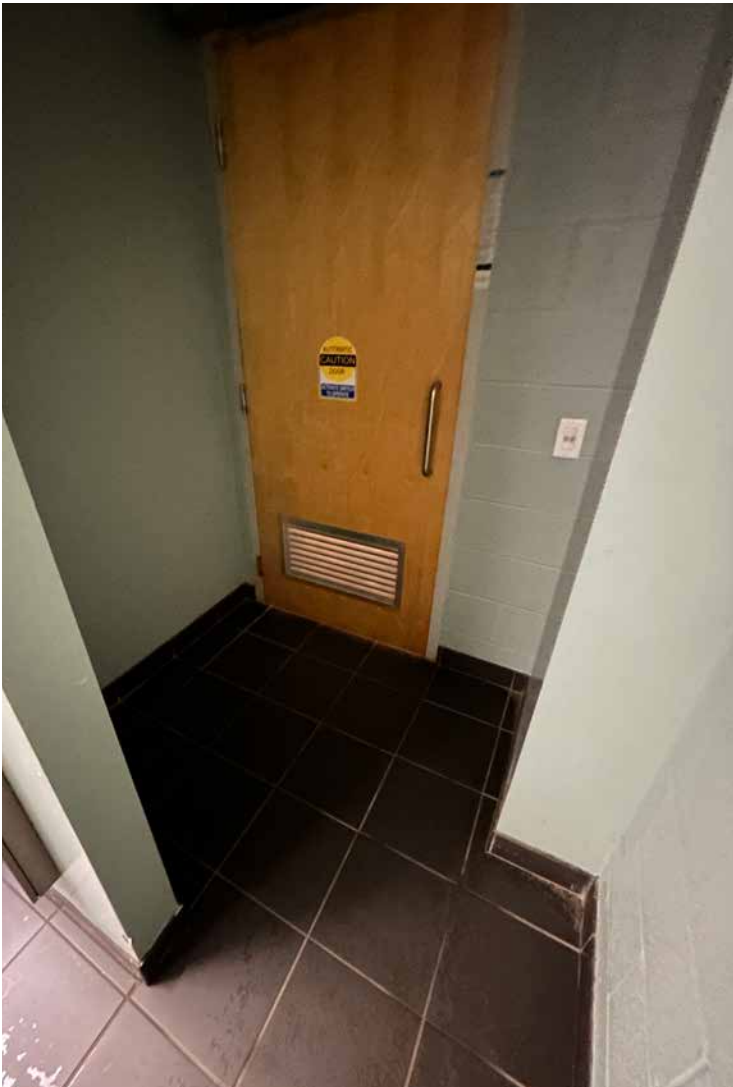
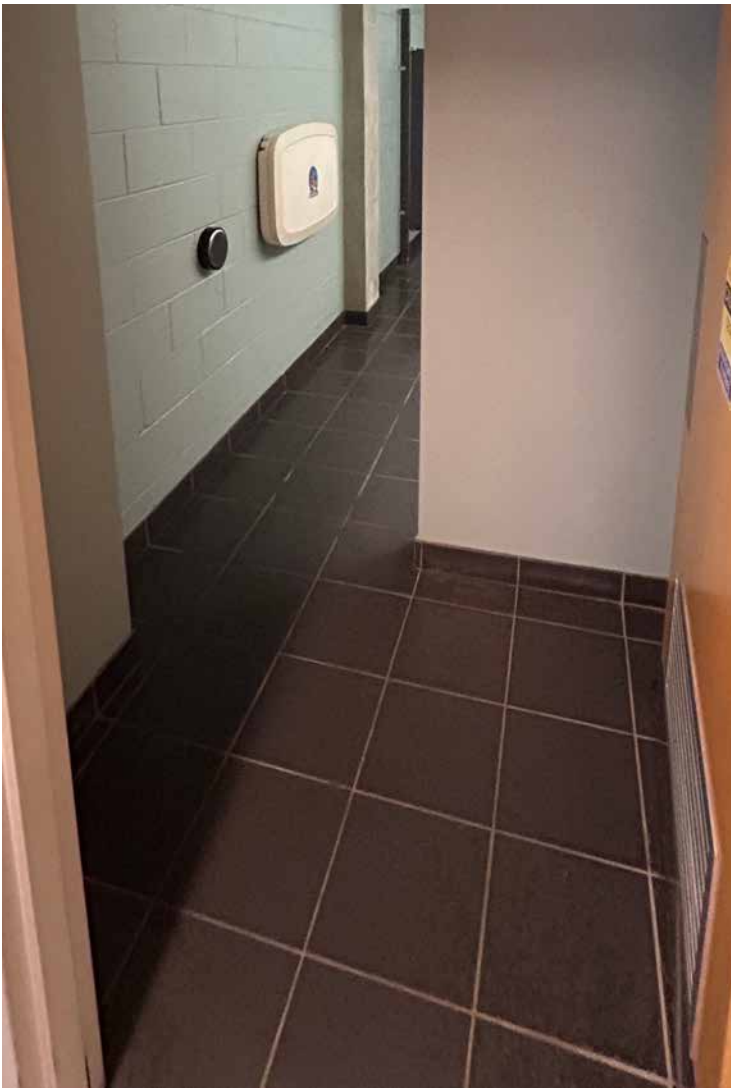
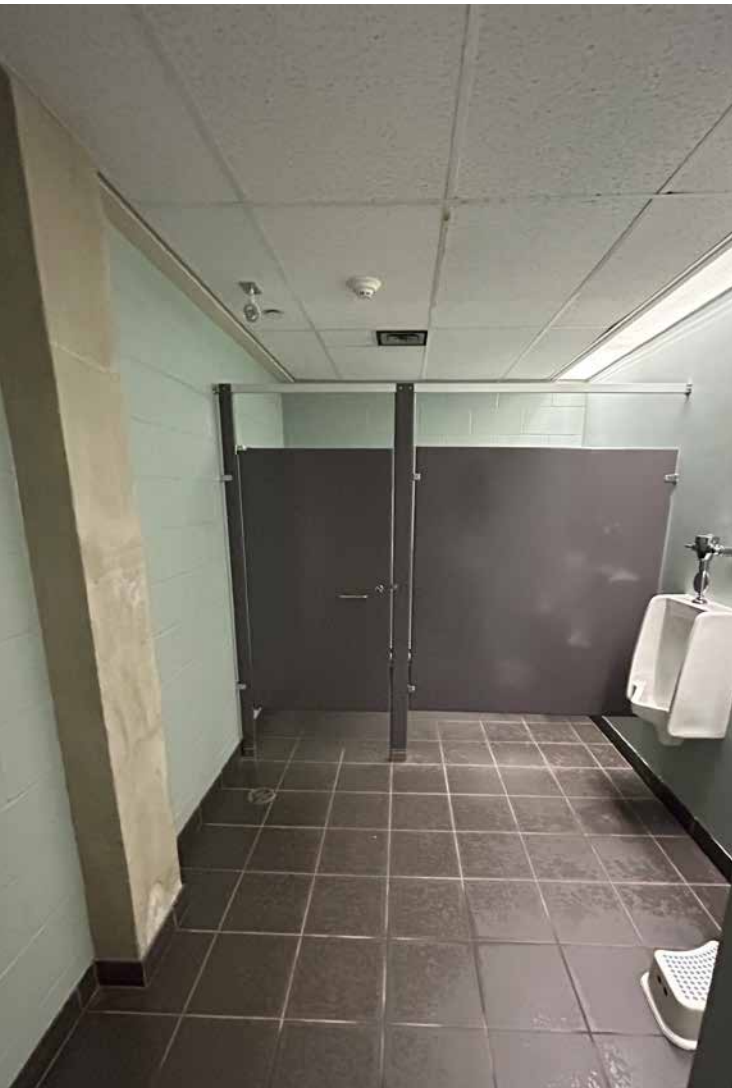
Power door operators have been provided on the doors of the gendered washrooms.

Bar-style push buttons would be a better choice as they can be operated from a variety of heights. The opening and hold-open time are sufficient.

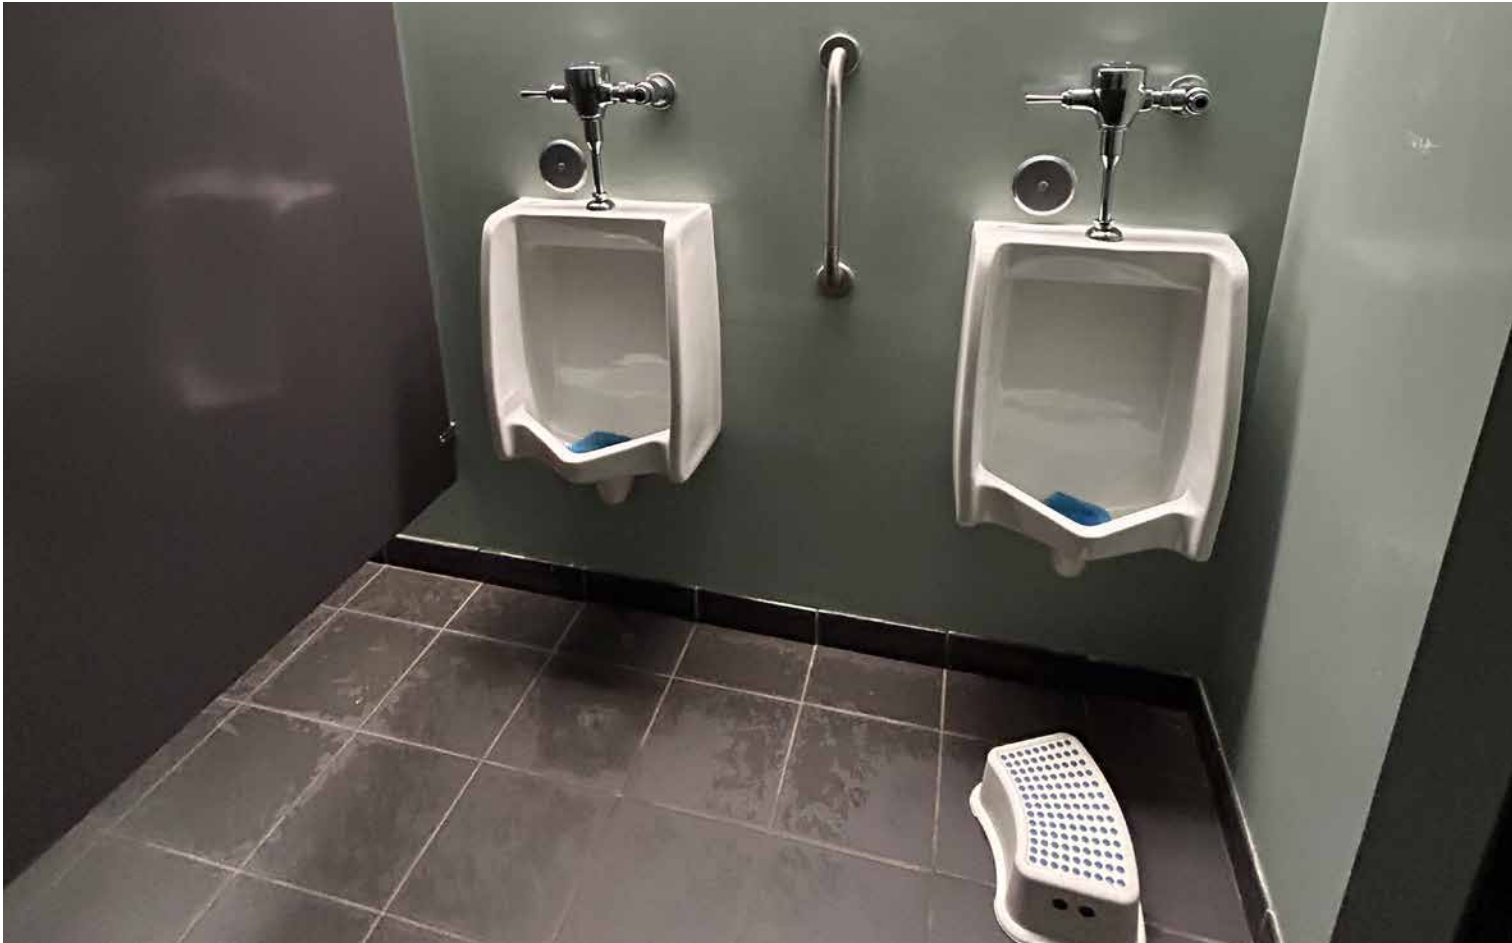
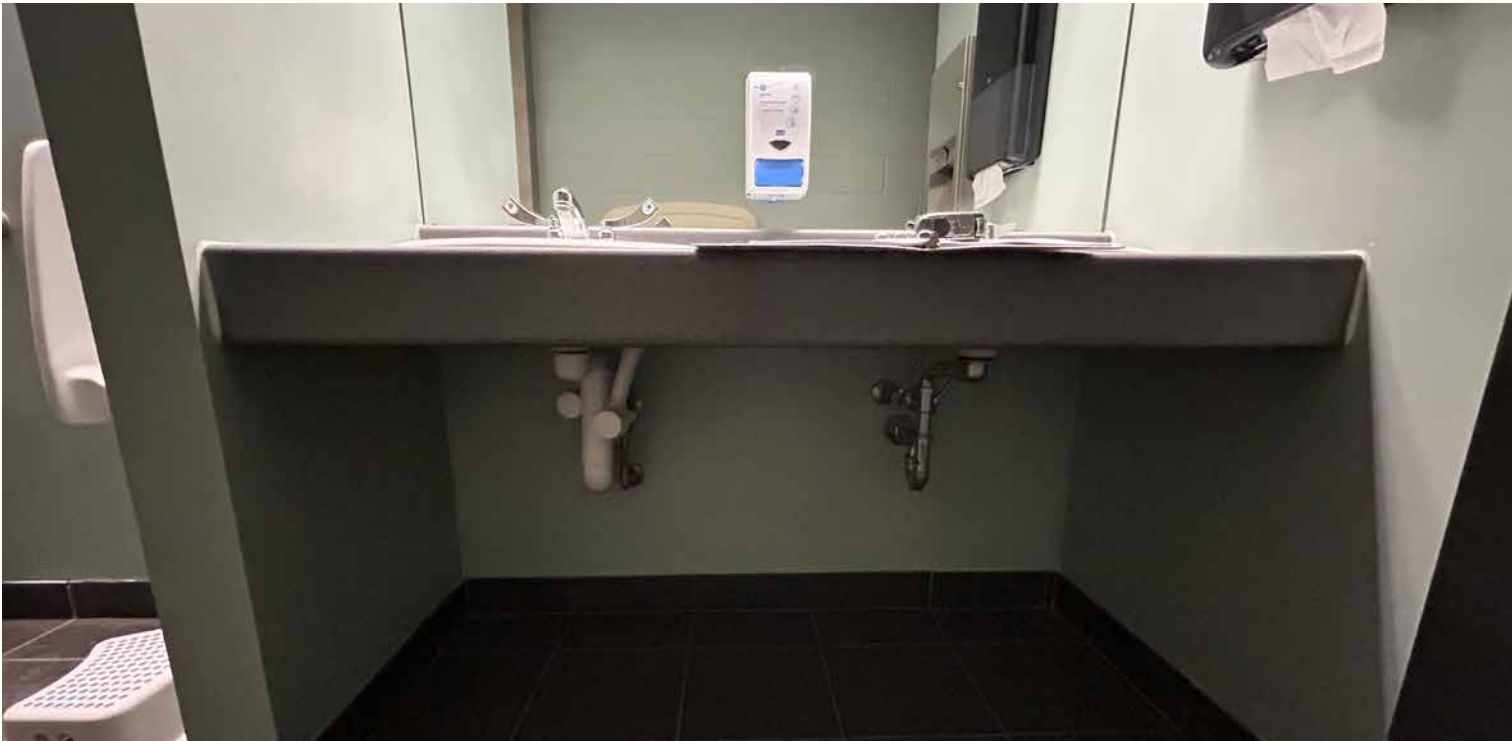
The corridor leading into the men's washroom is a bit narrow, and the lighting levels in both gendered washrooms are low with strong pools of light and shadow.

Stall locks in both washrooms are rotary style, which are challenging to operate for people with flexibility and dexterity issues. Stall doors also should have vertically-mounted pulls to help close them.

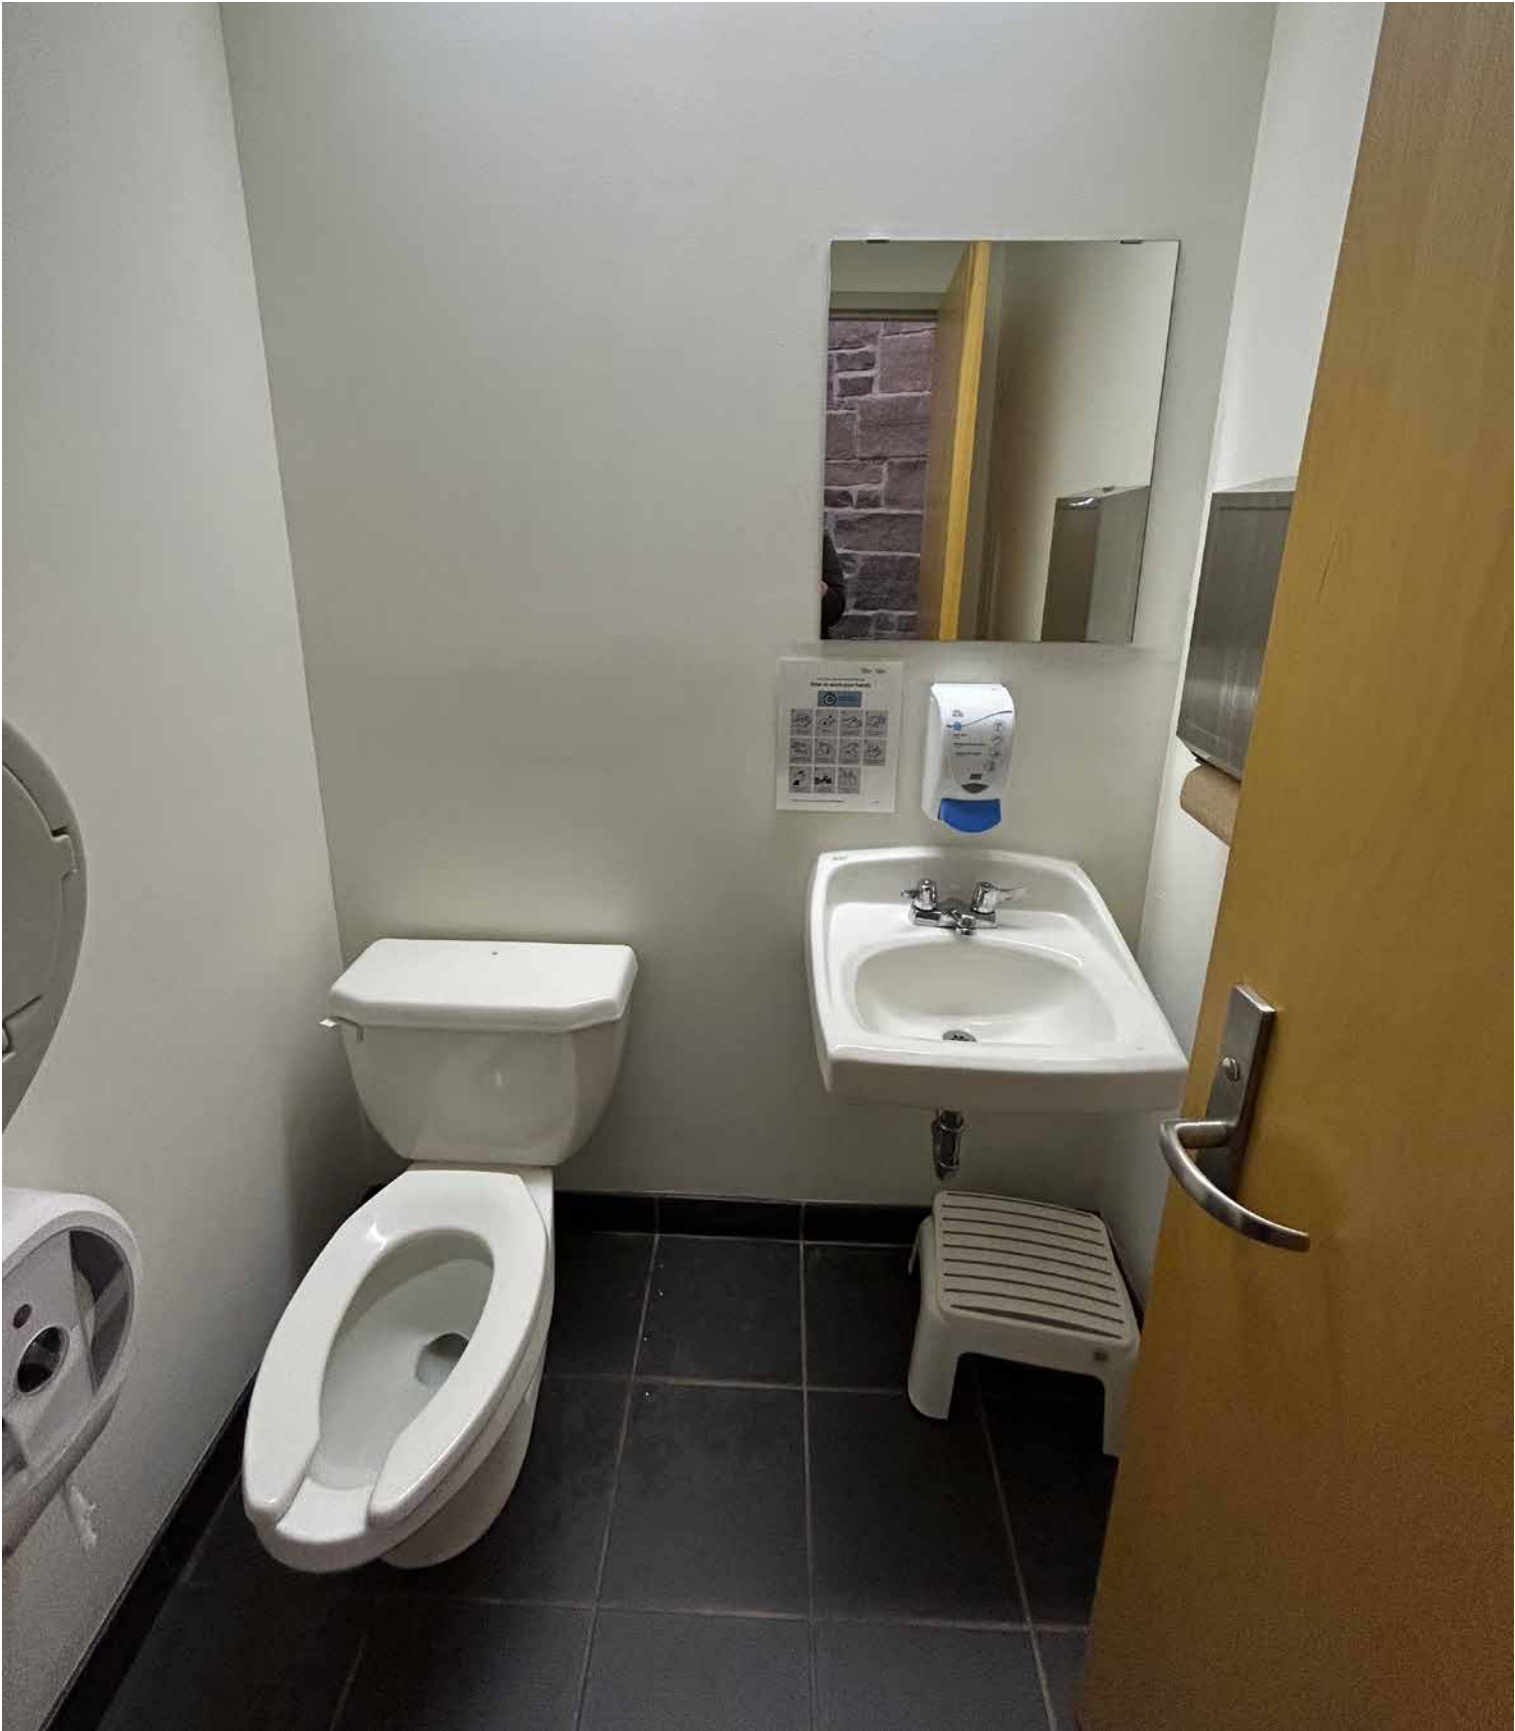
Grab bars behind toilets have the correct size and mounting height, but other grab bars have incorrect configuration and placement.

Some of the pipes are uninsulated, which presents a risk of burns if someone’s knees are beneath the counter.

Flush valves should be located on the transfer side of the toilet, where they can be reached.

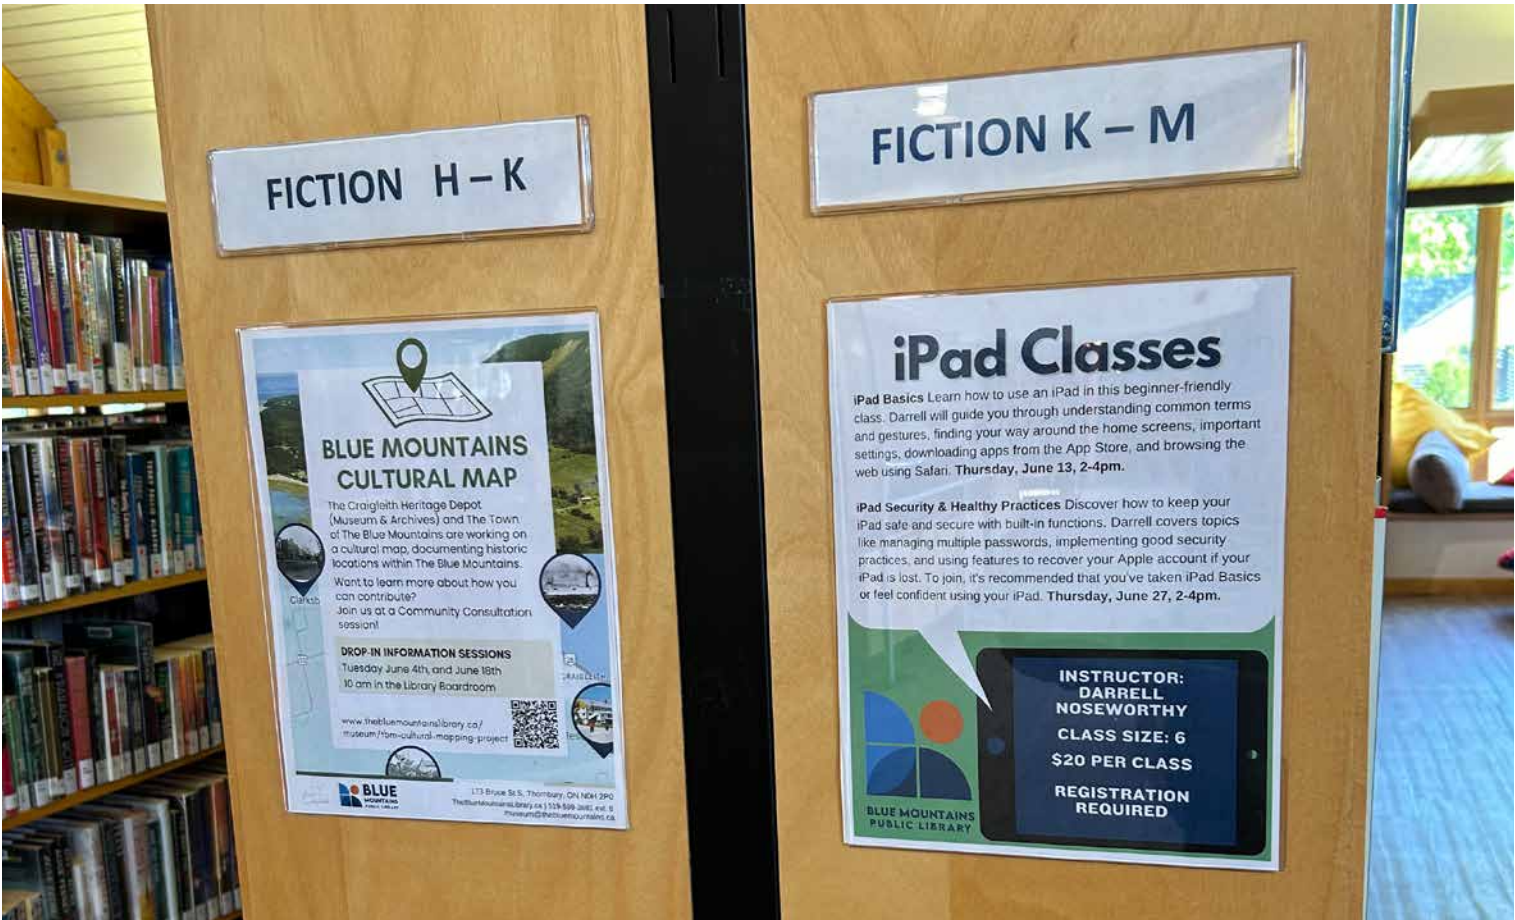
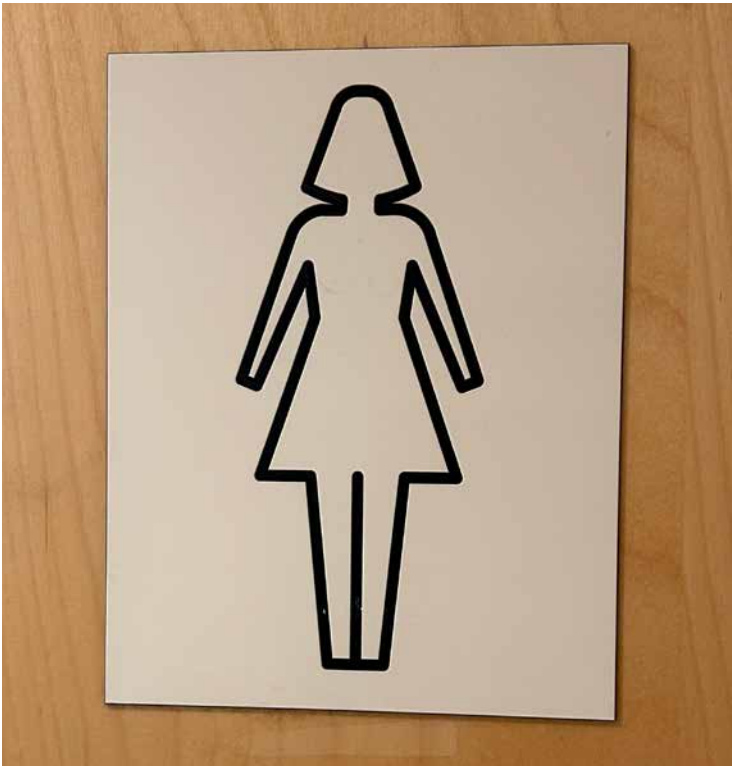
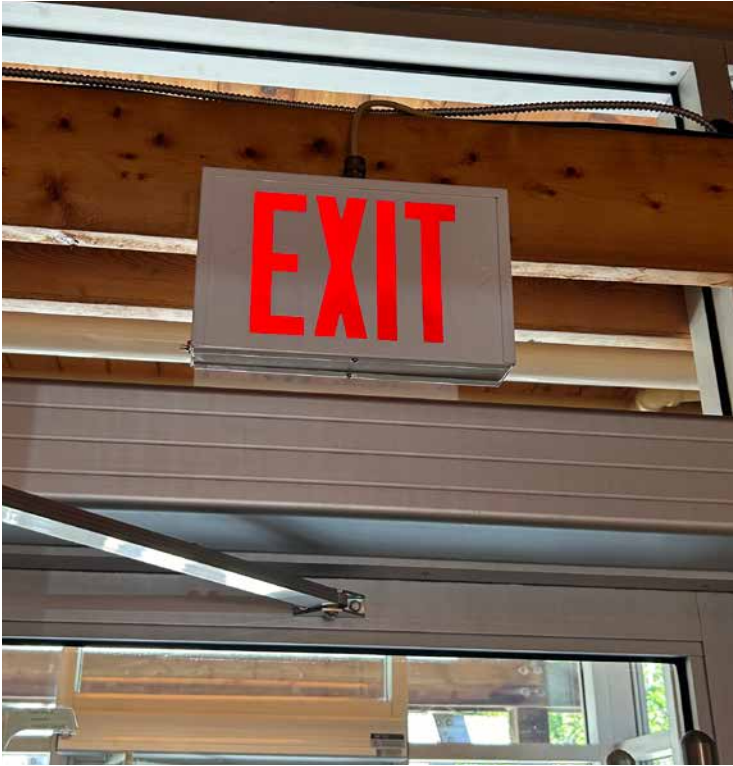
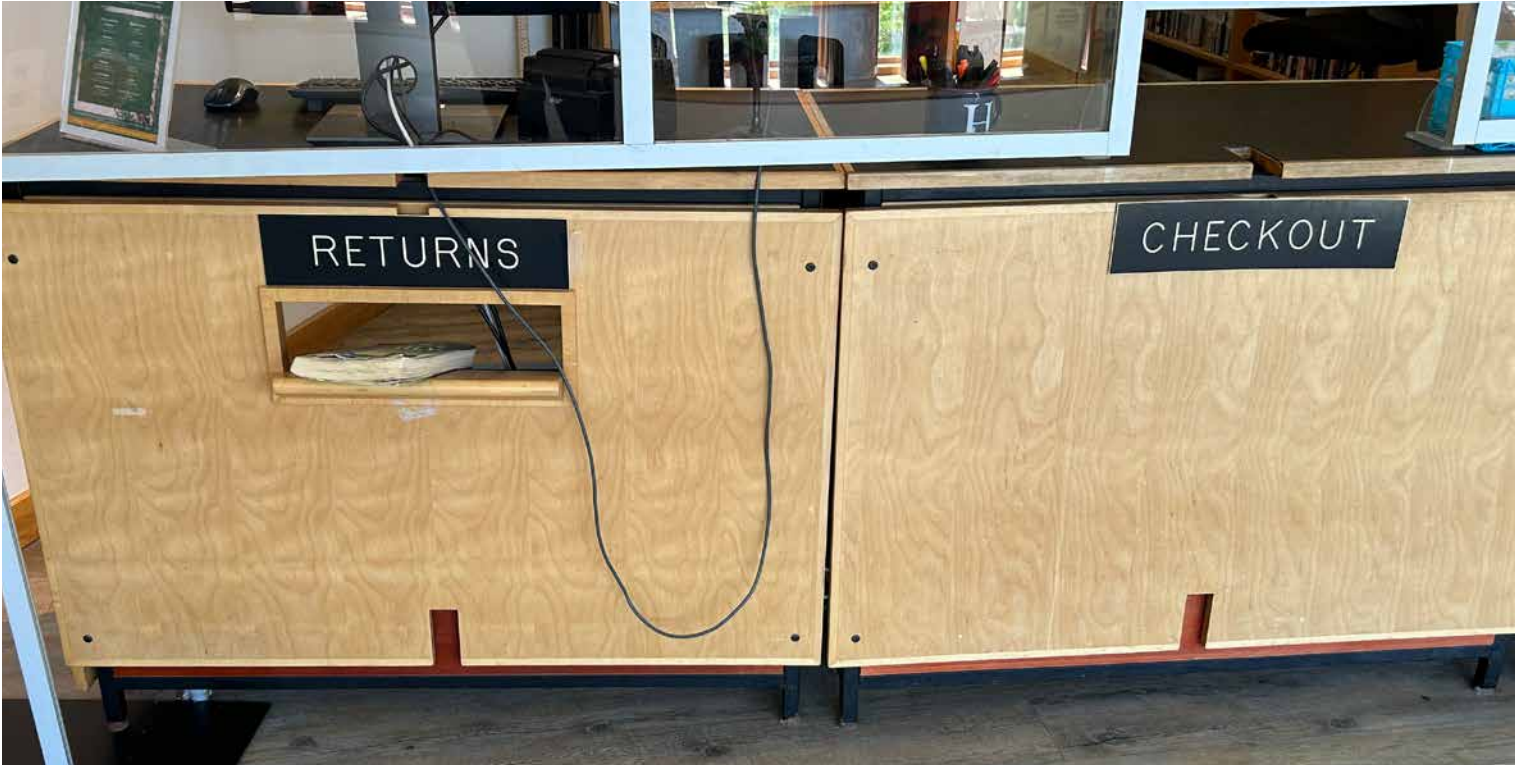
The building has lots of signage, but it lacks consistency and features that would make it more accessible.

Exit signs are of the older style that read "EXIT" in red letters.

Upgrading to new "green running man" exit signs is not required unless renovating, but could be considered.

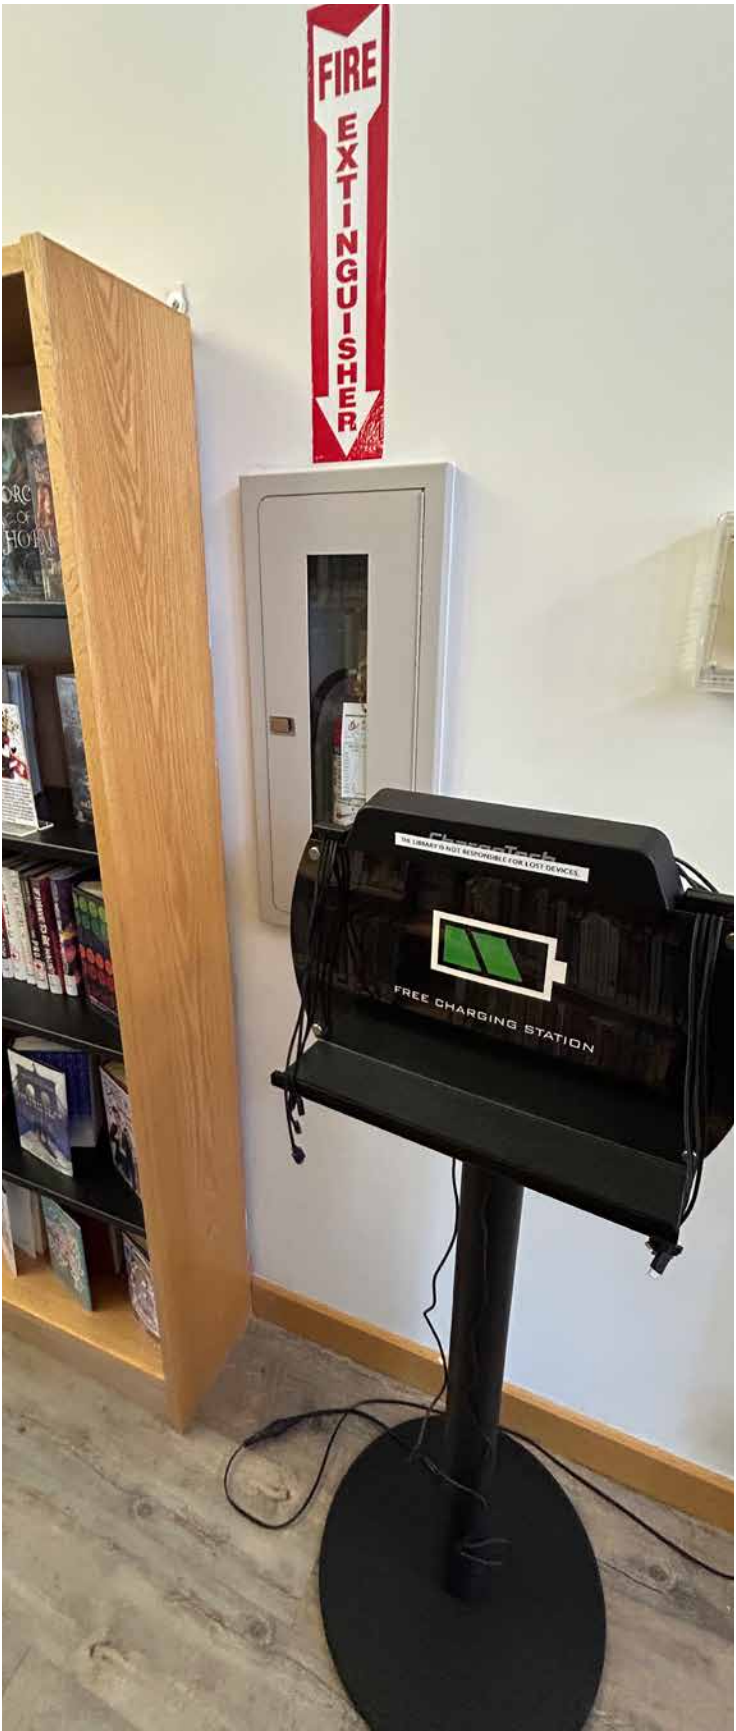
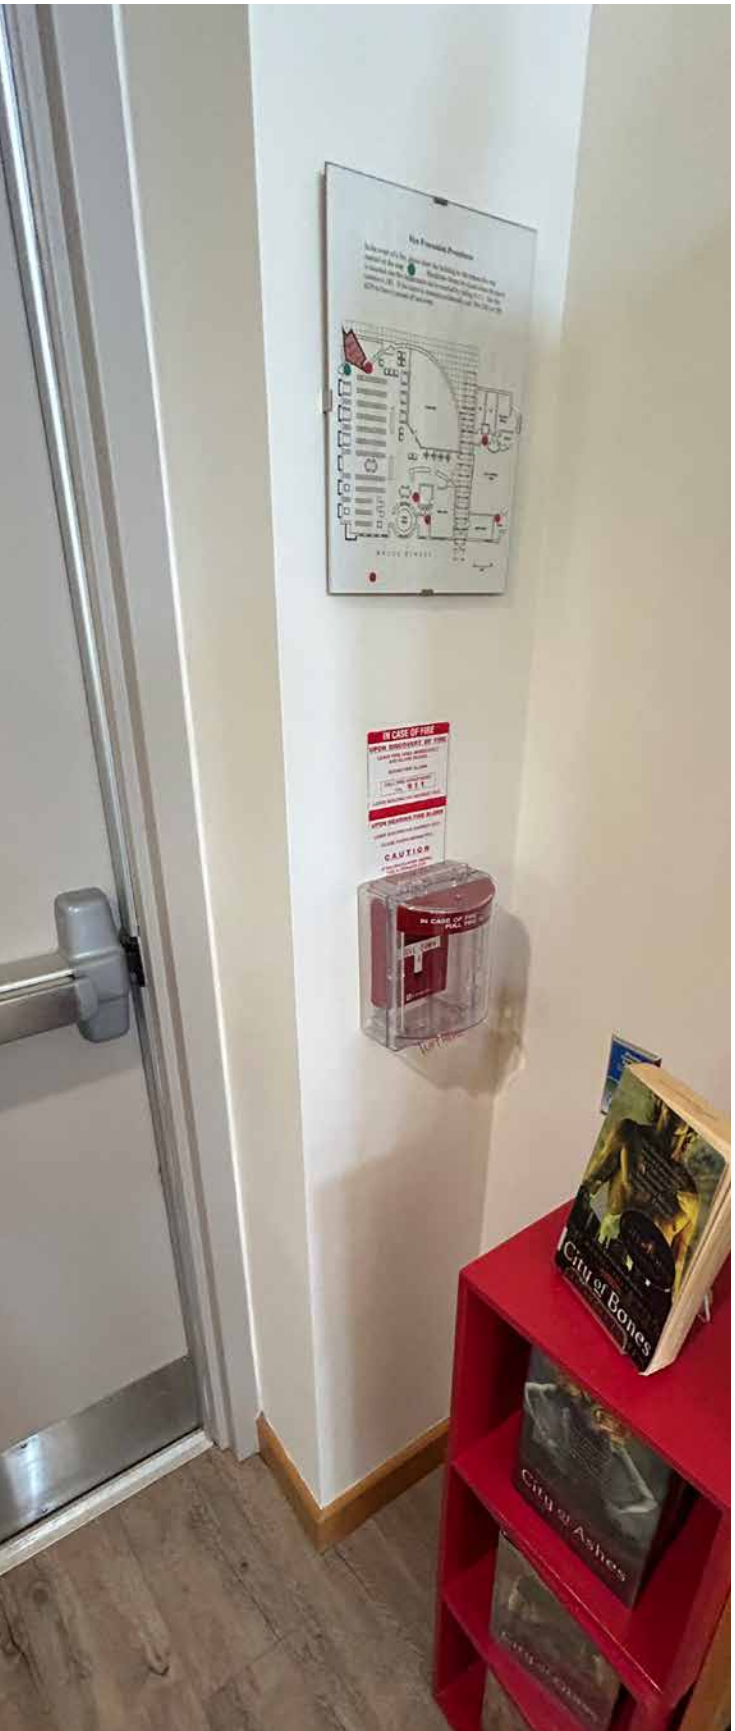
The building has visual fire alarms in some parts of the building, but they appear to be in compliance with the OBC requirements for visual fire alarms in assembly occupancies, which is inadequate.

All emergency systems should be mounted within accessible reach, and away from corners of walls or other obstacles so that someone using a wheeled mobility device has the clear space to approach and operate the equipment.

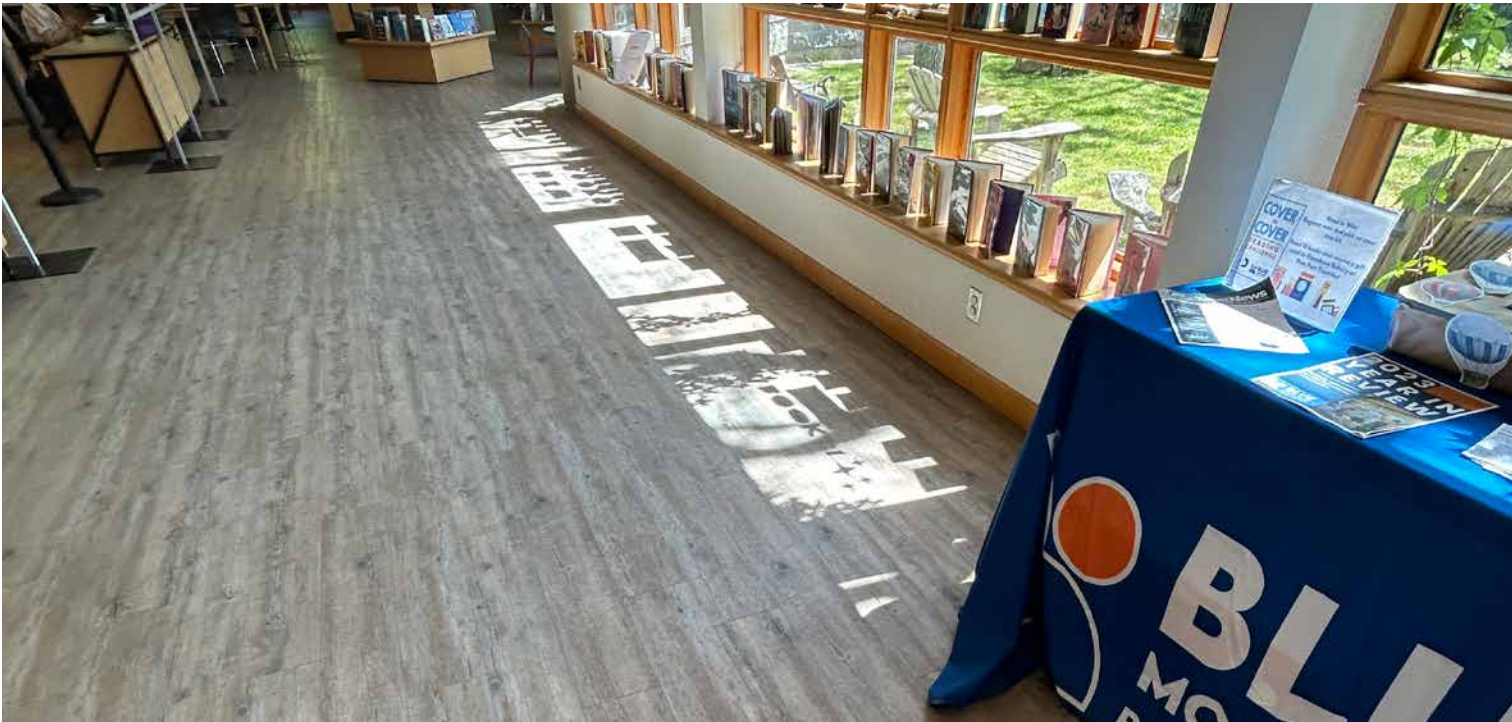
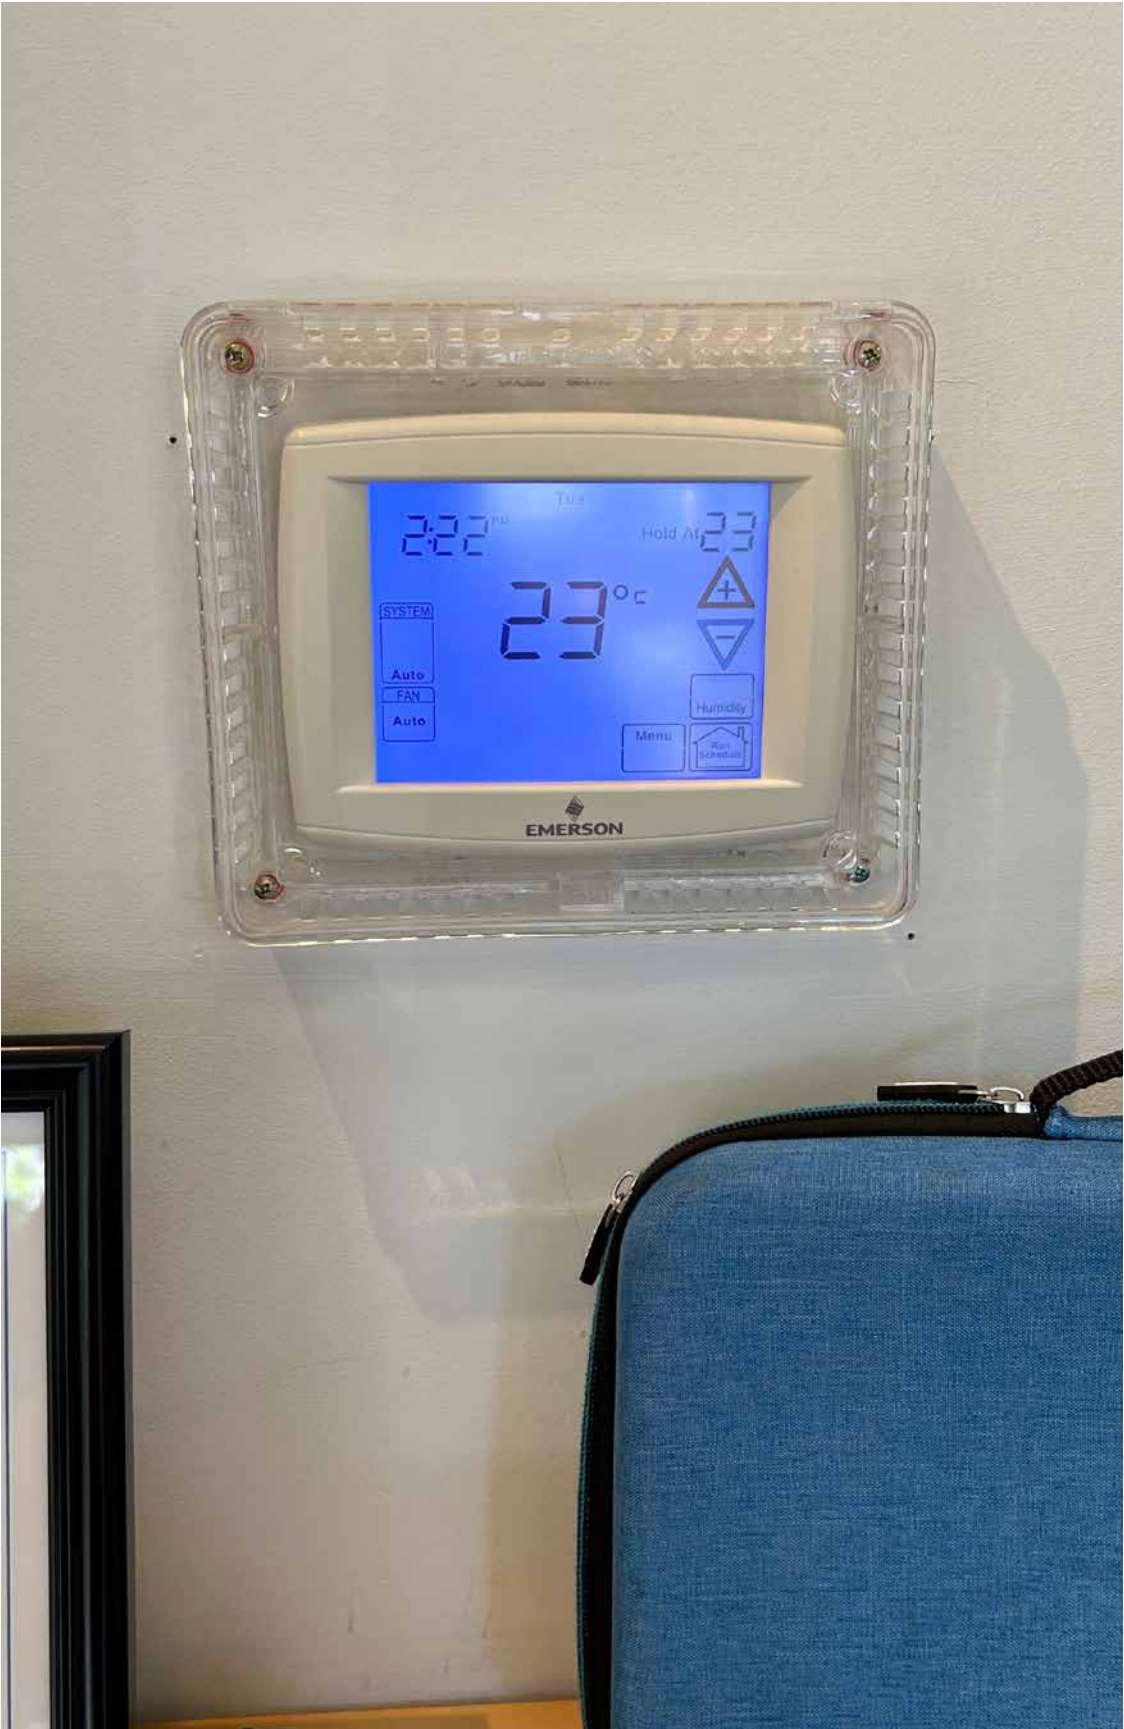
Thermostats are mounted outside of accessible reach and the touchscreen controls would not be usable by people with visual impairments.

It is recommended to change this to a model with physical buttons.

Where appropriate, glass can be replaced with insulated light diffusing glazing.
