Unity Design Studio was commissioned by the Town of The Blue Mountains and the Blue Mountains Public Library to review the accessibility of the L.E Shore Memorial Library at 173 Bruce St South in Thornbury.

Unity Design Studios’ scope of work included a visit to the building to assess current conditions as they relate to accessibility, and to subsequently propose various possible improvements that could be undertaken to improve the meaningful accessibility of the site.

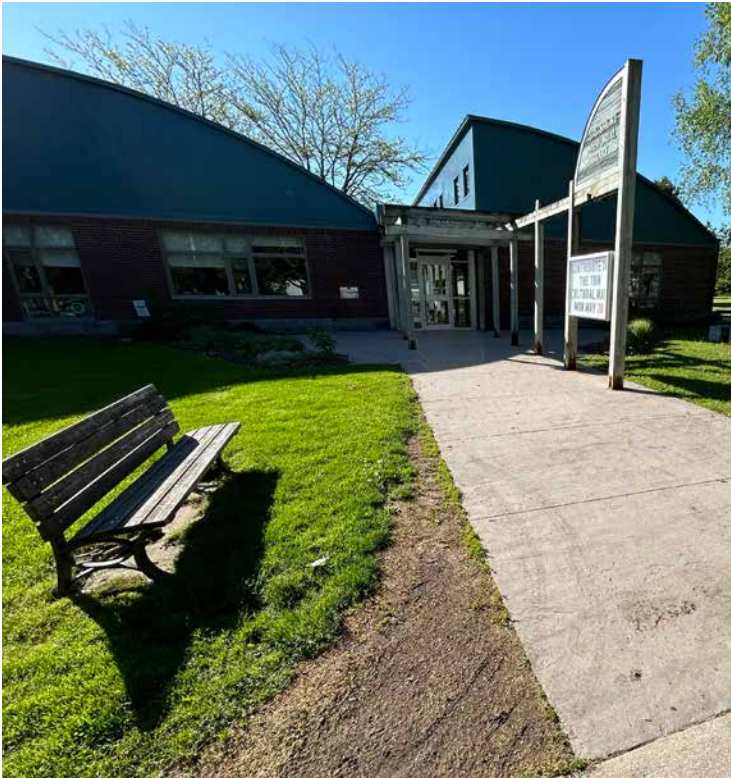
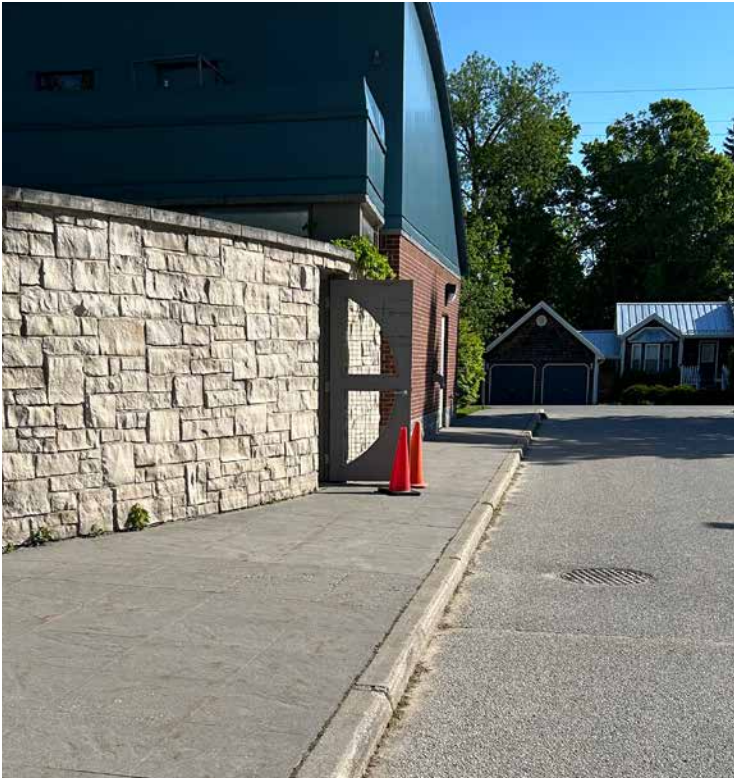
Doors into the courtyard have a 200mm step down into the courtyard area with no access ramps or sloping walkways, which make this space inaccessible to people in wheeled mobility devices.

Having a step right on the threshold of a door is also a safety hazard.

- Provide access to courtyard: level concrete pads that are 1700 x 1700mm in size, that ramp down into the courtyard space at a slope of at least 1:12, but over 1:20 is preferred
- Provide access to outdoor areas via hardscaped pathways. Note that pavers can be problematic as they can lift or spall over time – concrete is preferred.
- Provide accessible seating in outdoor areas: seats at accessible height with backs, options with and without arms, and that contrast with surroundings.

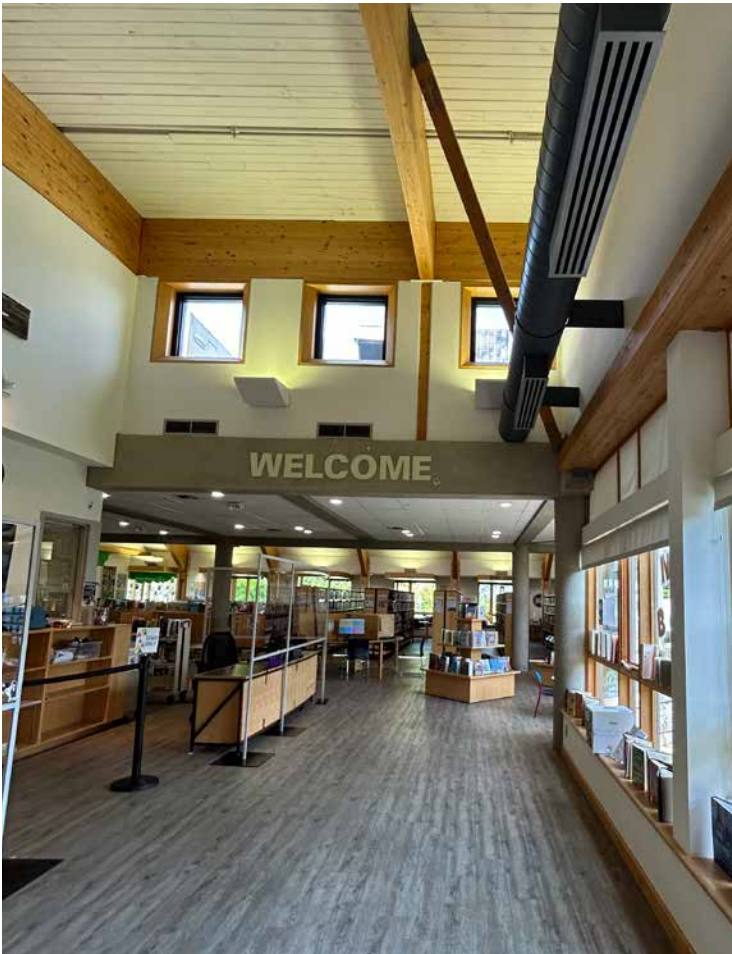
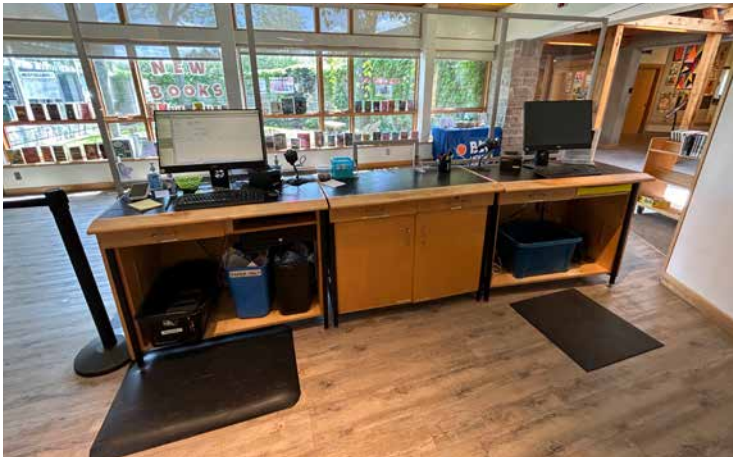
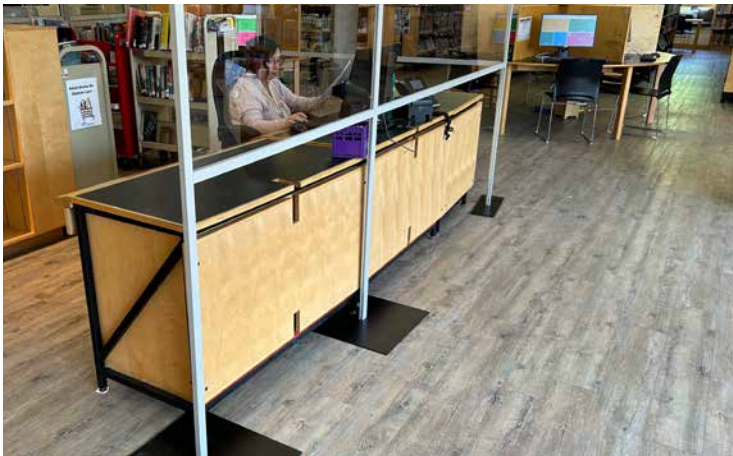
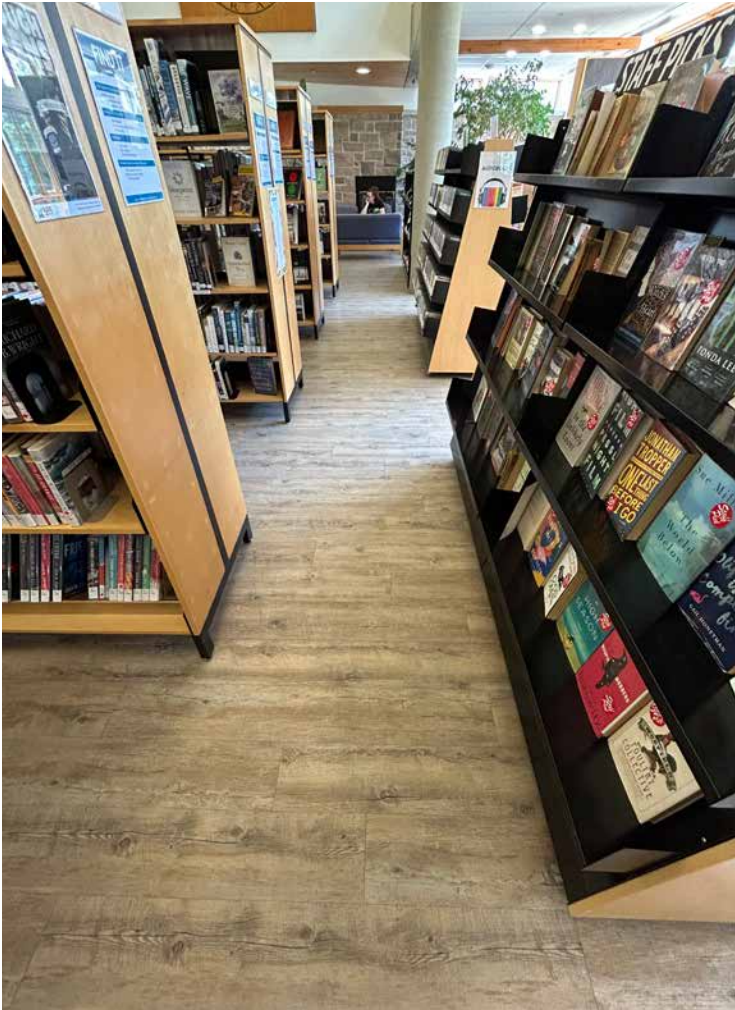
Within the book stacks, the top two shelves and bottom of the lowest shelf are not within accessible reach.

Many of the aisles comply with the minimum OBC width for accessible path of travel and they're close to the CSA B651 minimum, but there are some aisles that do not meet the OBC minimum.

| 19 | Replace or modify book stacks so that all shelves are within accessible reach. Select/fabricate product without any sharp edges. <ul style="list-style-type: none"><li>Shelves should be between 400-1200mm above floor finish, or 460-1100mm for better practice</li></ul> | | | | | | | | |

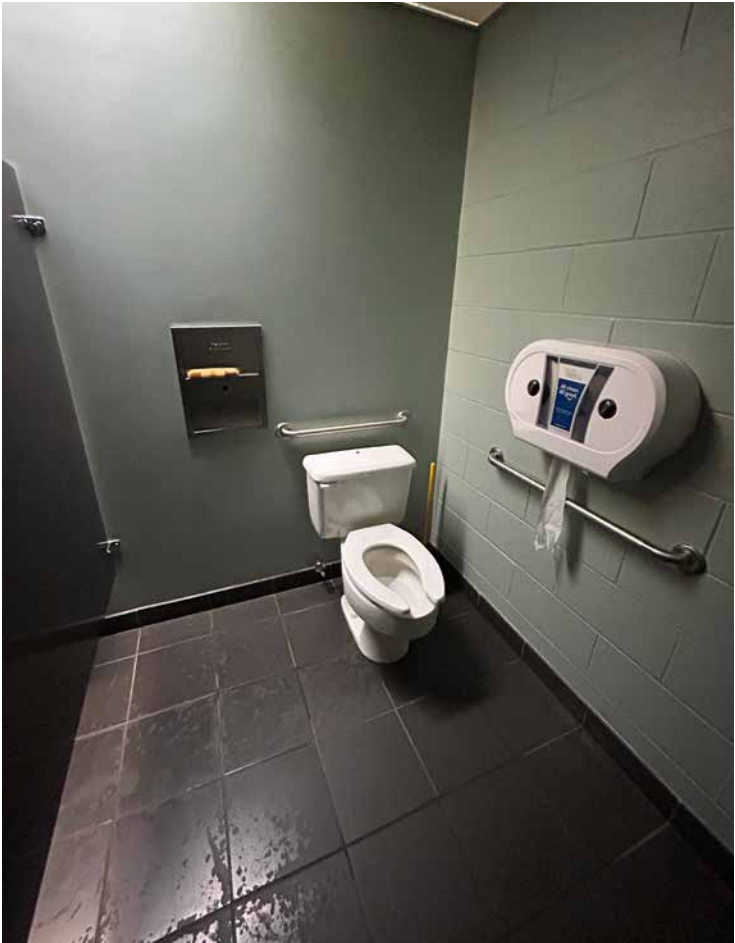
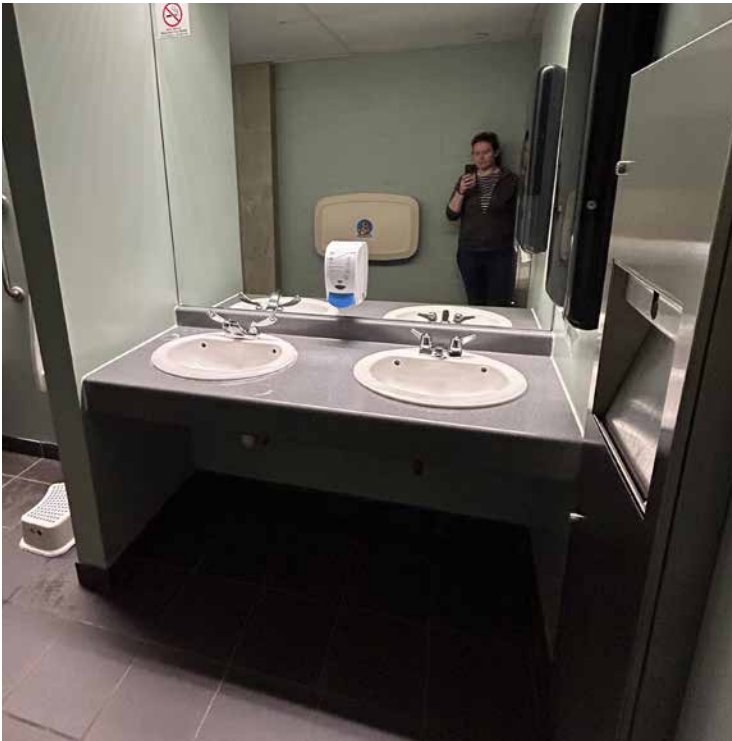
Grab bars behind toilets have the correct size and mounting height, but other grab bars have incorrect configuration and placement.

Flush valves should be located on the transfer side of the toilet, where they can be reached.

| # | Suggested Improvement | High Impact | Lower Impact | Short Term | Long Term |
|---|---|---|---|---|---|
| 34 | To improve the accessibility of the existing washrooms (universal washroom is being provided elsewhere): <ul style="list-style-type: none"><li>• Replace rotary style locks with sliding locks</li><li>• Orient washroom stall handles vertically</li><li>• Provide sinks at appropriate height and distance from side wall</li><li>• Insulate all sink pipes</li><li>• Provide single lever style faucets</li><li>• Ensure flush lever is on the transfer side of toilet</li><li>• Placement and mounting height of washroom accessories to meet OBC and CSA B651</li><li>• One urinal in the men's washroom should be made accessible. Mount with rim 430mm max from the floor, with appropriate size and configuration of grab bars</li></ul> | | | | |
